MH17 Crash

Crash of Malaysia Airlines flight MH17

Hrabove, Ukraine, 17 July 2014

The Hague, October 2015

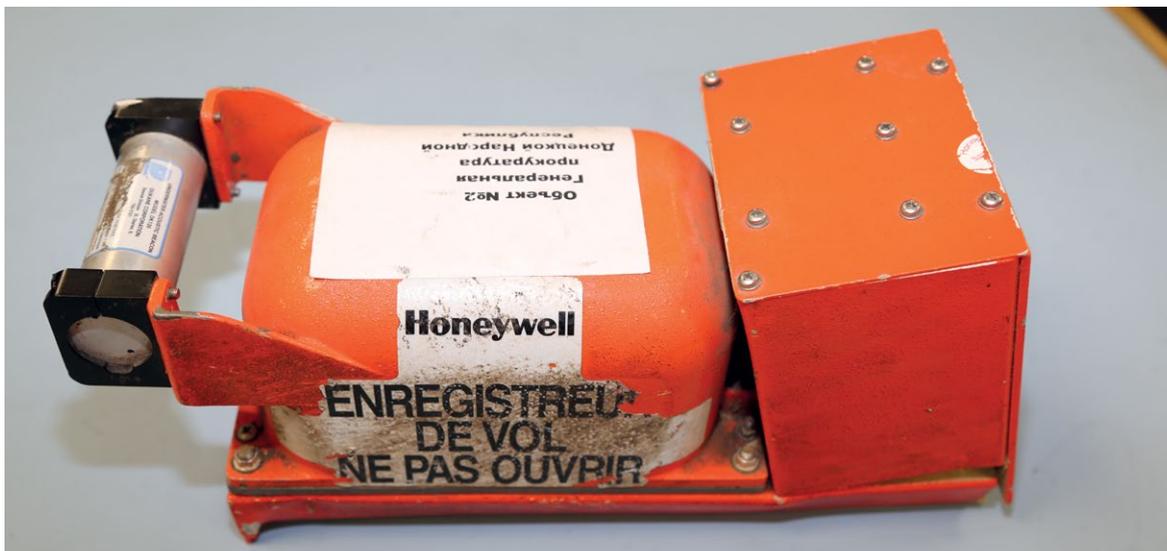
The housing of the Cockpit Voice Recorder (Figure 8) was damaged. The model and serial numbers were unreadable on the data plate, but the serial number 1366, was stamped on the underside of the chassis. The serial number 1366 was also provided by Malaysia Airlines. The external damage to the Cockpit Voice Recorder was consistent with impact damage; however, the internal memory module was intact. The Cockpit Voice Recorder was successfully downloaded and contained valid data from the flight.

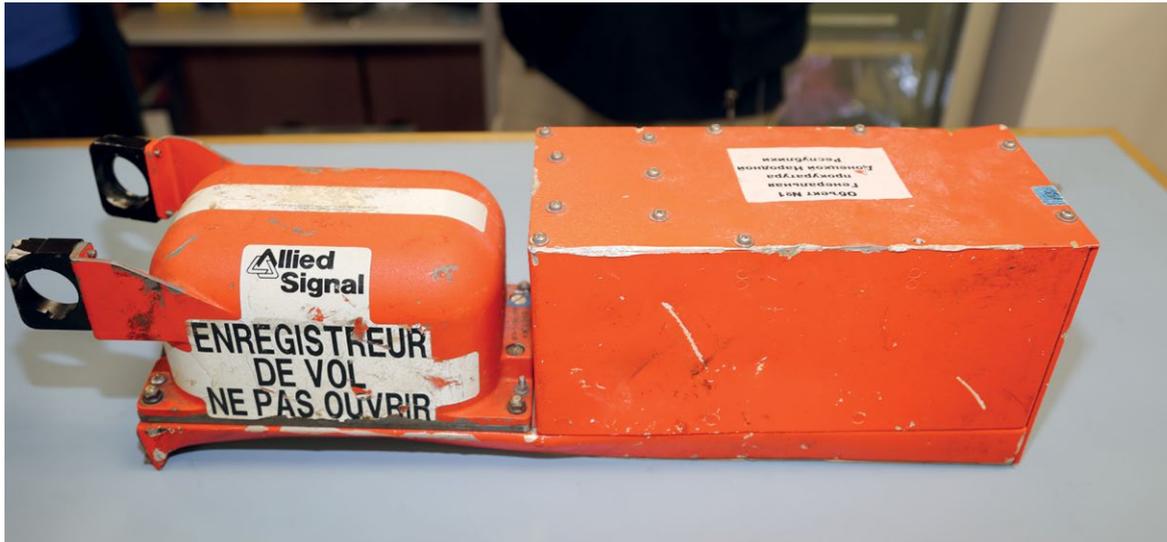
The exterior of the flight data recorder was slightly damaged, but the internal memory module was intact. The external damage on the Flight Data Recorder and the loss of the underwater locator beacon was consistent with impact damage. The Flight Data Recorder, designed so that a minimum of the last 25 hours of operational data is retained on the recording medium, was successfully downloaded and contained valid data from flight MH17.

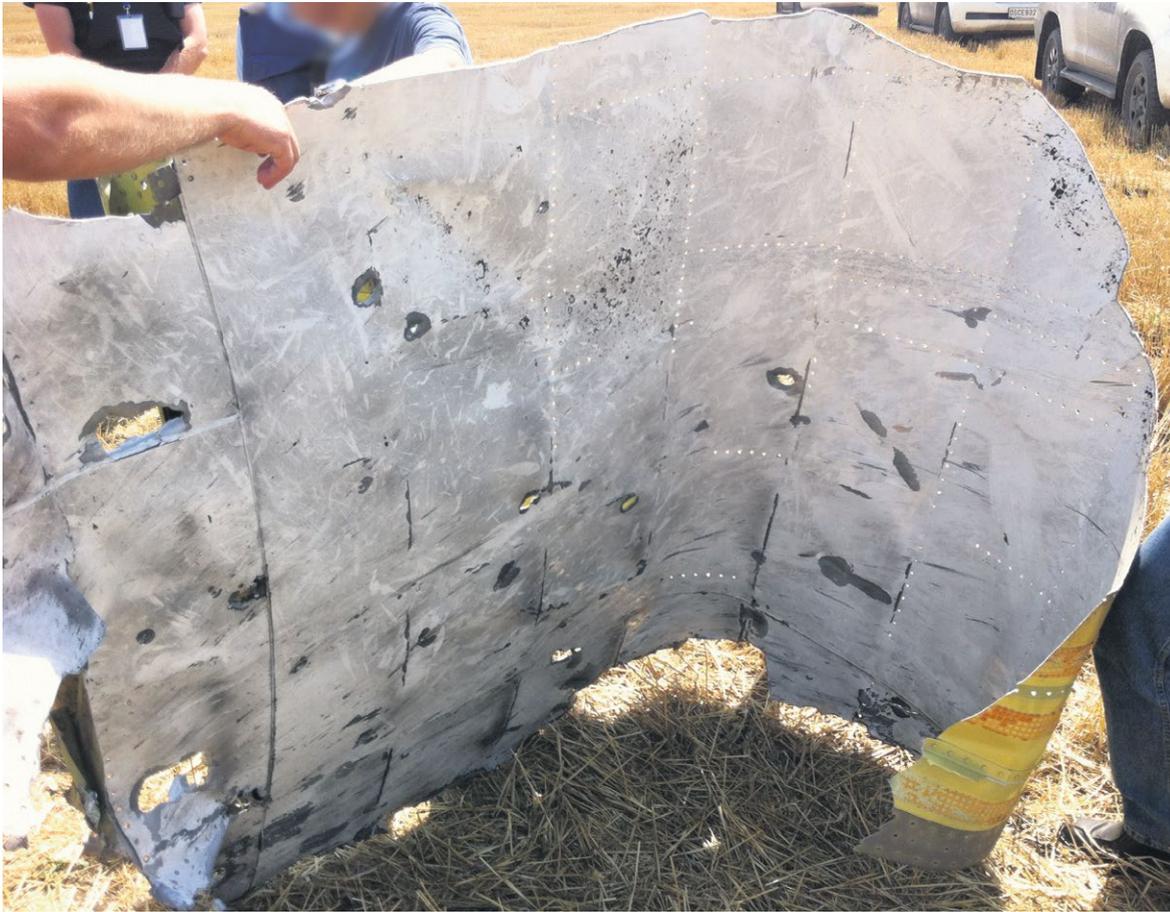
showed evidence of perforation from the outside. The aft side of the fuselage skin was bent upwards and a number of formers and stringers were missing from the fuselage. The upper side of the fuselage showed traces of soot.

Figure 15: Upper left hand cockpit fuselage. (Source: DCA Malaysia)

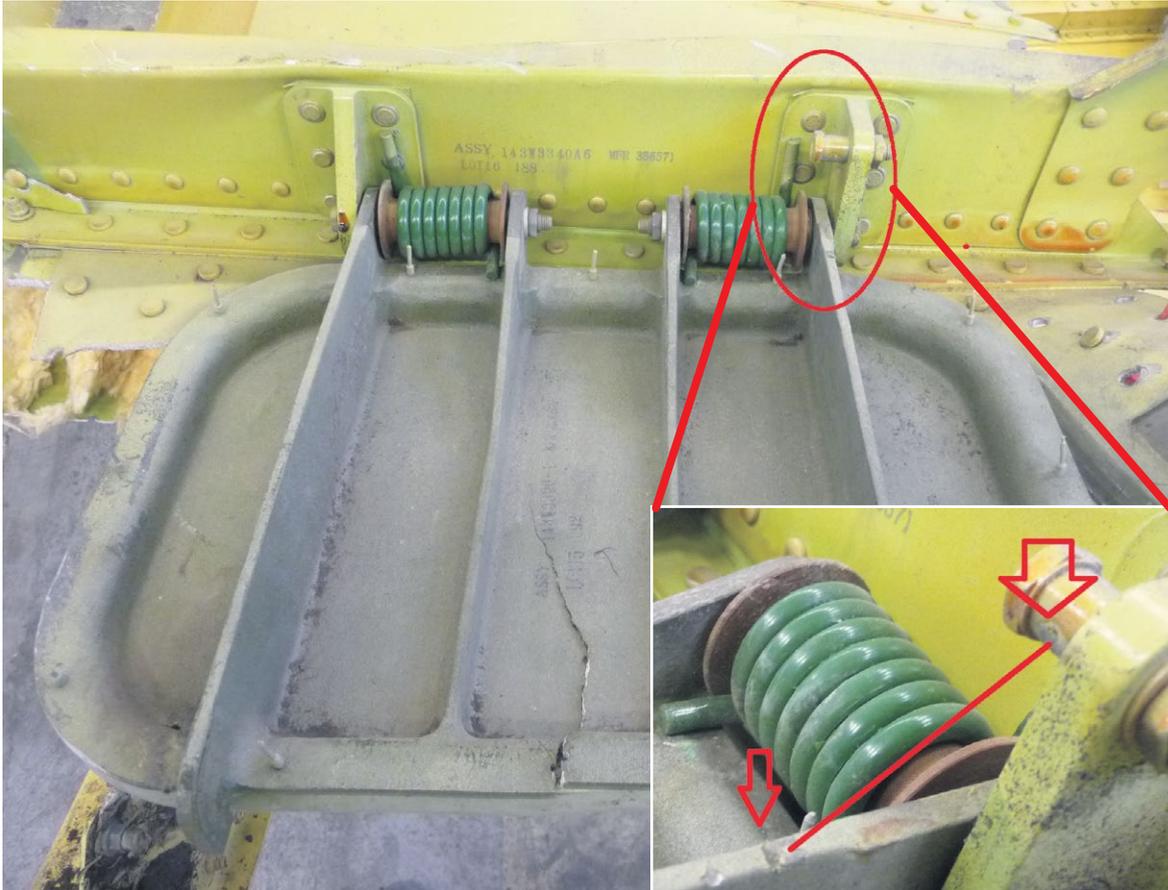
Figure 16: Inside of the valve in closed position with crack and marked bracket. Inset shows detail of the bracket with pin showing damage on pin and rib. (Source: Dutch Safety Board)

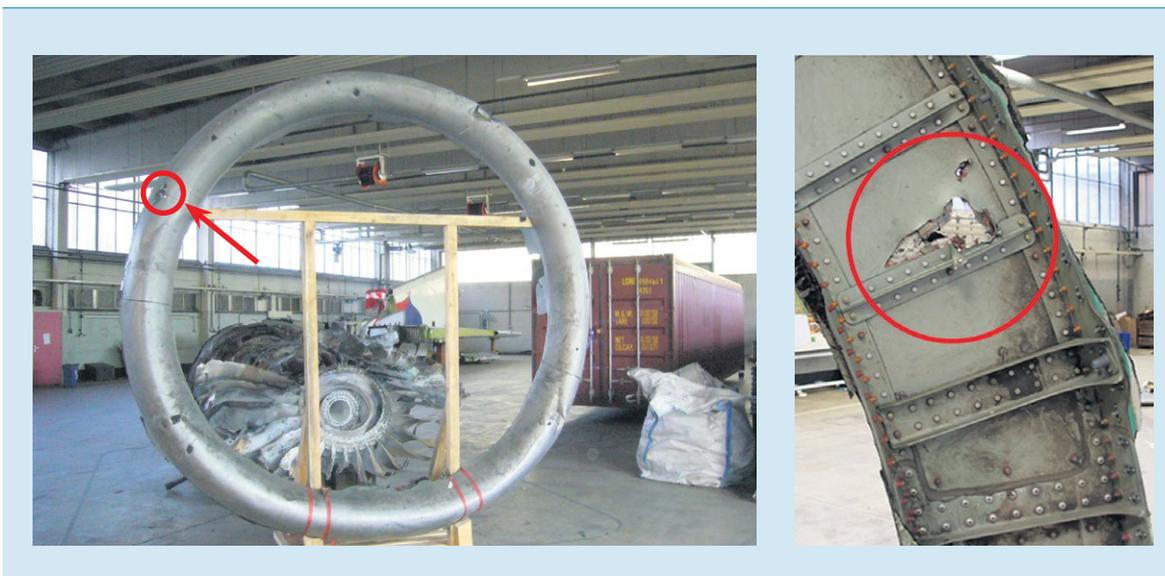
Figure 17: Damaged left engine intake ring, with impact marks seen from the front side (left photo) and from the rear side (right photo). (Source: Dutch Safety Board)

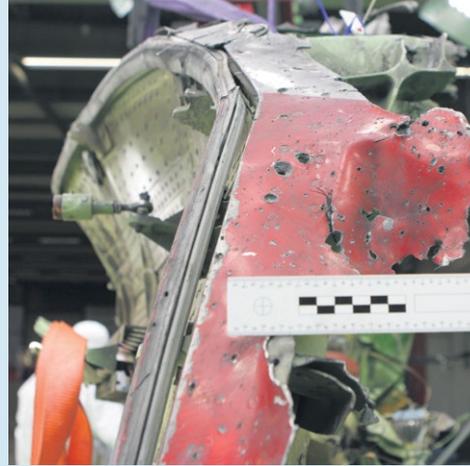
Figure 21: Puncture holes on left hand fuselage at the forward pressure bulkhead. (Source: Dutch Safety Board)

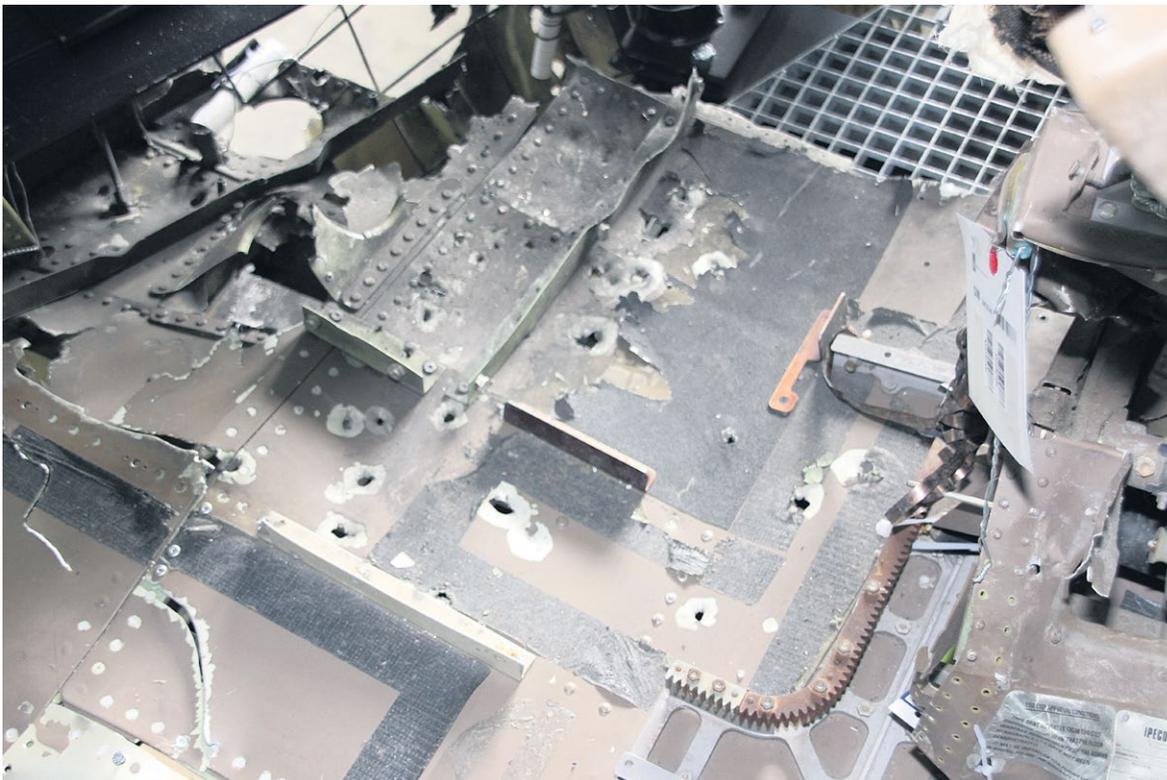
Figure 22: Cockpit floor with floor parts showing perforation holes. (Source: Dutch Safety Board)

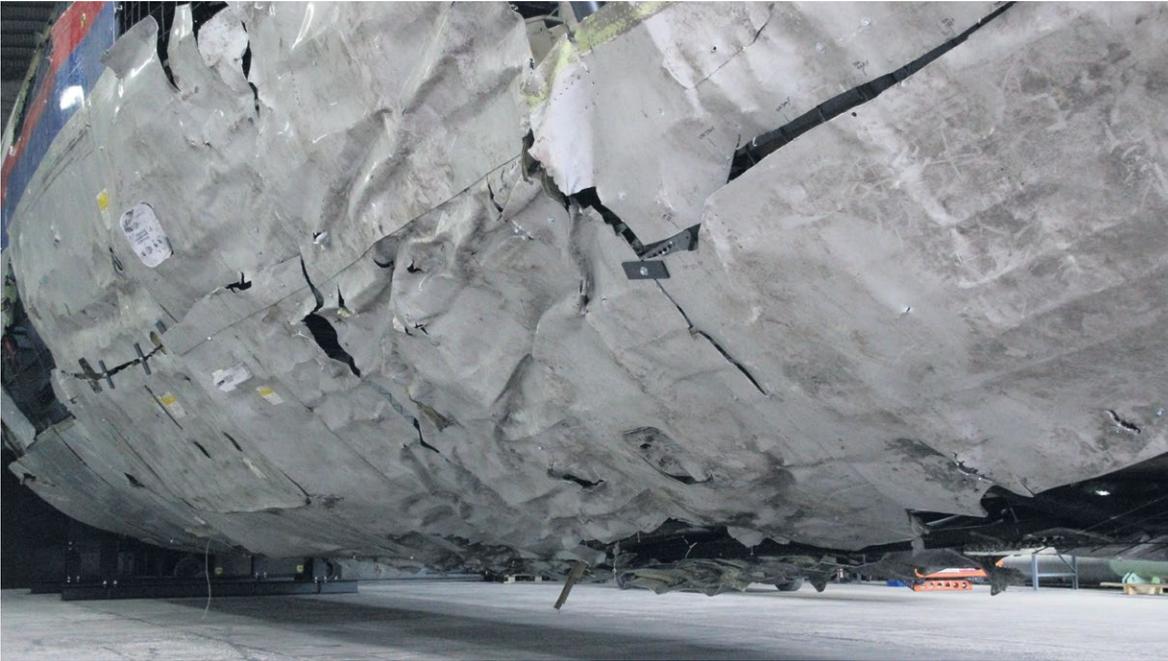
Figure 23: Fuselage skin pushed in between stringers and frame. (Source: Dutch Safety Board)

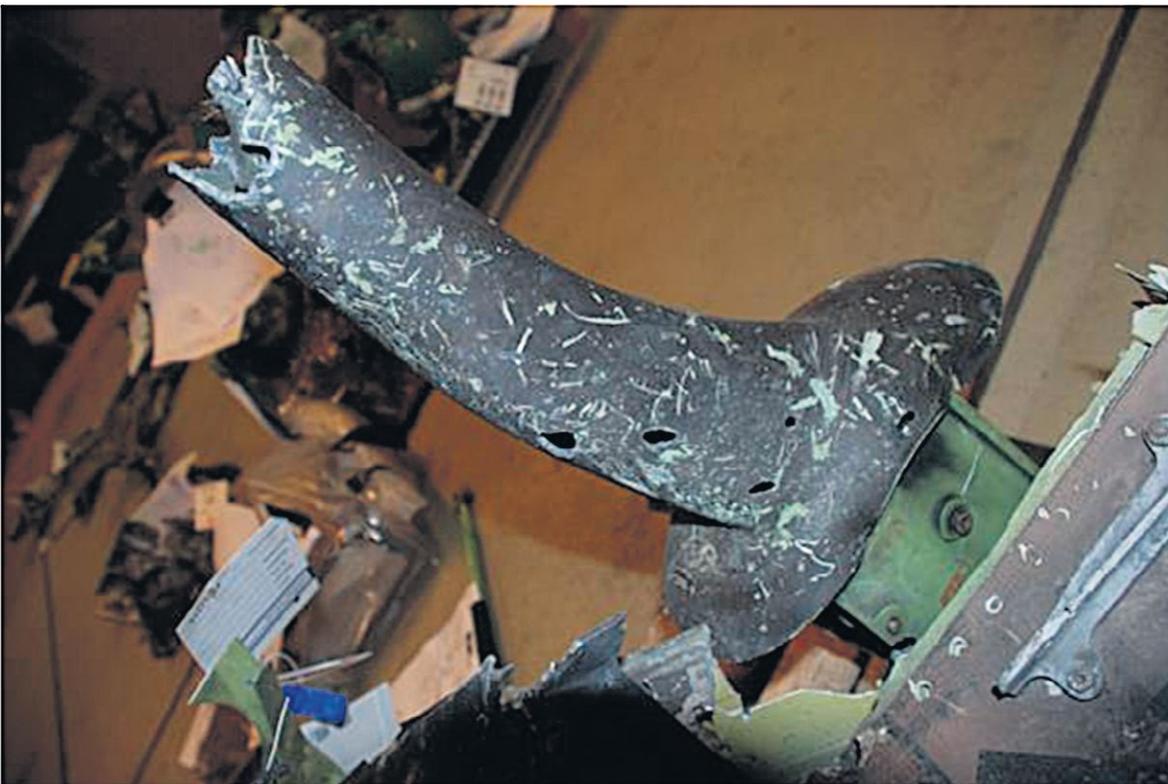
Figure 24: Lower part of Captain's control column showing perforation damage. (Source: NLR)

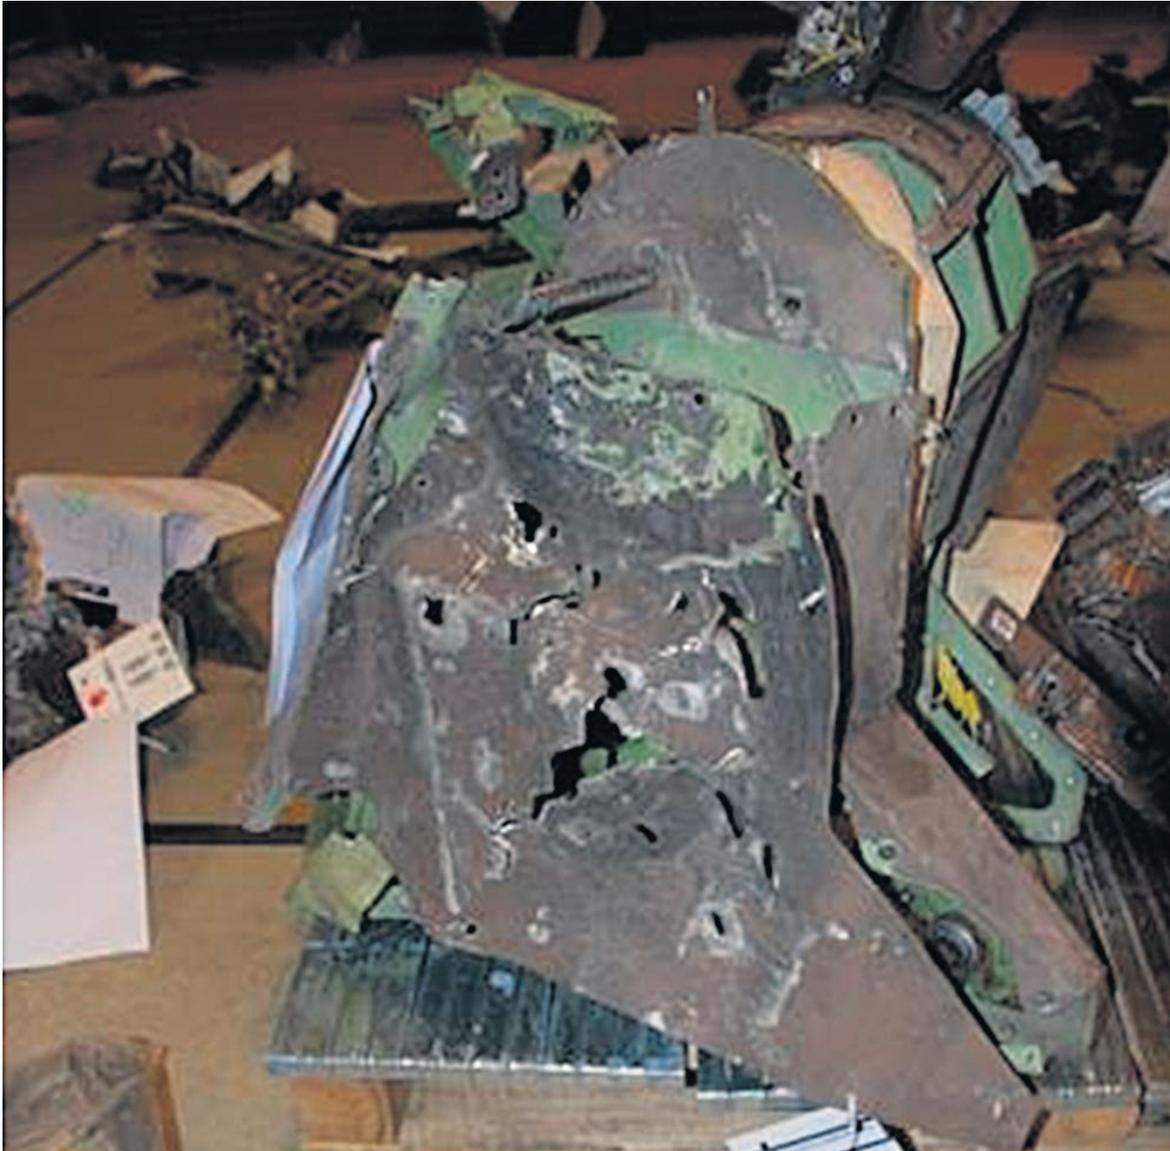
Figure 25: Throttle quadrant (viewed from the left hand side) showing perforation damage. (Source: NLR)

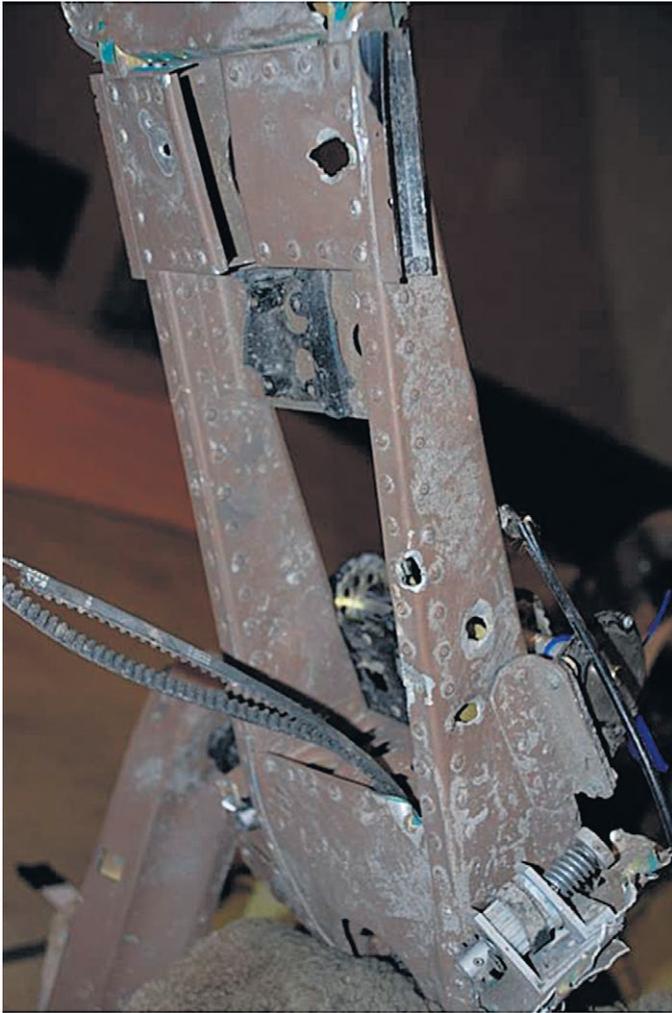
Figure 26: Backrest support of first officer's seat, showing perforation damage. (Source: NLR)

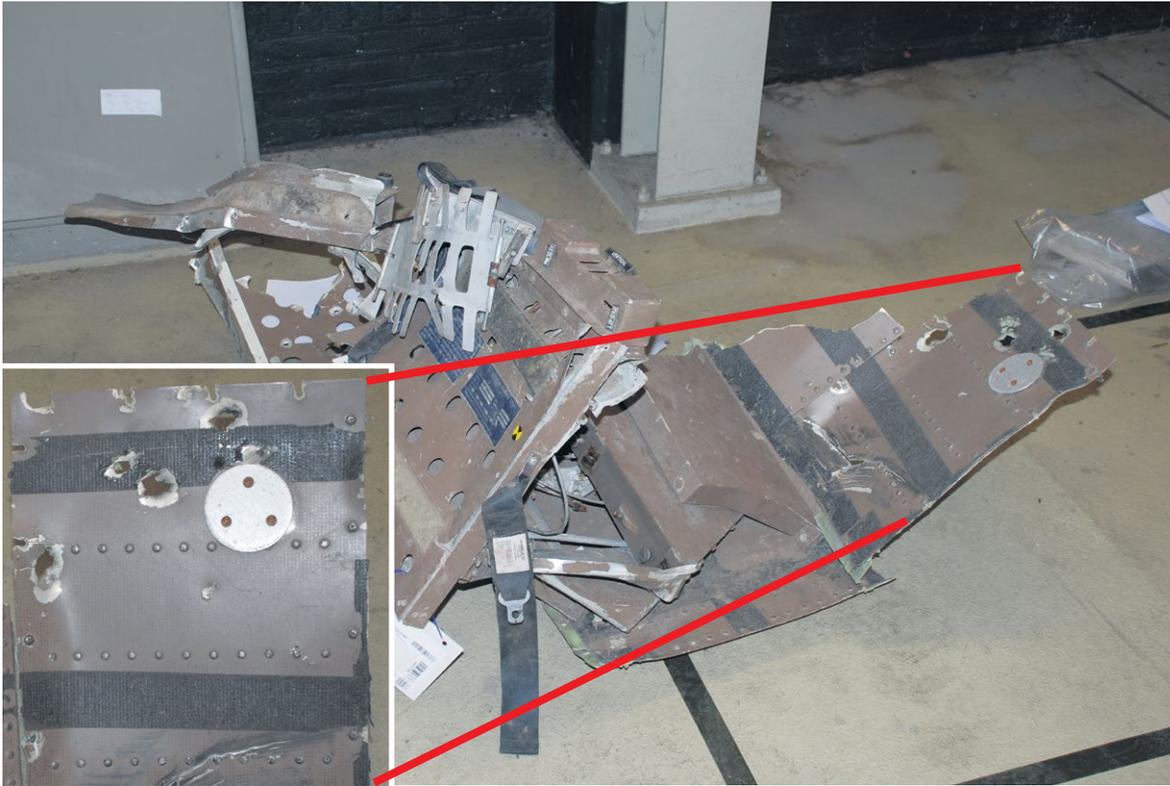
Figure 27: Perforation holes in seat back panel of left observer seat. Note: The seat back panel is shown flat on the floor in this image. (Source: NLR)

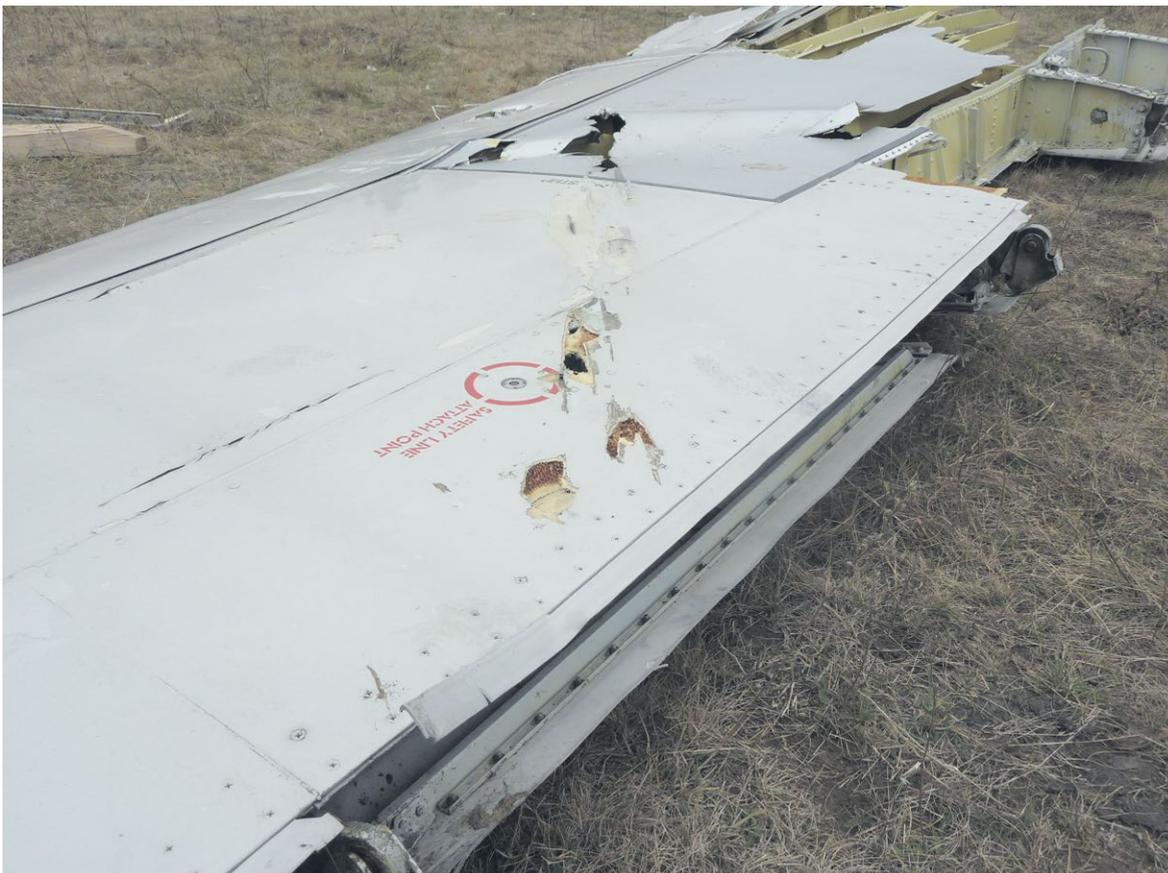
Figure 29: Left wing tip with impact damage near and outboard of the safety line attachment point. (Source: Dutch Safety Board)

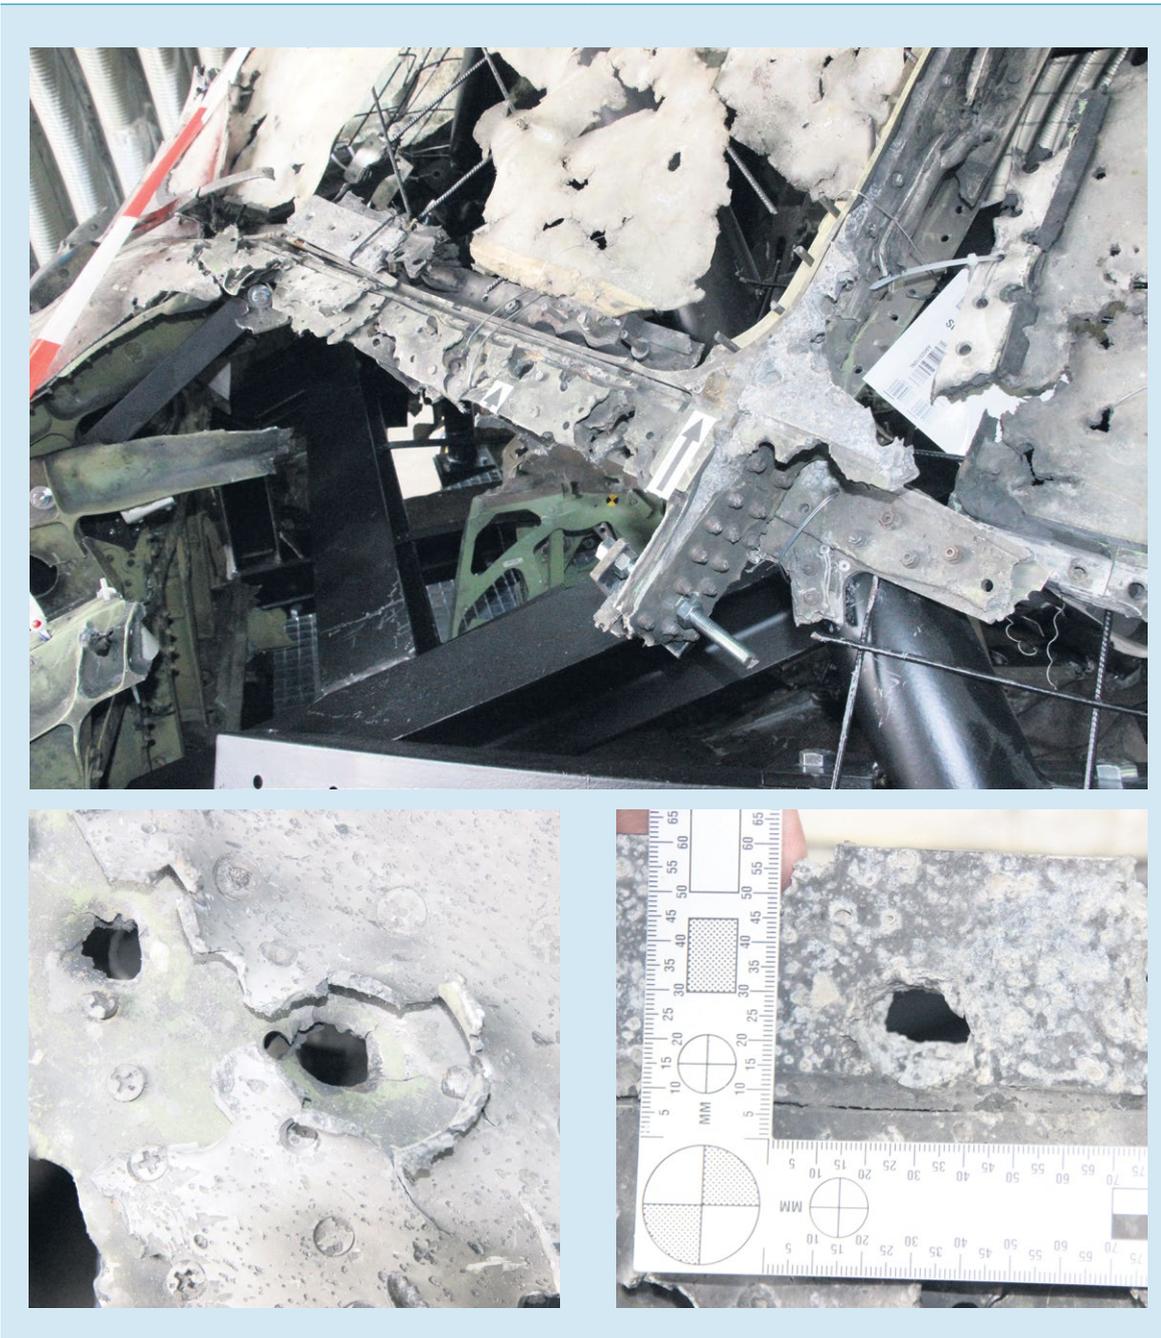
Figure 47: Part of the left hand cockpit window frame with enlarged detail. The perforation damage had a regular pattern of larger and smaller holes. (Source: Dutch Safety Board)

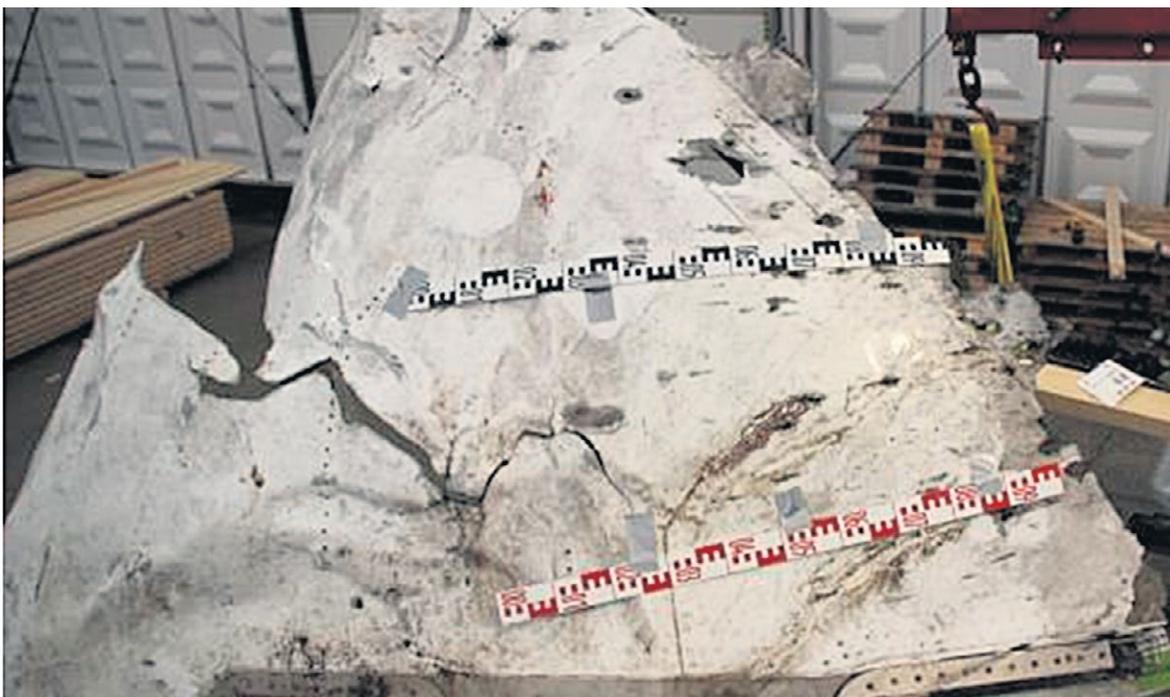
Figure 49: Grazing on cockpit roof. (Source: NLR)

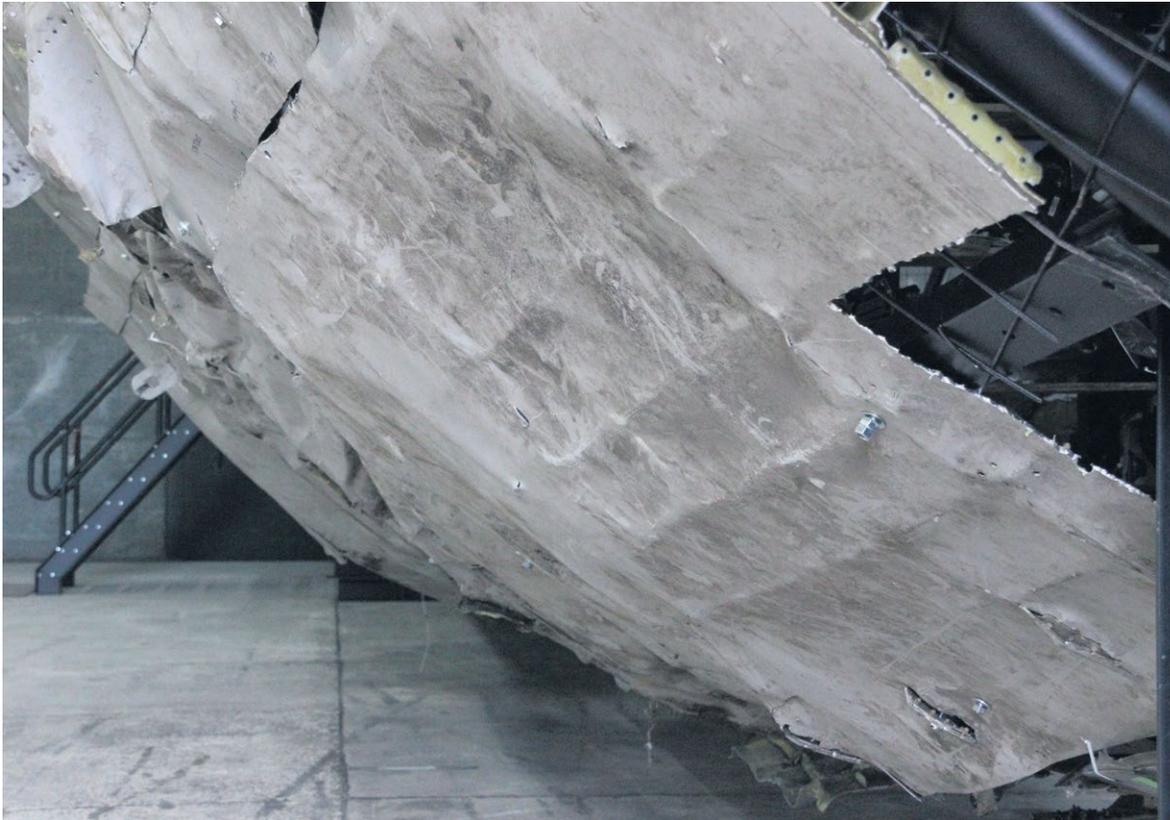
Figure 51: Blast damage on the forward right hand side of the fuselage. The panel was also damaged by the break-up of the aeroplane and impact with the ground. (Source: Dutch Safety Board)

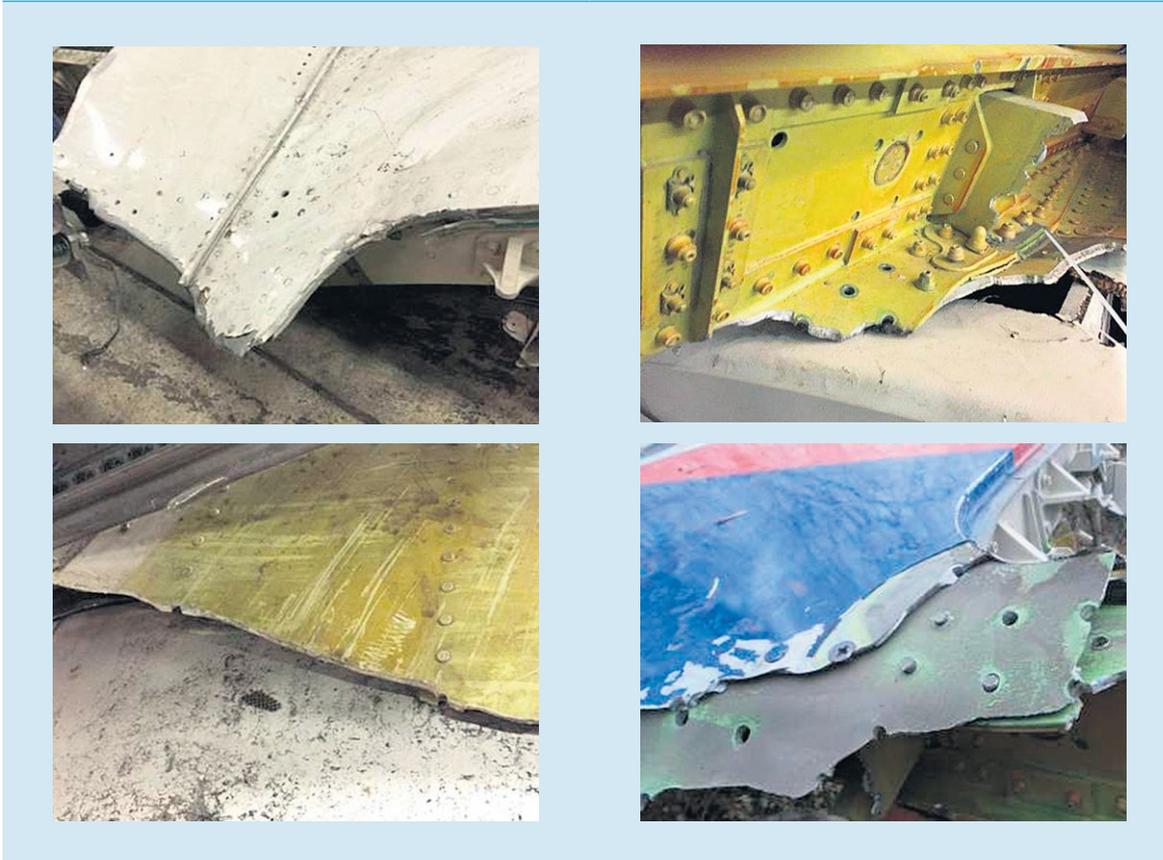
Figure 69: Examples of tensile overstress fracture at passenger doors 3L and 3R. (Source: Dutch Safety Board)

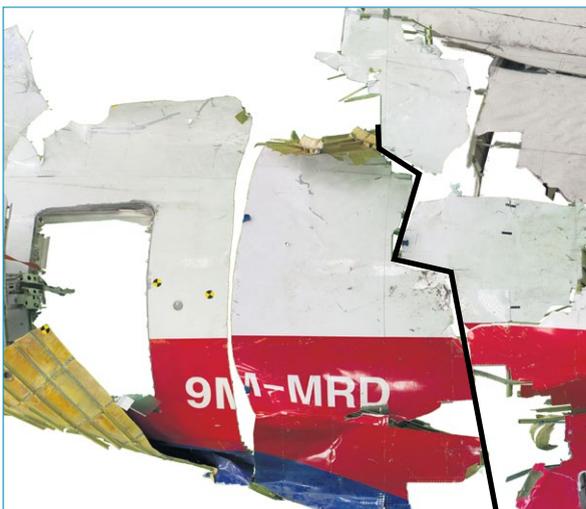
Figure 70: Left hand side separation fracture between rear fuselage and the tail. Separation is at the irregular fracture indicated by the black line. The vertical cut through the left letter M was made for transportation purposes. (Source: Dutch Safety Board)

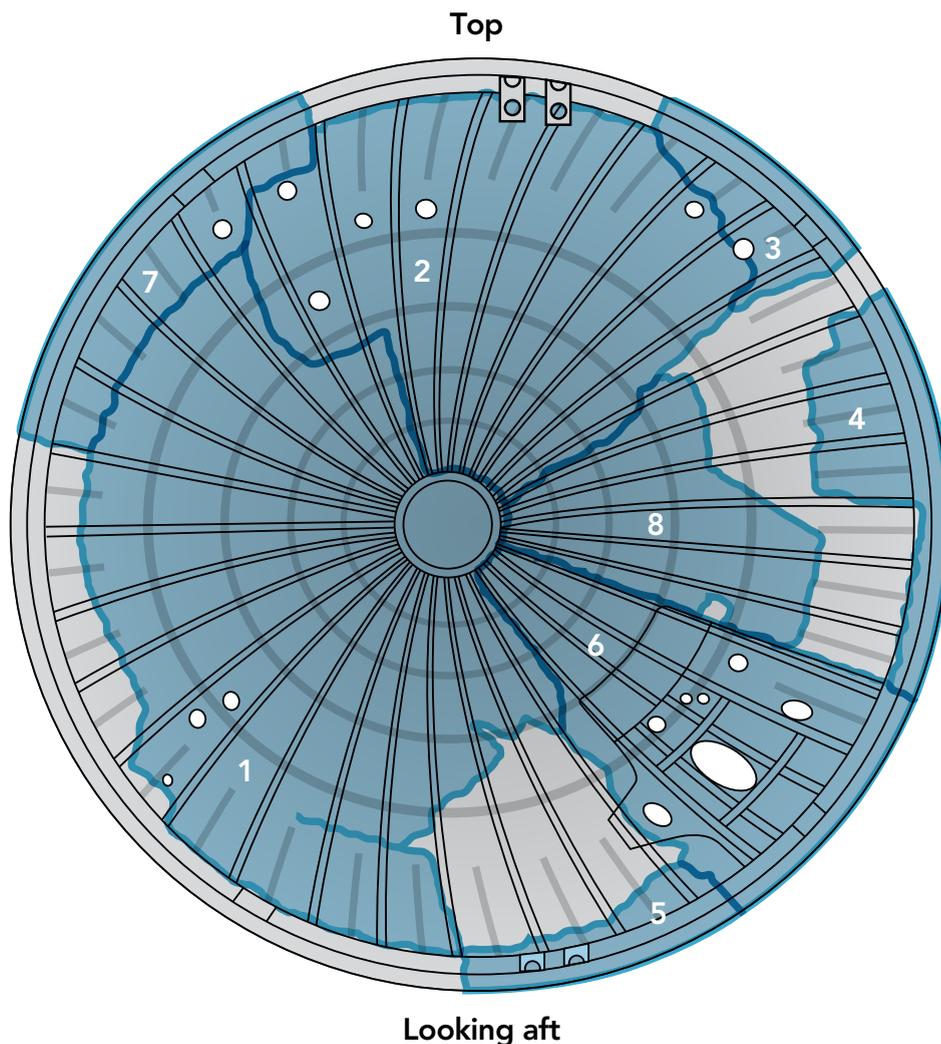
Figure 71: Fractures in rear pressure bulkhead. Looking aft. The parts that were available for investigation are numbered 1 to 8. (Source: Dutch Safety Board)

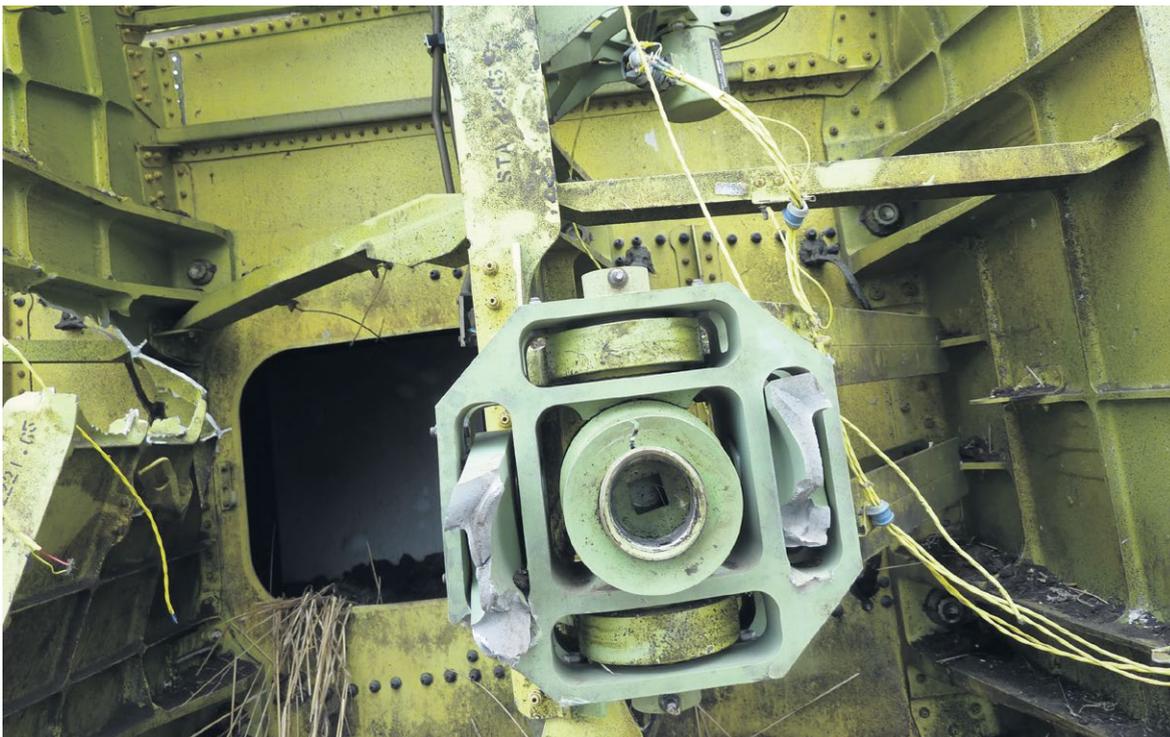
Figure 72: Overload failure of the vertical stabilizer. (Source: Dutch Safety Board)

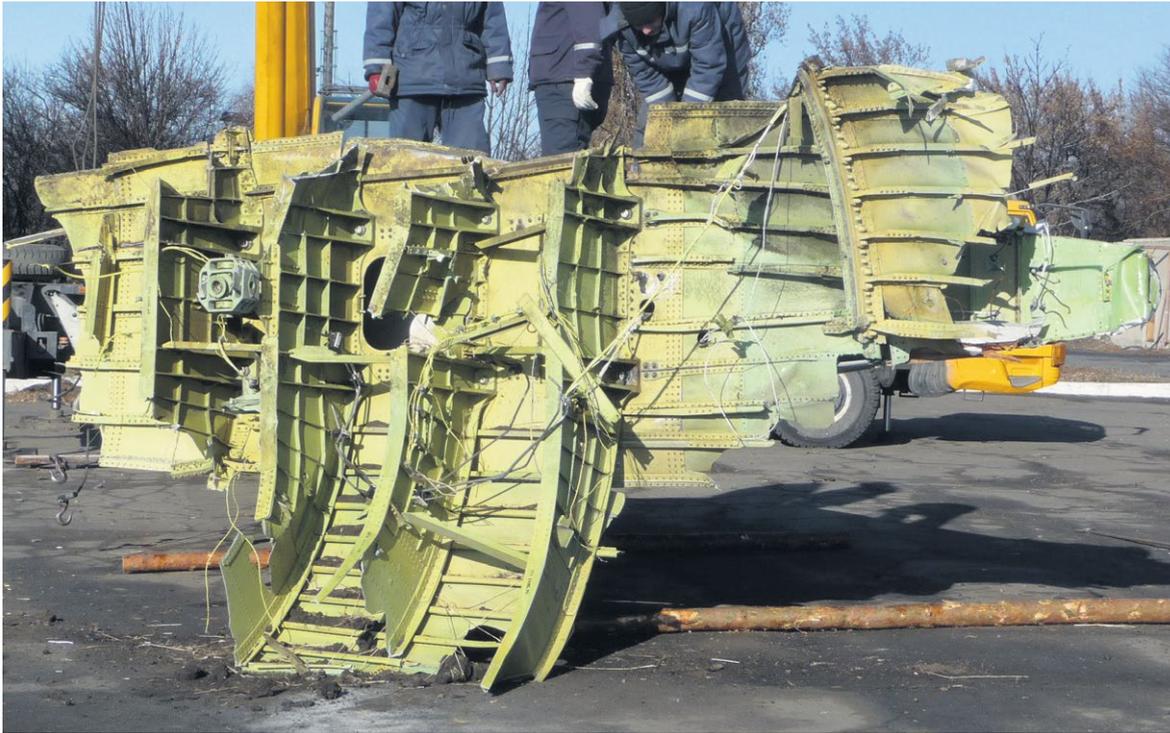
Figure 73: Fracture separating the vertical stabilizer from the fuselage. Attached skin and broken vertical stabilizer-to-fuselage frames bended out of their plane and fractured. (Source: Dutch Safety Board)
