How the Malaysian "Boeing" was shot down

A rod from the "air-to-air" missile R-60M was found among the wreckage of MH17

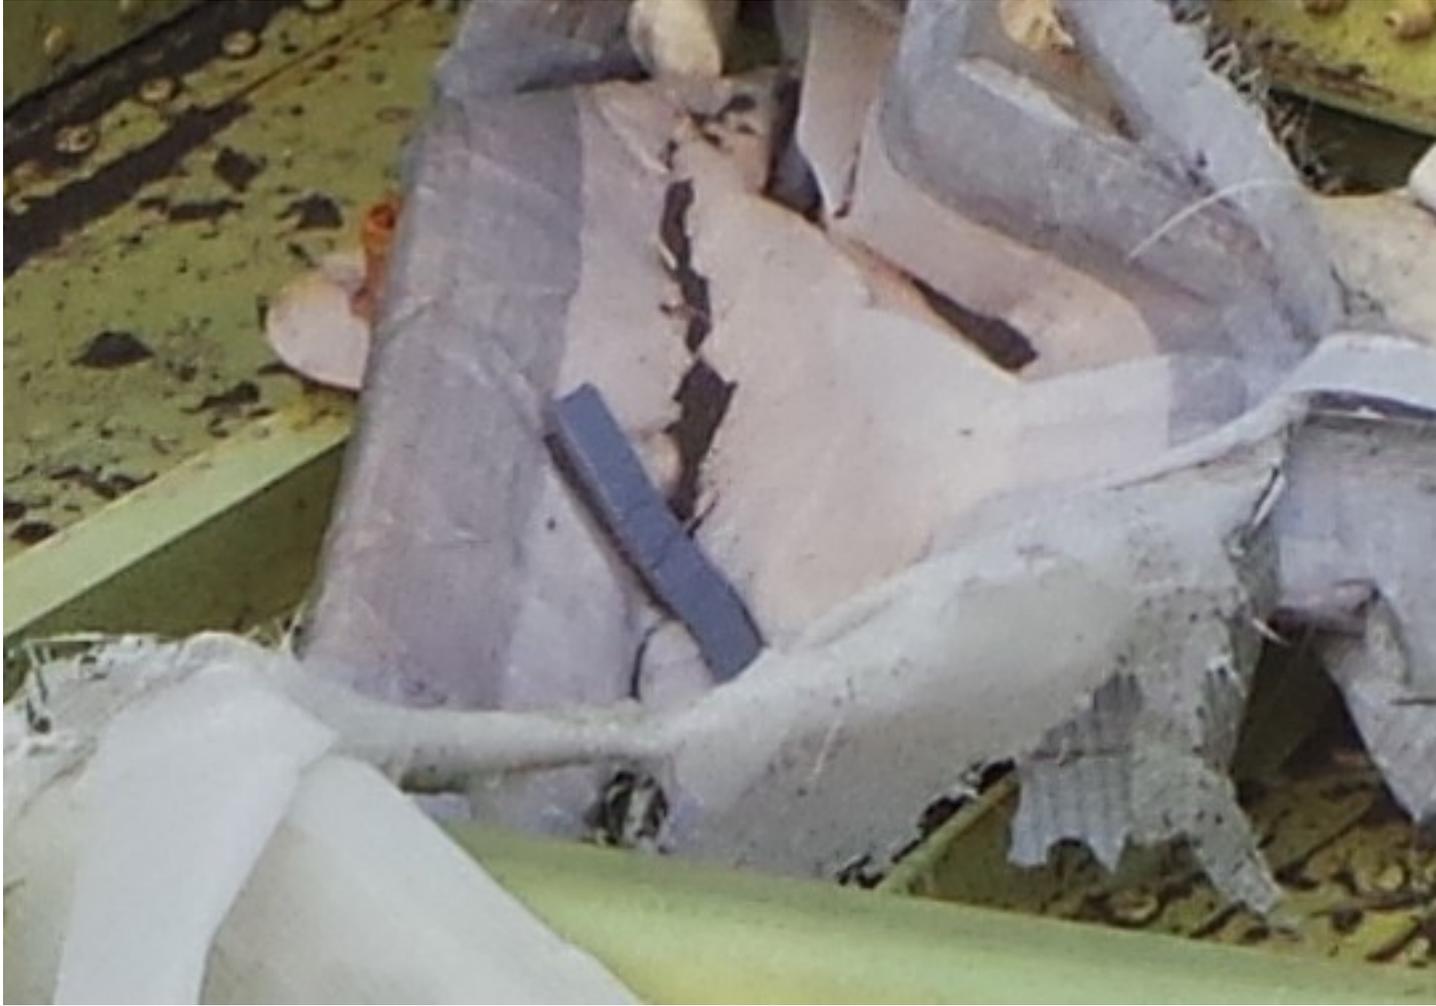
On one of the photos we can see the object, which looks like a rod from the AAM missile R-60M. On the other photo — a round hole in the air intake of the right engine. There are at least nine holes in the skin that are characteristic of the effect of an "air-to-air" missile.

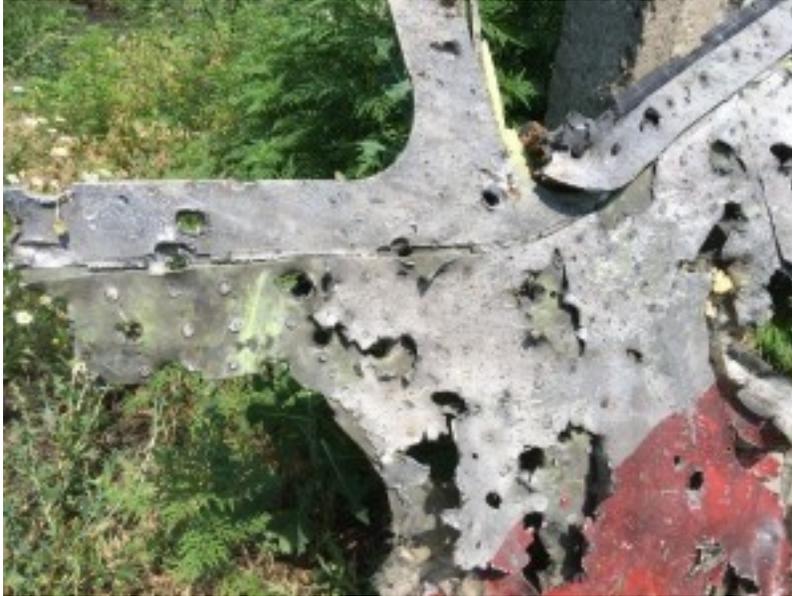
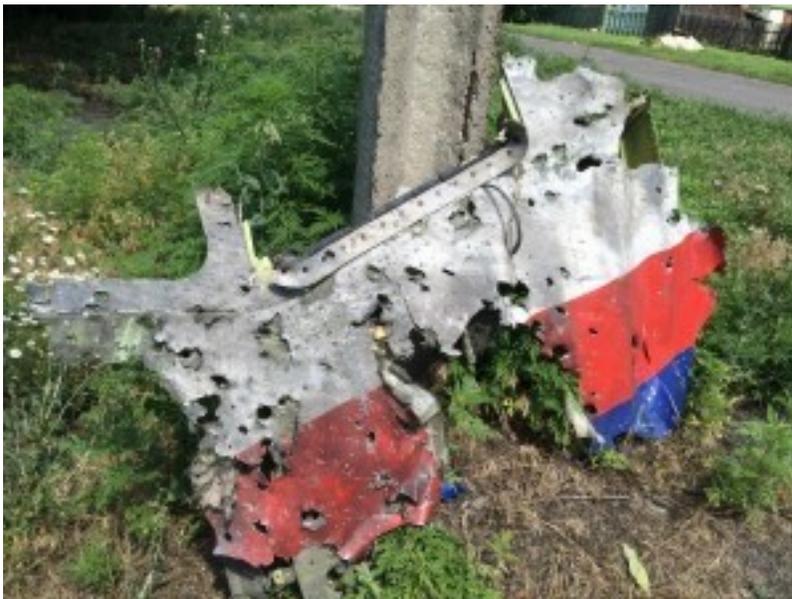
The left side of the pilot cabin immediately attracted the most attention, the aircraft had the most damage there. The largest hole in the center of the fragment has ragged edges, bent outside, which is characteristic for an internal explosion or decompression due to a sharp change in pressure.

Further on the photo we see more than 20 large round holes, which penetrated among other things the glass framing and the left side of the cabin. The material of the skin in this area has the highest density — it is made of reinforced aluminum (titanium plates are used according to other data), which is laid out in two layers in order to prevent cabin damage in the case of a possible collision with a bird. According to some data, the thickness of the first layer is 1.8 mm and the thickness of the second layer is 0.8 mm.

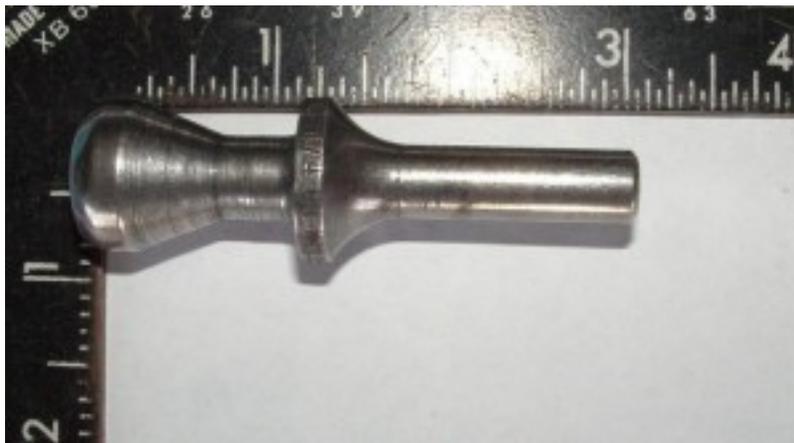
To find out the diameter of the holes in the skin of the cabin we need to know the diameter of the head of the standard aviation rivet. It [is equal to 0,488 inch](#) or 11 mm.

By correlating the parameters we get the size of the holes of about 20-30mm. The diameter of the round holes in the skin of the cabin in the size of 2-3 diameters of the hat of the aviation rivet.

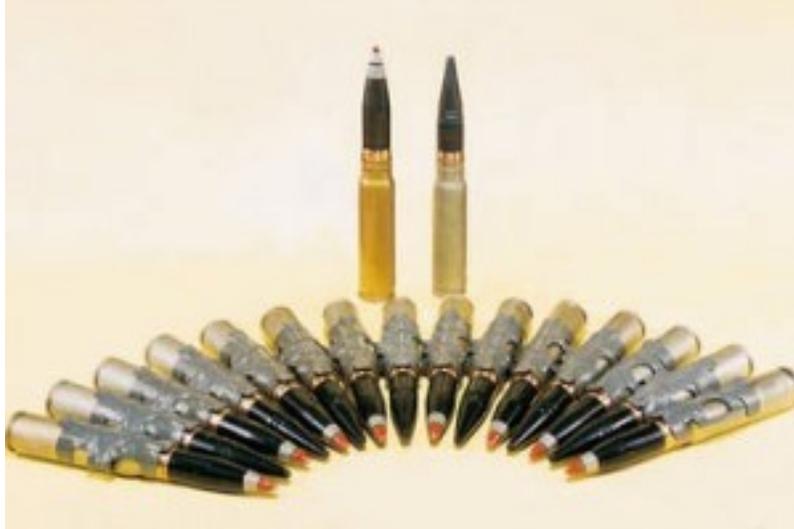
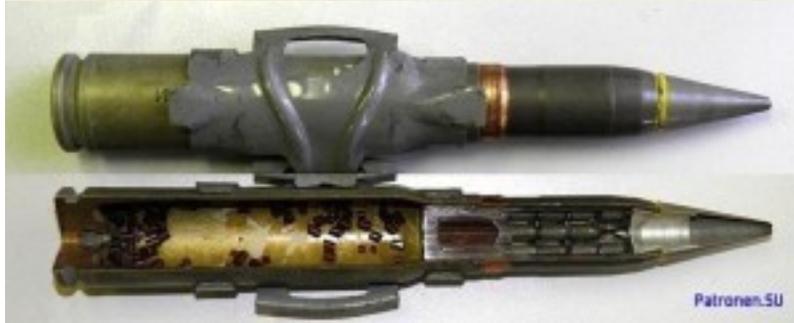
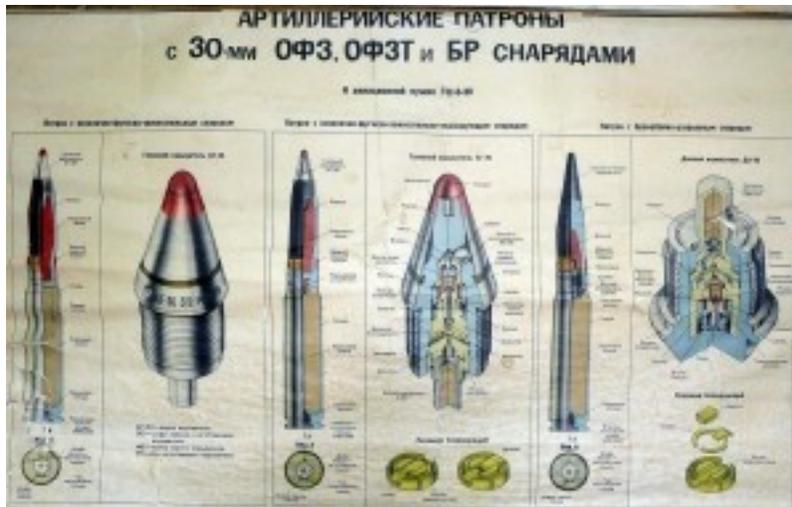
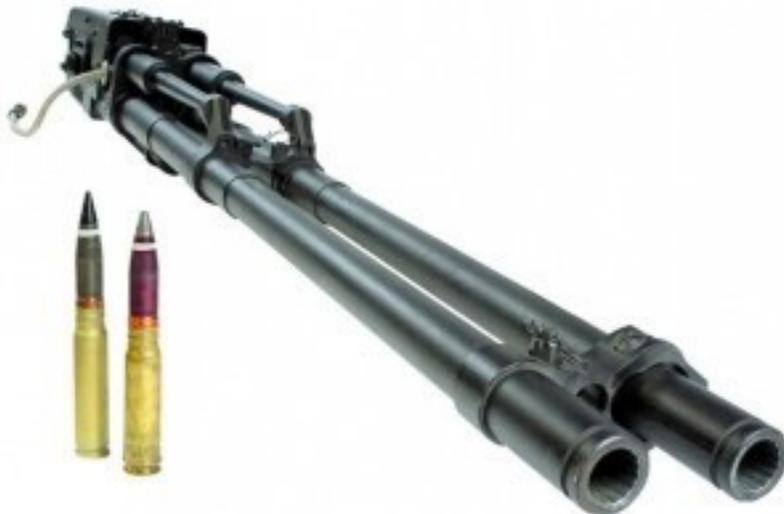
The ribbon of armor-piercing and high-explosive shells in an aircraft cannon, the shrapnel elements have cylindrical shape.

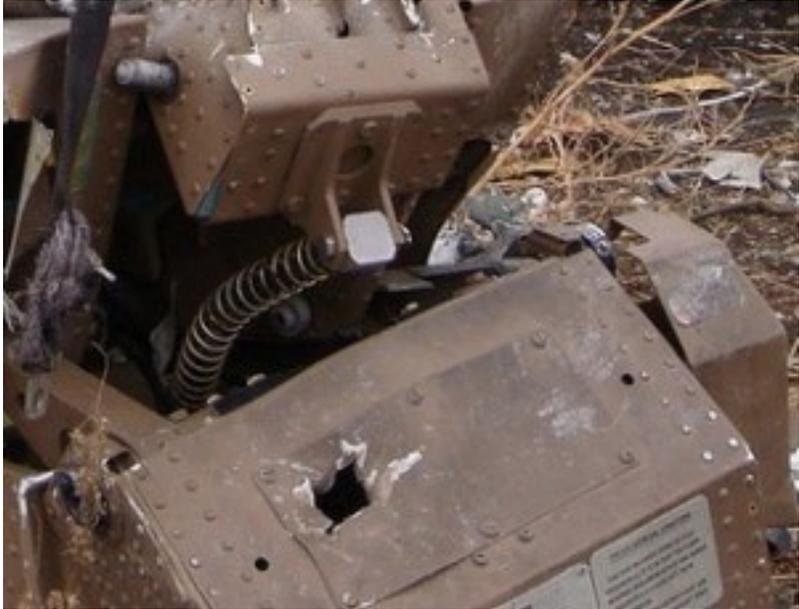
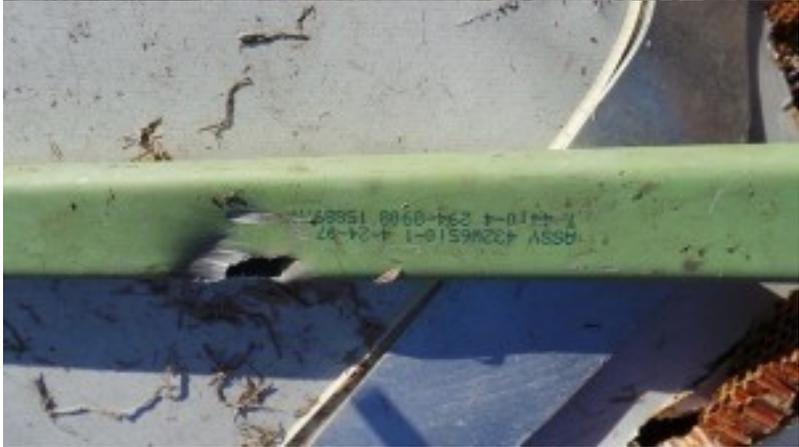
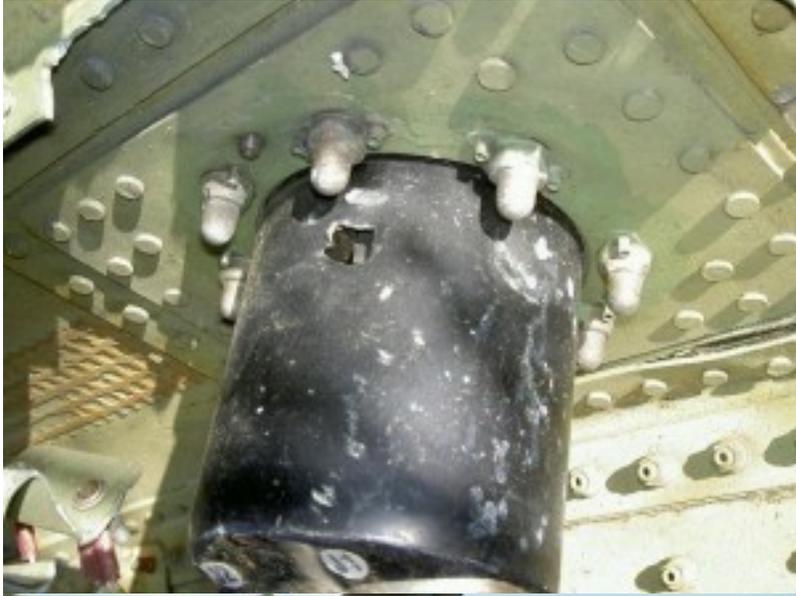
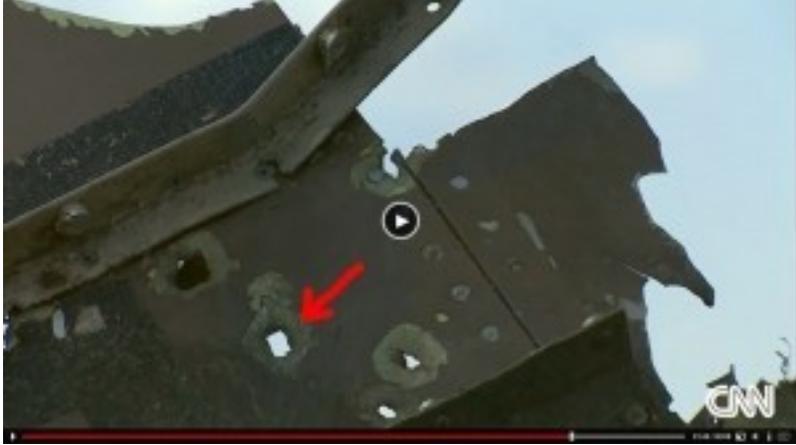
Besides several tens of round and oval holes, in the front part of the "Boeing" there are **at least five more holes, which have rectangular and square shape**. However, none of them penetrated the skin on the outside, so it is hard to determine their size. But we can speak of the sizes above 1 cm.

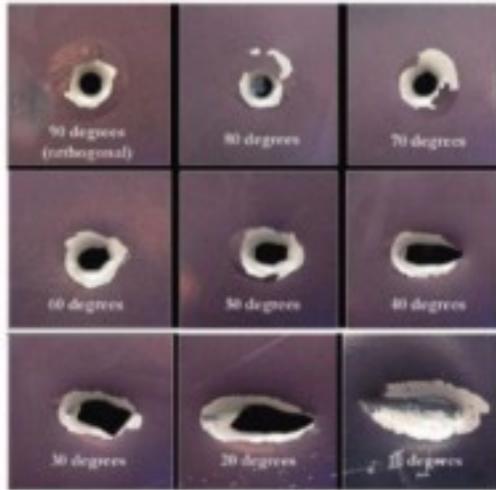
Dieses Bild zeigt Einschüsse aus verschiedenen Einschusswinkeln, vergleicht man damit das Einschussloch in der Tat, ergibt sich ein Einschusswinkel von ca. 25°.

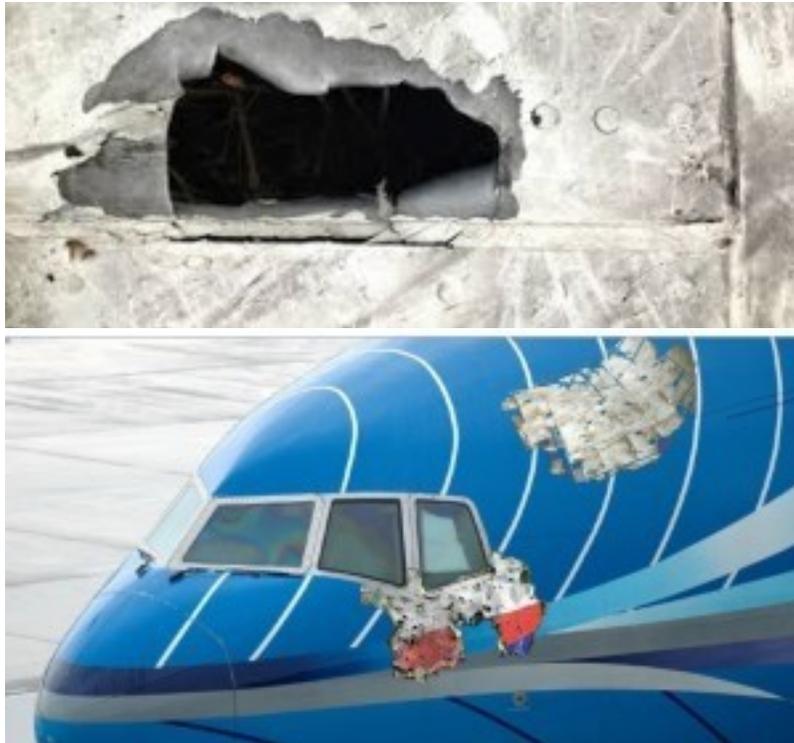
Perhaps, this is what explains the presence of holes of various sizes on one of the skin pieces to the side of the pilot cabin (Point 4 on the scheme of the [left side of the Boeing](#)).

By comparing the holes with the rivet heads we can see that the width of these holes varies between 3 cm and 10 cm. The angle of penetration of these shards may be equal to 25-30 degrees.

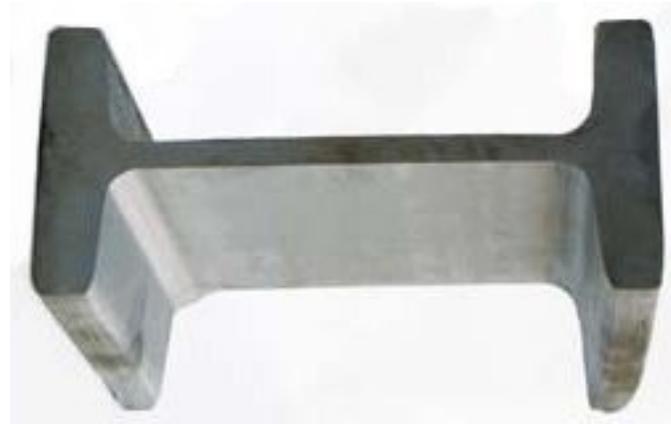
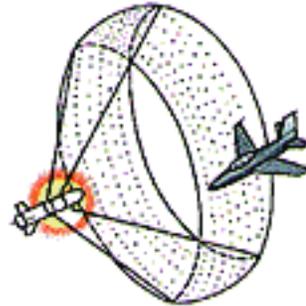
The 9M38M1 missile, which is used in the "BUK-M1" complexes, consists of the fragmentation warhead 9H314, which weighs 70 kg. In its base there

are 32 kg of sub-projectiles (4500 sub-projectiles, each weighing 8 g in the shape of an I-section [something between the shape of H and X] and of 1500 cubes, each weighing 4 g). [The source](#)

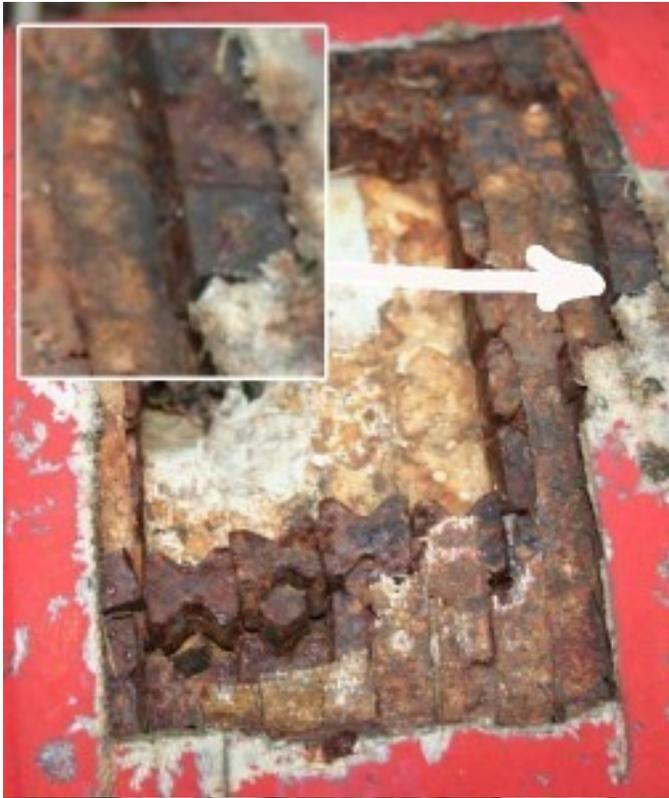
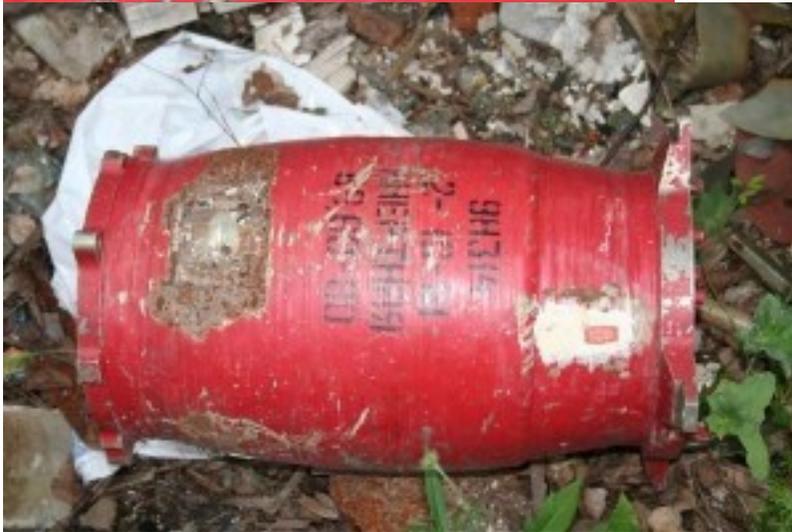
On the internet there is a photo of one of the warheads of the missile complex. **The I-section shrapnel –13 mm. The diameter of cubes is below 10 mm.** [Source](#) and [another source](#)

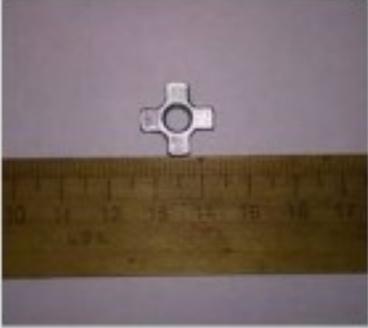
Наконец удалось проверить, какой след оставляет в дюралевой обшивке пресловутый "двухтарник", как его окрестили в интернете, точнее, X-образные готовые поражающие элементы, которые видны на разрезе корпуса БЧ Бук. За неимением настоящего, пришлось изготовить подобный. На отверстие в центре можно не обращать внимание: "я его слепила из того, что было".
Материал - сталь, скорость около 1500 м/с.

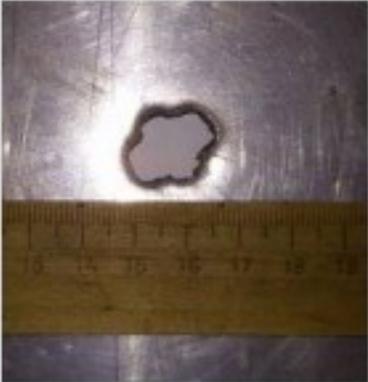
А вот результат попадания.

К сожалению "крестик" подошел к преграде имея некоторый угол, поэтому отпечатался не плашмя. Тем не менее в такой пробине его можно легко узнать. Так, что, если бы вблизи Боннга взорвалась БЧ, оснащенная ПЗ такой X-образной формы, на оставшихся деталях обшивки до сих пор можно было бы увидеть подобный след. Таким образом, версия о применении ракеты Бук той модификации, которая имела характерные поражающие элементы, выглядит вполне правдоподобно.

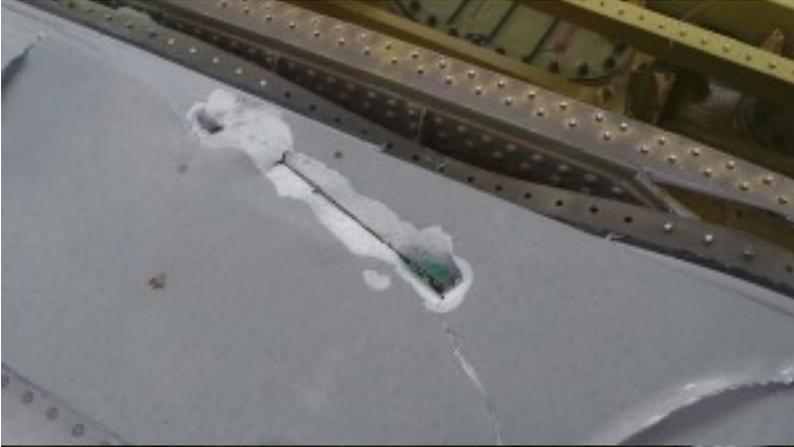
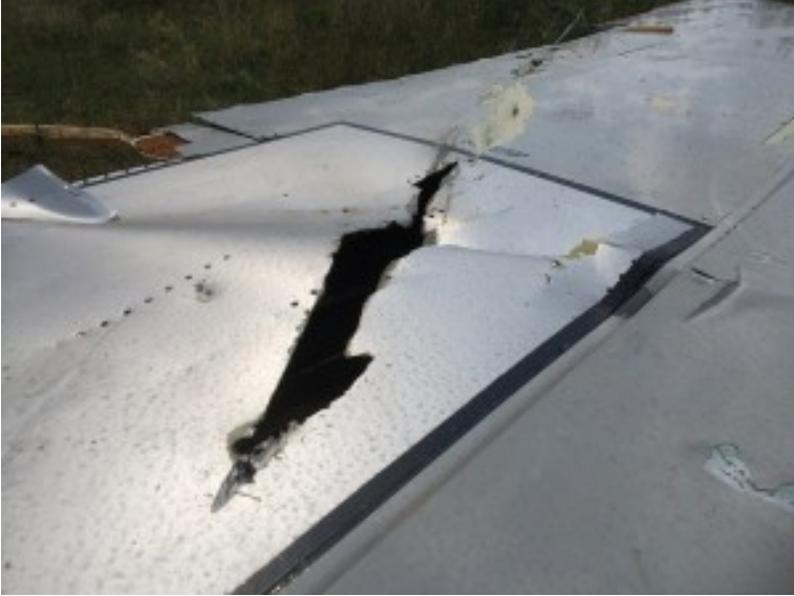
The left wing

We can see at least three cutting holes among the wreckage: on the left wing, in the area of the second left door, on the elements of the tail (see the scheme [Left side of "Boeing"](#)). For example, the hole in the skin next to the second left door has the length of about 10 cm.

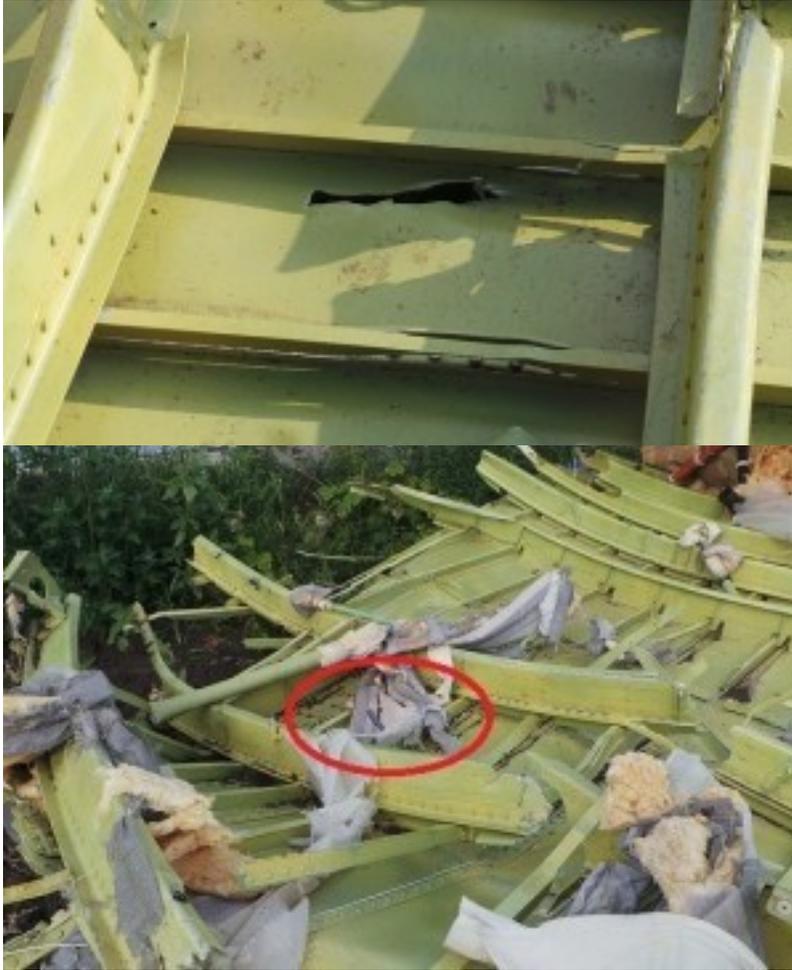
The cabin floor near to the second left door.

Next to this hole and the frames that are "cut" along it we can see an elongated element, which is externally similar to a fragment of the rod-shaped sub-projectile from the "air-to-air" aviation missile R-60M. [The original photo](#)

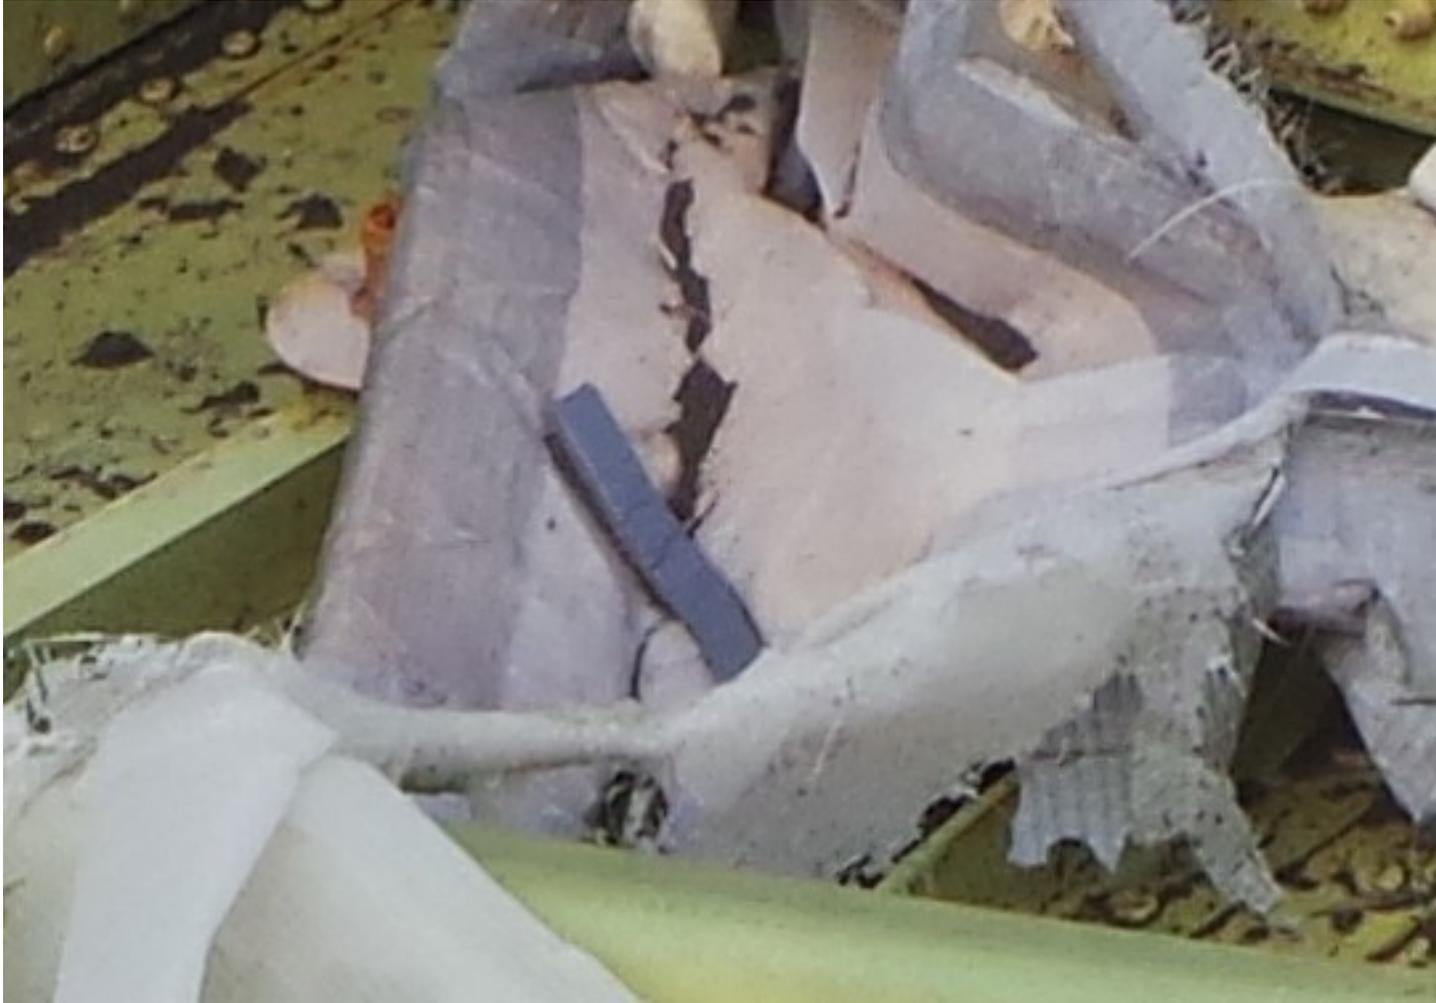
The skin of the lower part of the fuselage, next to the second door on the left [Source](#)

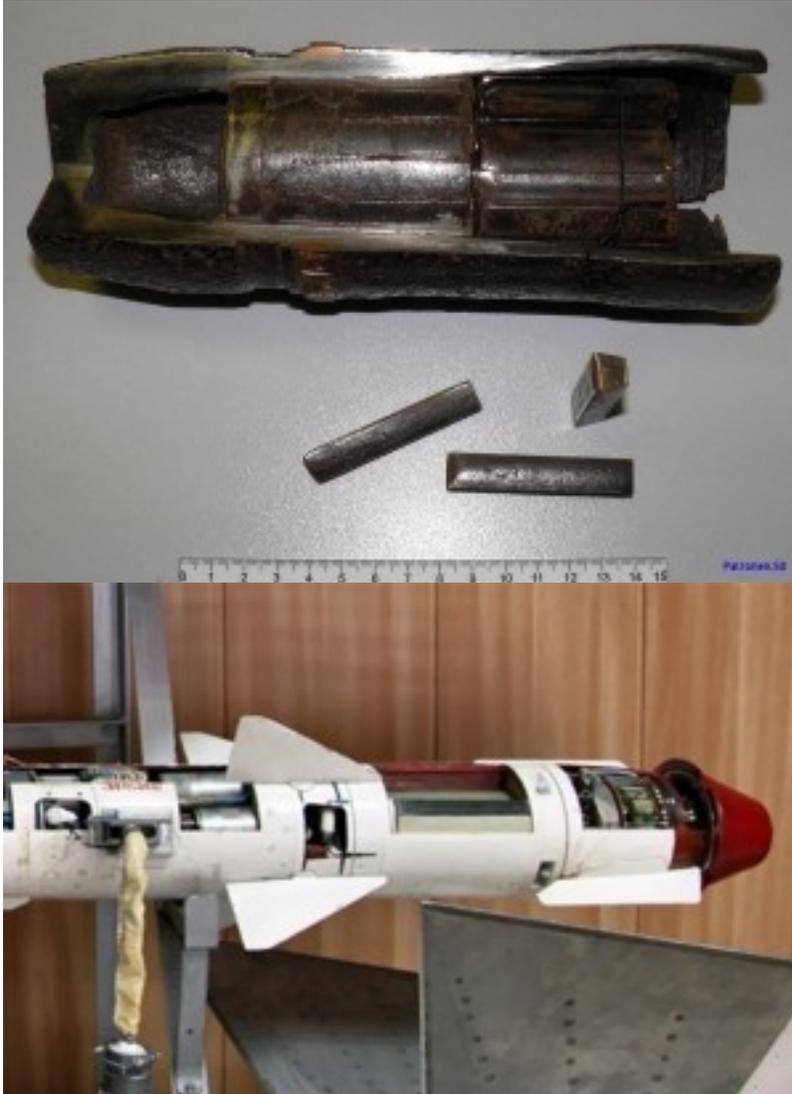
Left – this is approximately how the rod-based warhead that is used on the Ukrainian attack jets looks like ([Source](#)). Right – the warhead of the R-60 missile

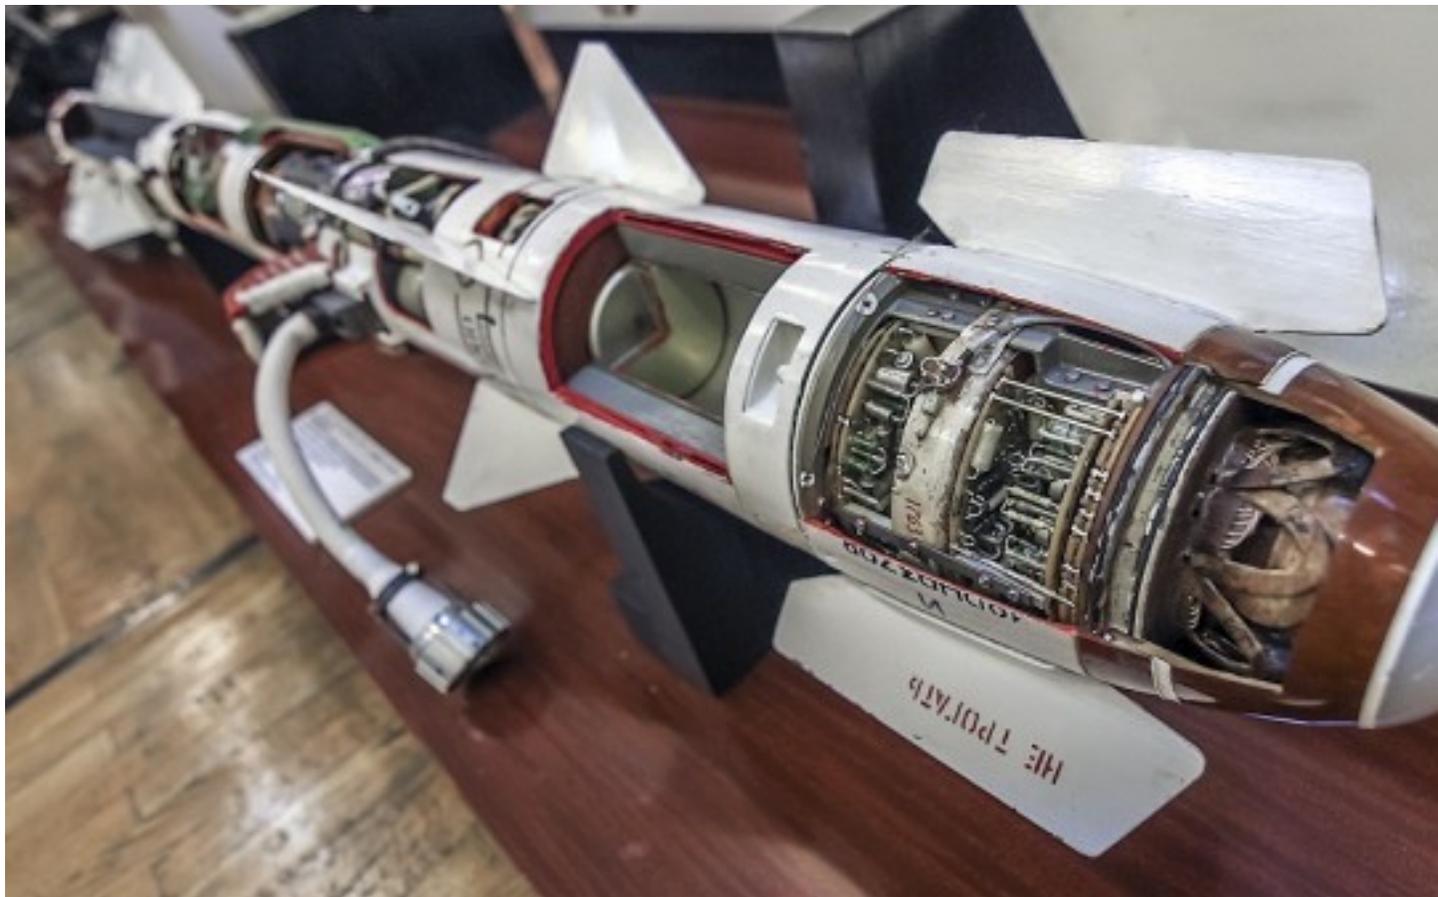
The cross-section of the rocket without the striking elements [Source](#)

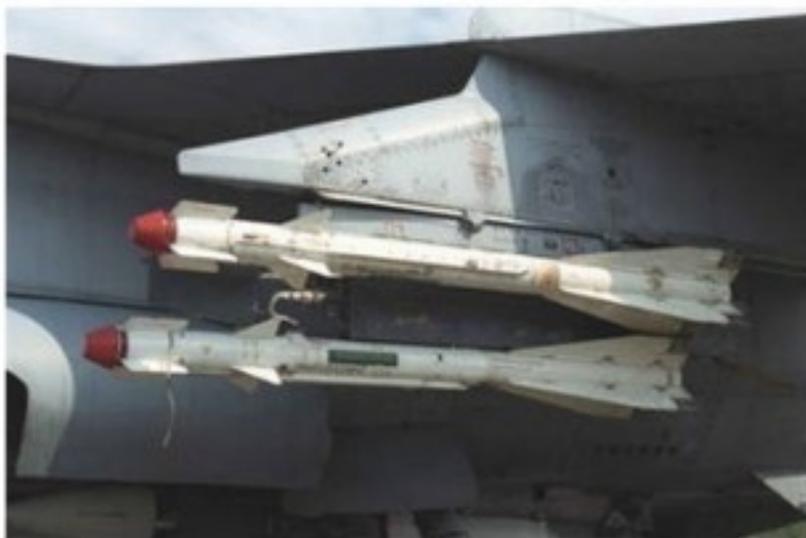
Фото 16. Ракеты Р-60М на внешней подвеске самолета

P-60M	
Длина, м	2,1
Диаметр, м	0,1
Размах крыла, м	0,39
Масса, кг	45
Масса БЧ, кг	3,5
Скорость	2,5М
Диапазон высот поражения цели	0,03
Максимальная дальность пуска, ППС/ЗПС	10/8
Минимальная дальность пуска, ЗПС, км	0,3 -

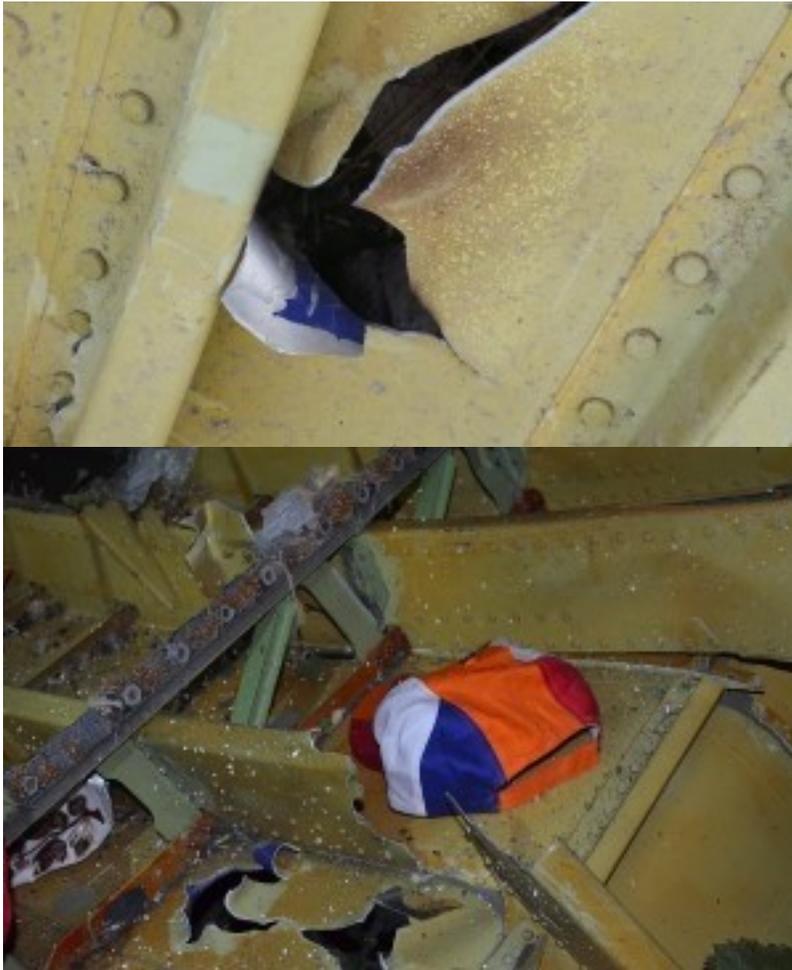
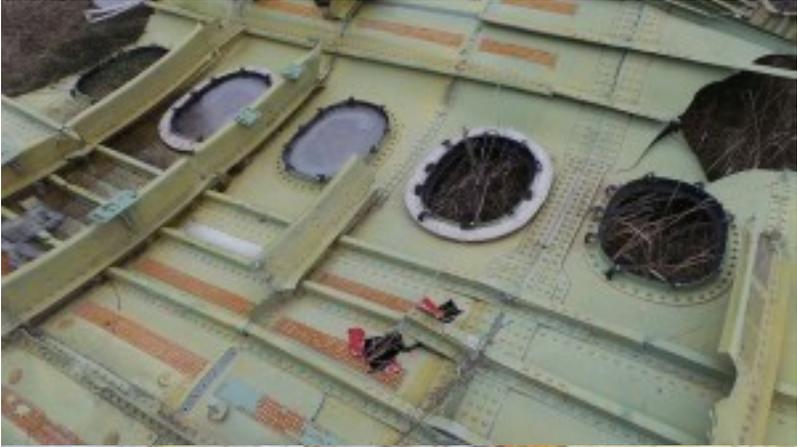
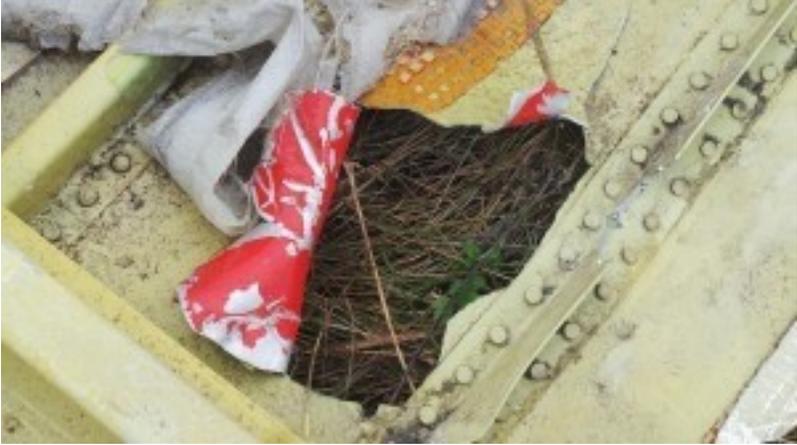
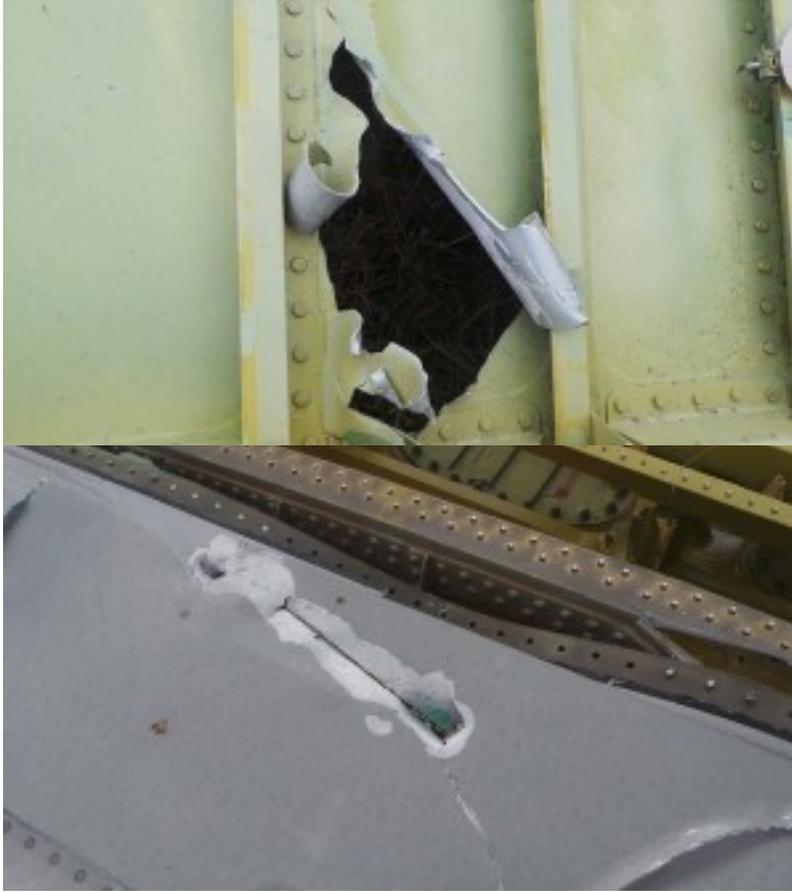
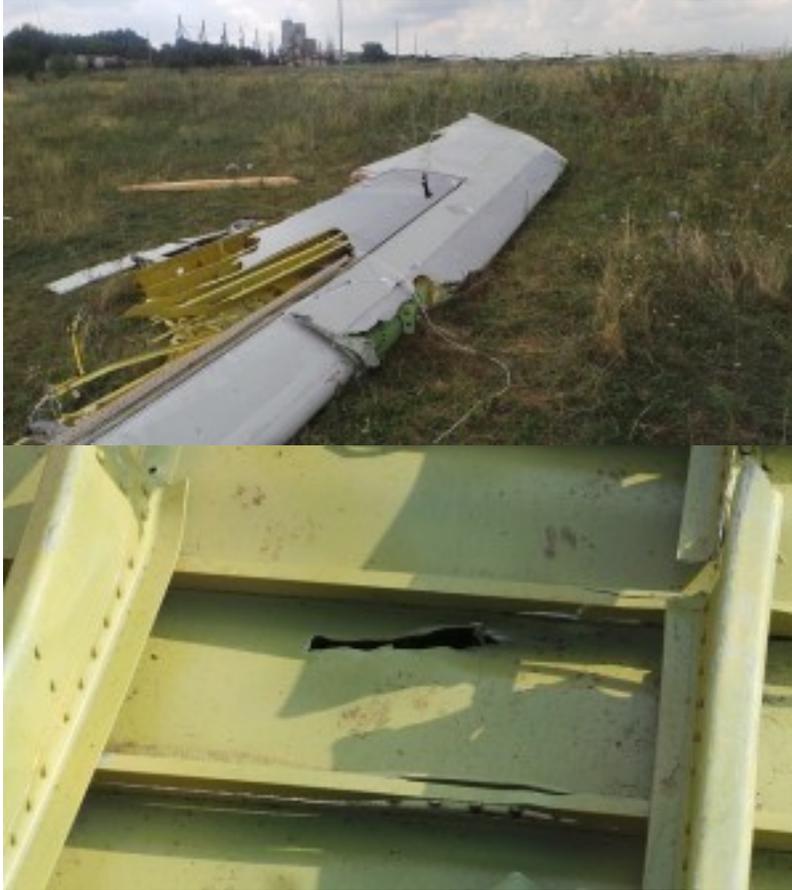
Six delta- and diamond-shaped holes and three cutting holes on the left wing and on the lower part of the skin next to the second left door:

The shapes of the holes match the damage that would be expected from the warhead of the R-60M, which is mounted on Su-25M1 attack jets.

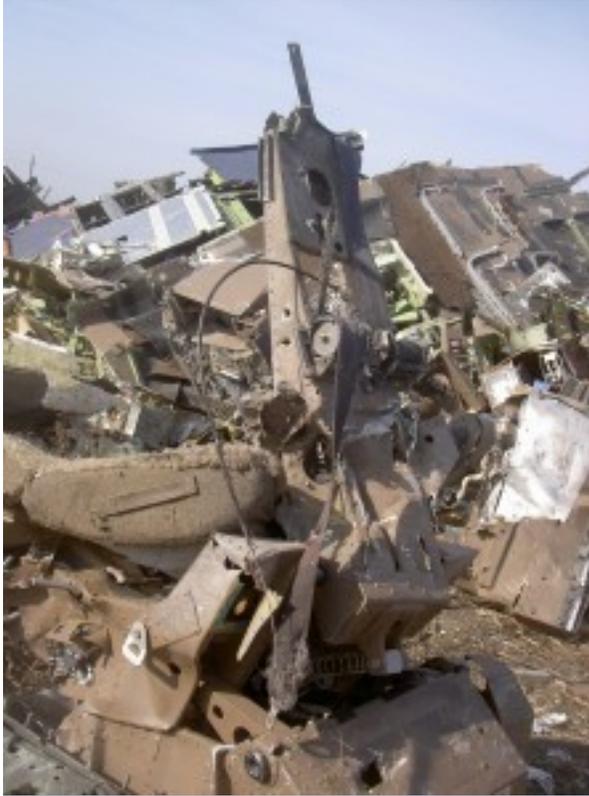
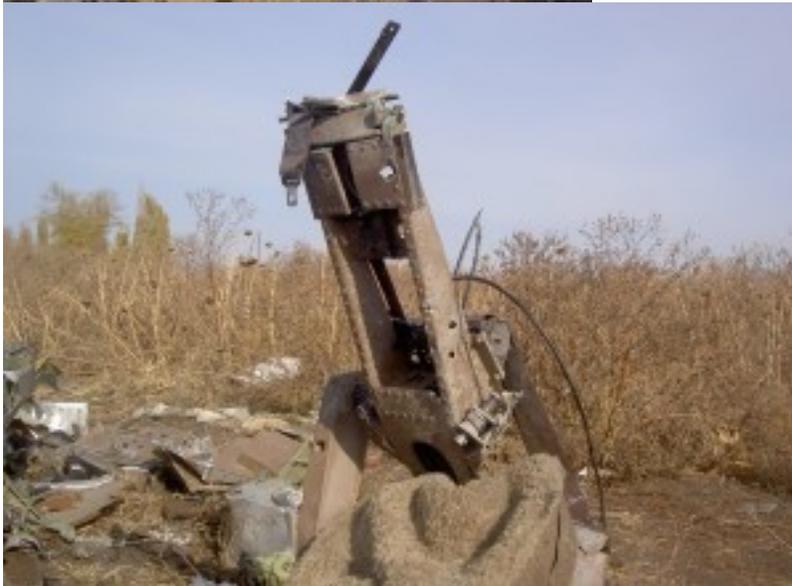
The left side of the cabin, the skin of floor of the cabin received the most damage from the shrapnel elements. Numerous holes are visible in the area of the crew commander chair, several holes — in the chair of the second pilot. At least four holes are visible in the body of the crew commander. All of these holes have round shape.

The back of the seat of the second pilot, numerous holes can be seen on the side and in the back.

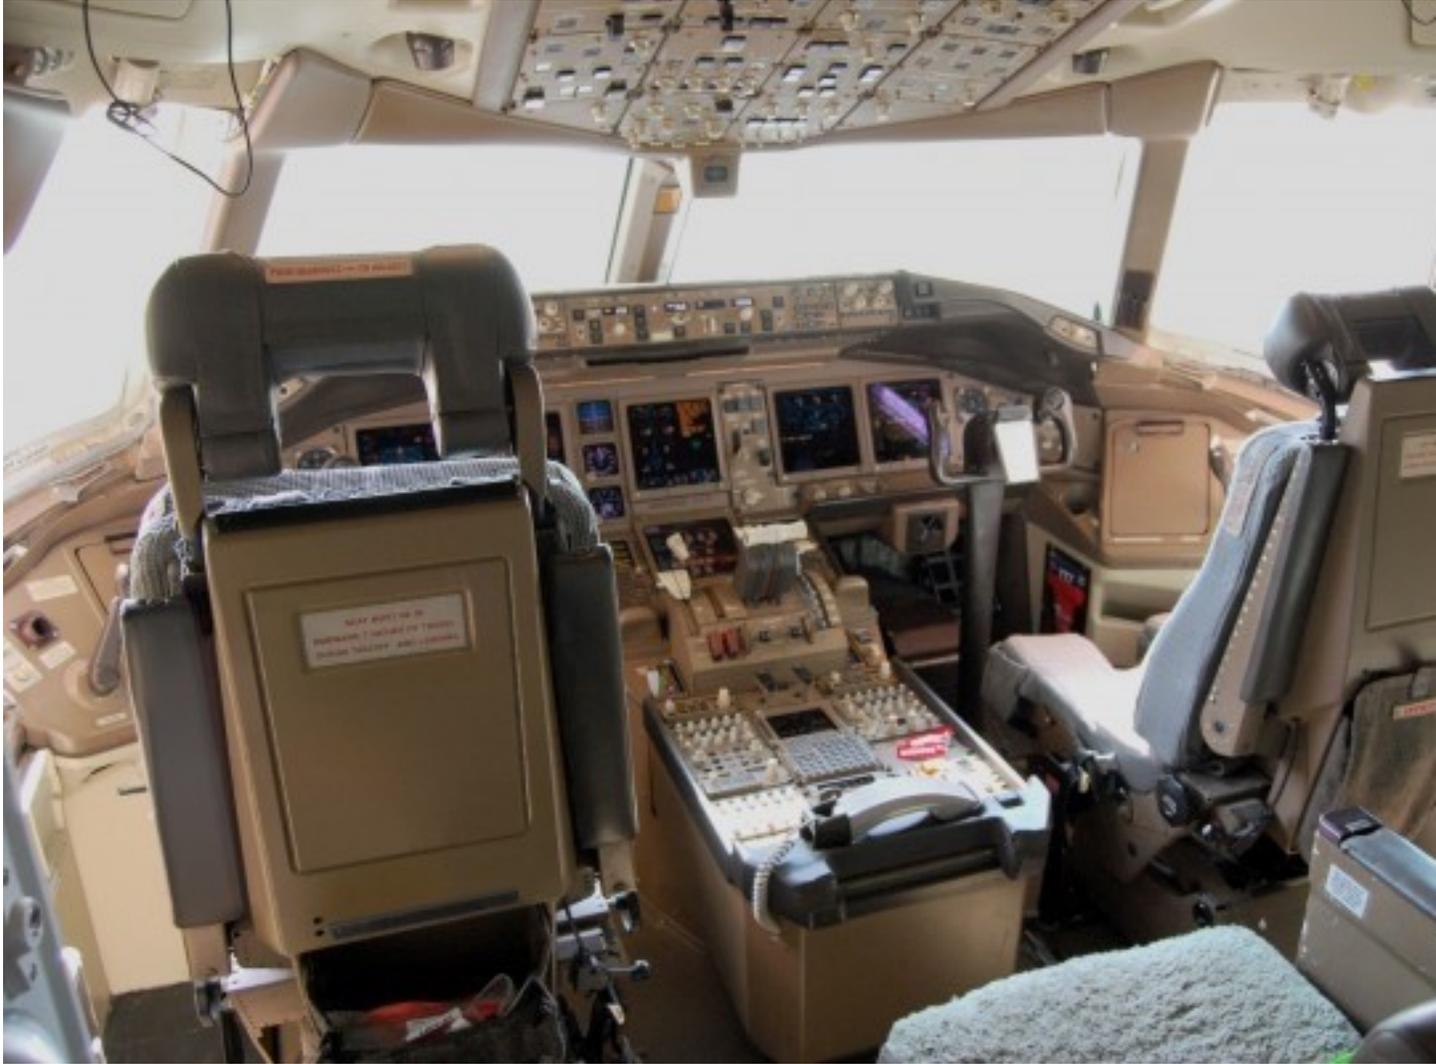
Considering the remains of the soot and a large number of small black dots — the traces of impact by the detonation products, the missile charge was engaged in exactly this area — outside the pilot cabin at close range.

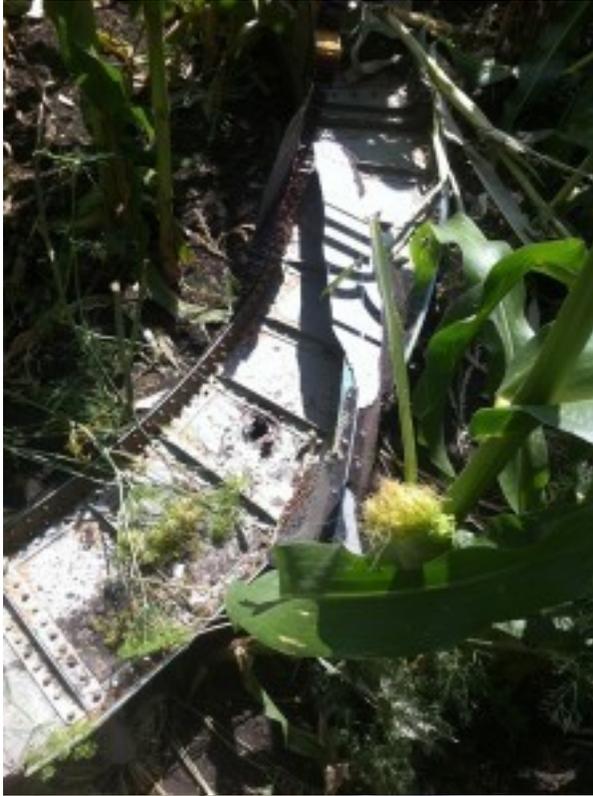
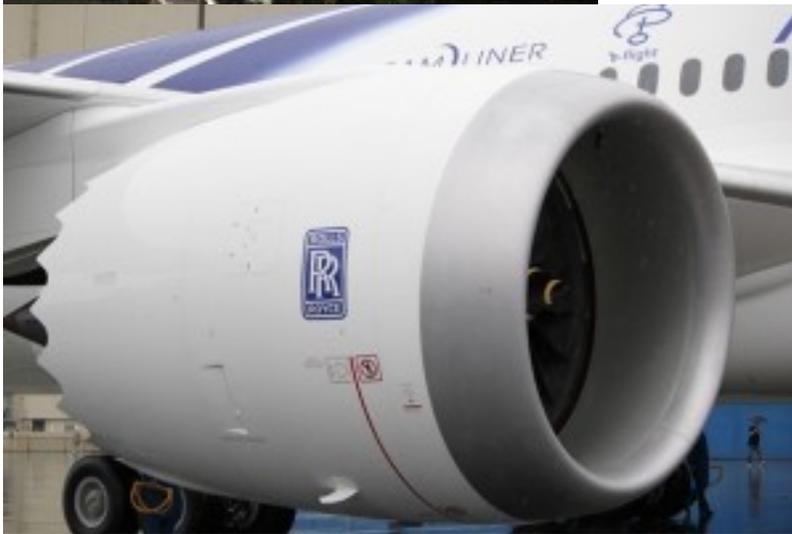
The fragment faces us upside-down — on the left side we can see a piece of the internal skin that was torn out and the right side is the other side with faint RR letters — if this piece is turned, then this will be a part of the air intake of the RIGHT ENGINE.

This small hole was discovered on the right engine of the "Boeing" — as stated by the authoritative sources of the [Wall Street Journal](#). The edges of

the hole are torn to the outside, so in this case the piece of shrapnel penetrated the air intake by flowing from the tail side.

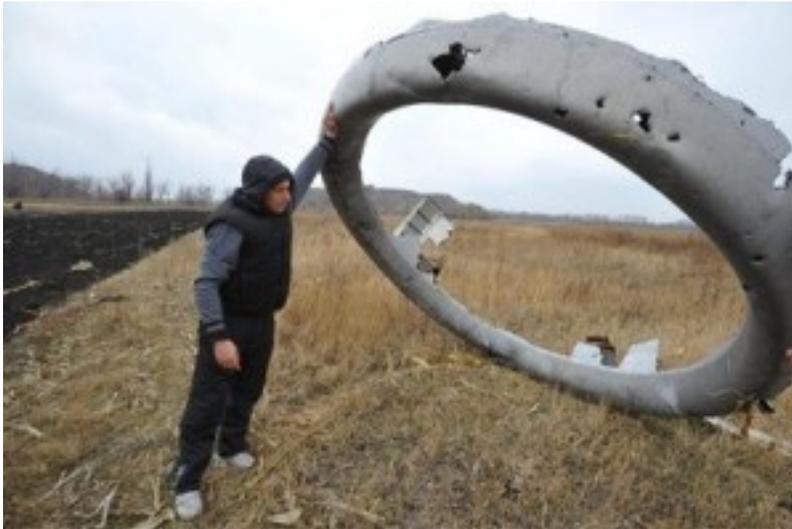
There is another piece of the engine — the rim of the turbine with the traces of the inbound holes, however it is impossible to determine which of the engines it belongs to. It is known that [this fragment was found](#) in the outskirts of Petropavlovka, where the right air intake was located. However, the left door was found here as well, which is located in front of the left engine.

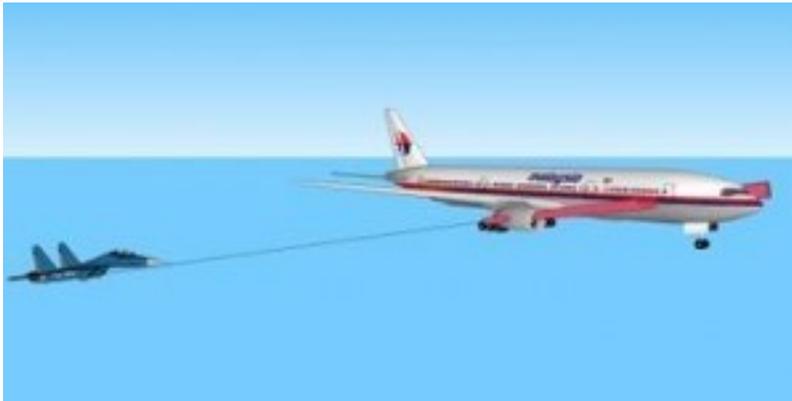
Here is how the first attack using the aircraft cannon from the right and the back "in pursuit" — the bullets penetrate the engine skin, the right side of the business-class and hit the pilots in the back. [This version is considered in more detail here.](#)
