How the Malaysian "Boeing" was shot down

A rod from the "air-to-air" missile R-60M was found among the wreckage of MH17

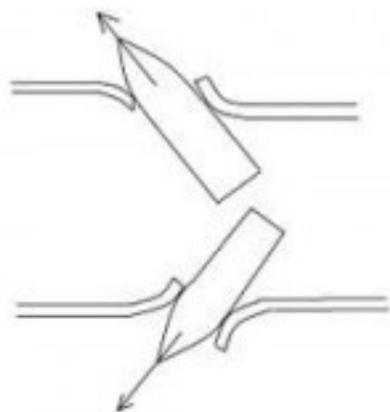
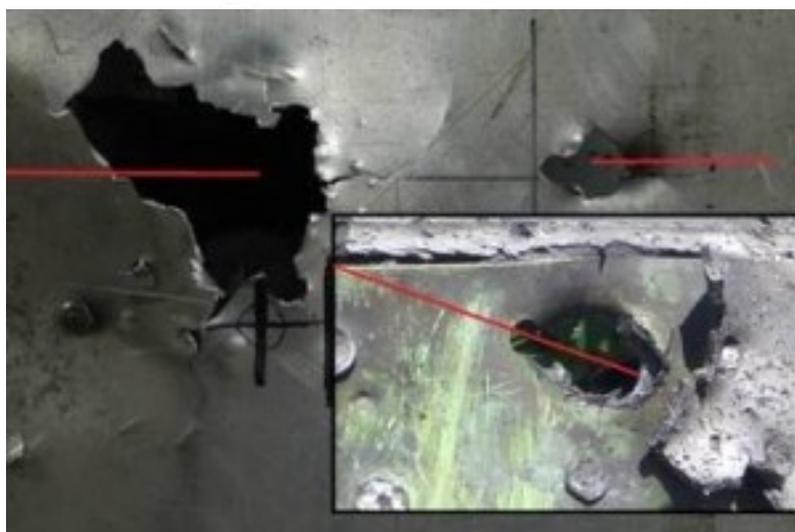
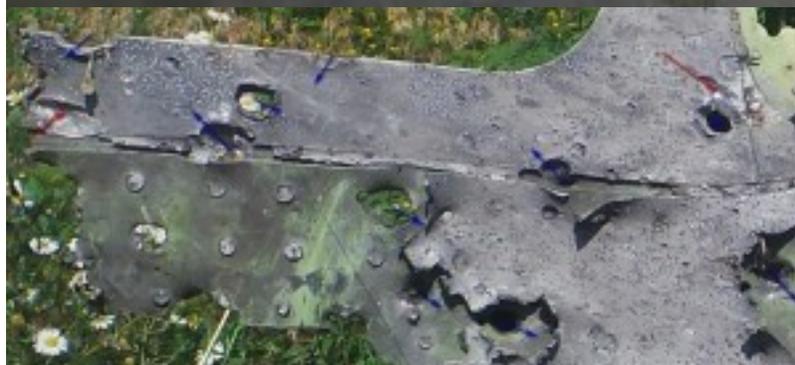
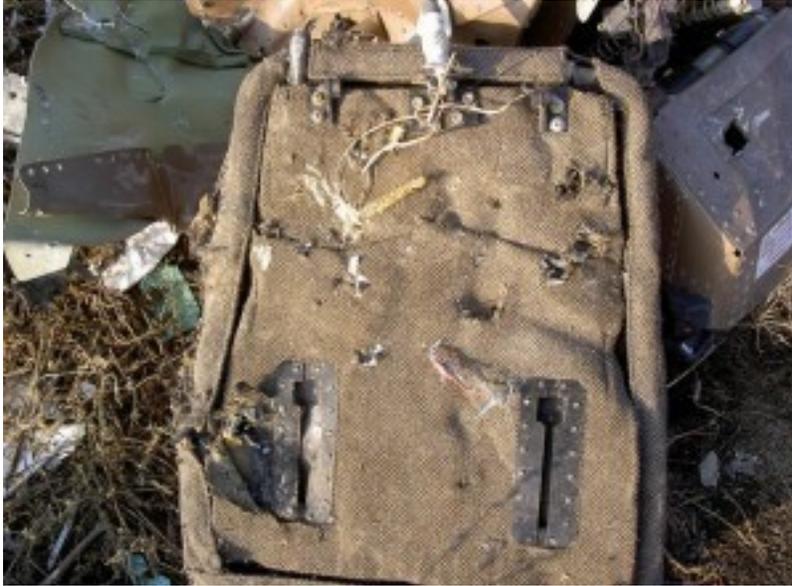
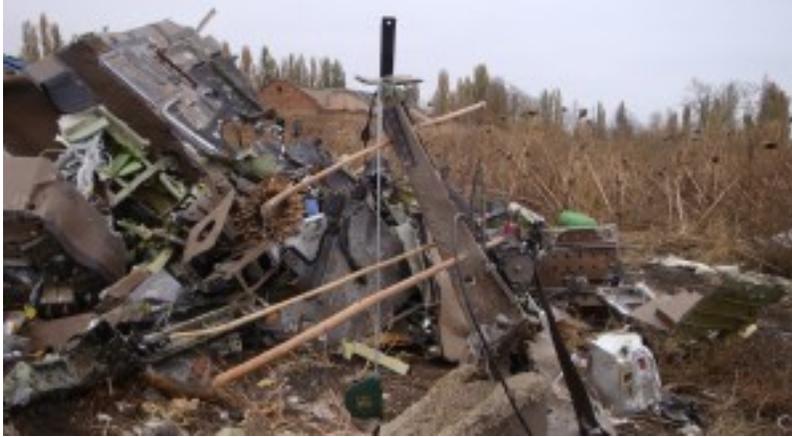
Entry and exit holes in the pilot cabin

The back seat of the pilot. It is possible to compare how the holes that form due to penetrating the fabric and the metal one may compare [here](#) and [here](#)

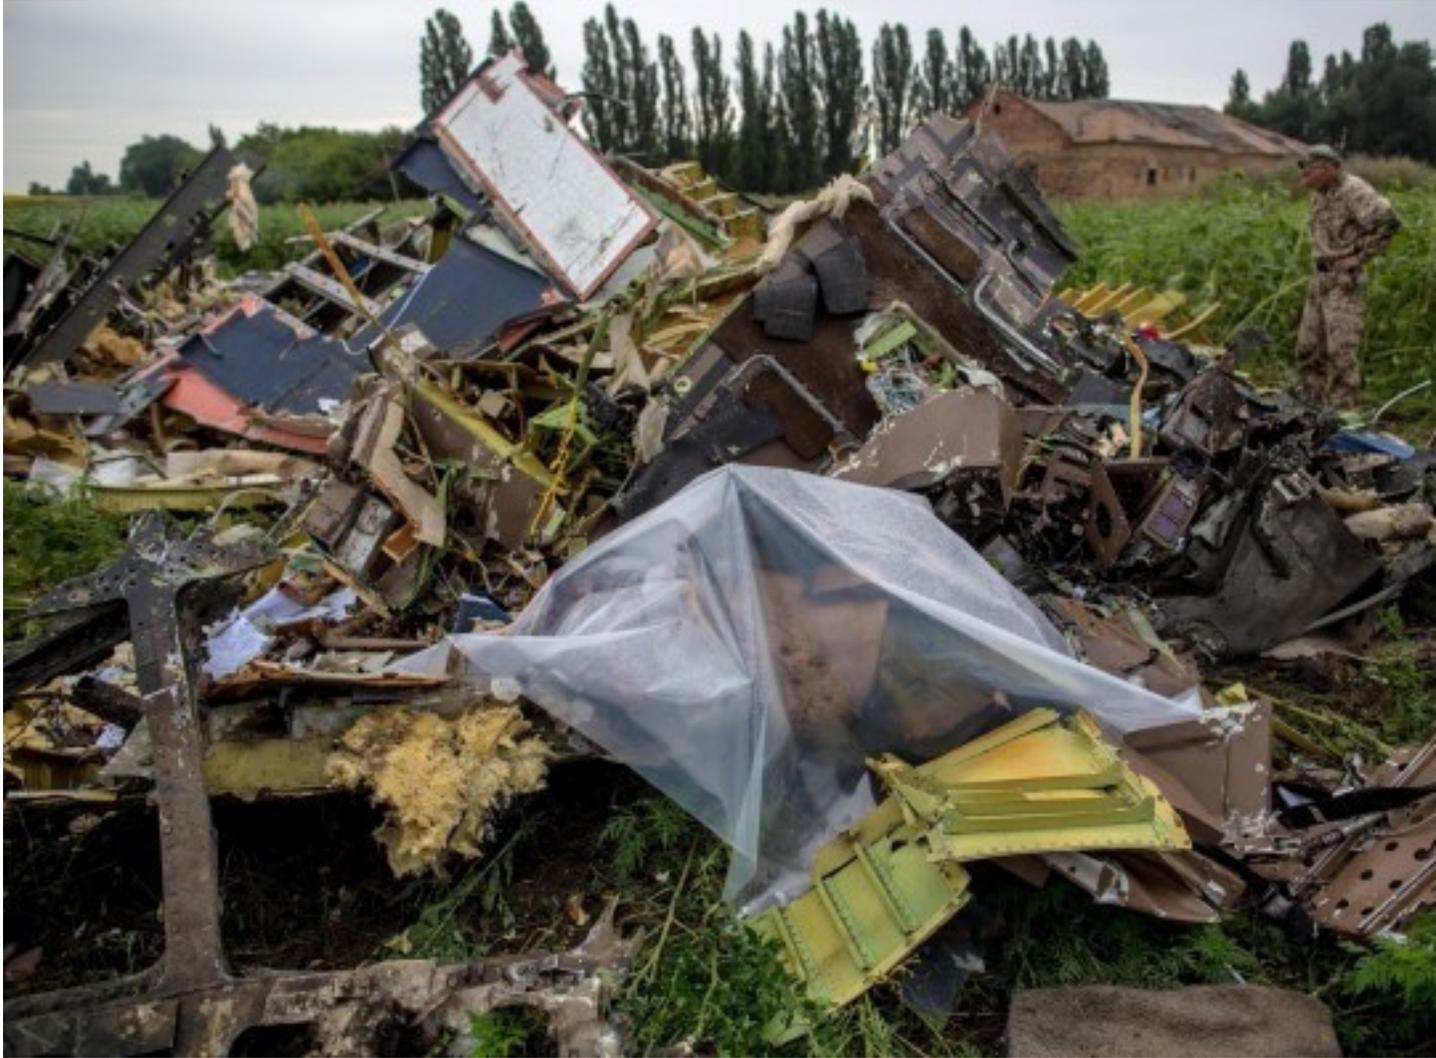
The body of the crew commander with holes in the chest.
