MH17 Crash

Crash of Malaysia Airlines flight MH17

Hrabove, Ukraine, 17 July 2014

The Hague, October 2015

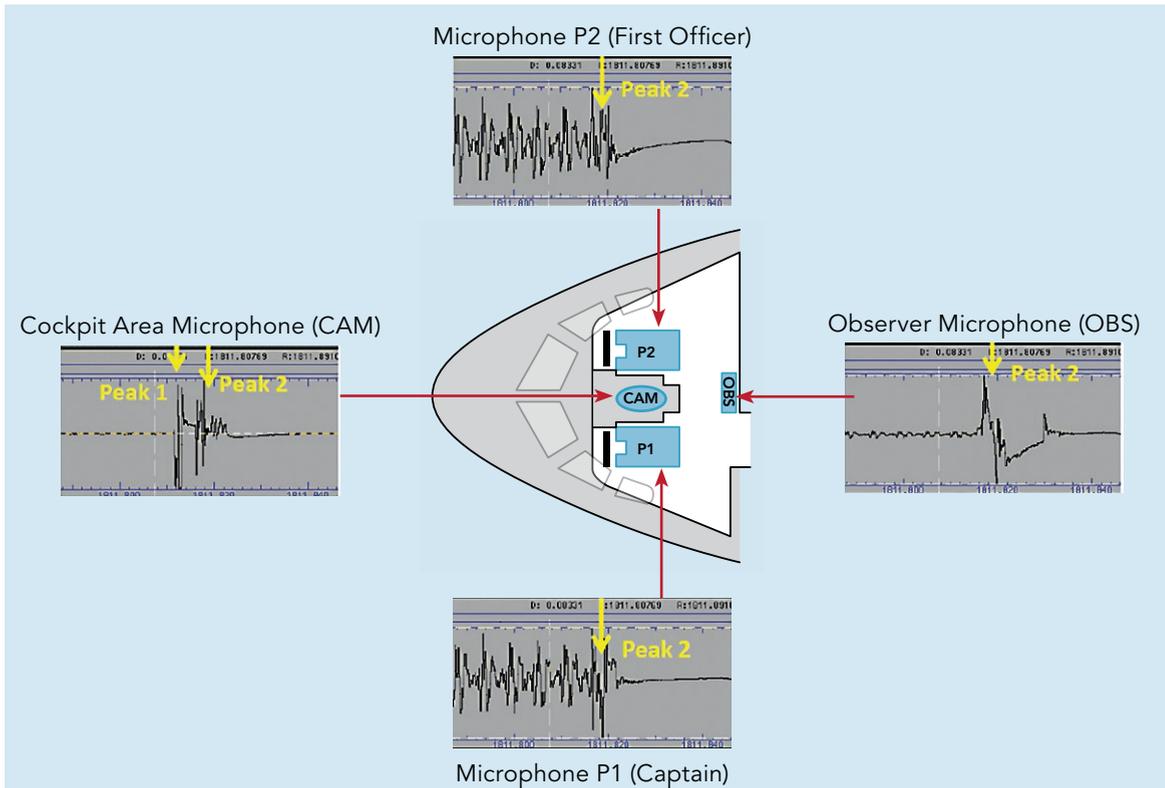
At the end of the recording, two sound peaks were identified on the last 20 milliseconds of the recording. A graphic representation of the two sound peaks for the four Cockpit Voice Recorder microphones is shown in Figure 9.

Figure 9: Sound peaks recorded at the end of the CVR recording. (Source: Dutch Safety Board)

The time period shown on each image is 4 milliseconds. The sound identified as 'peak 1' was only recorded on the cockpit area microphone (CAM).

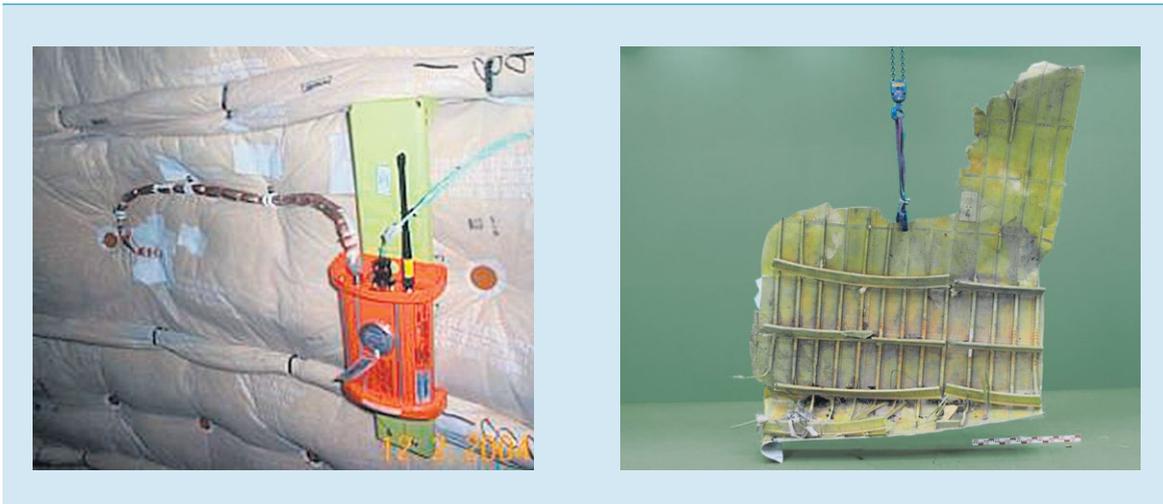
The fixed Emergency Locator Transmitter was not recovered by the investigation team, although the fuselage structure at the rear of the aeroplane onto which the fixed Emergency Locator Transmitter was mounted was recovered. Figure 11 shows the typical installation of a fixed Emergency Locator Transmitter in a Boeing 777 (left) and the panel recovered from the wreckage of flight MH17 where the fixed Emergency Locator Transmitter was mounted (right).

Figure 11: Fixed ELT location installed in a Boeing 777 (left), panel recovered from 9M-MRD with no insulation material or ELT attached (right). (Source: Dutch Safety Board)

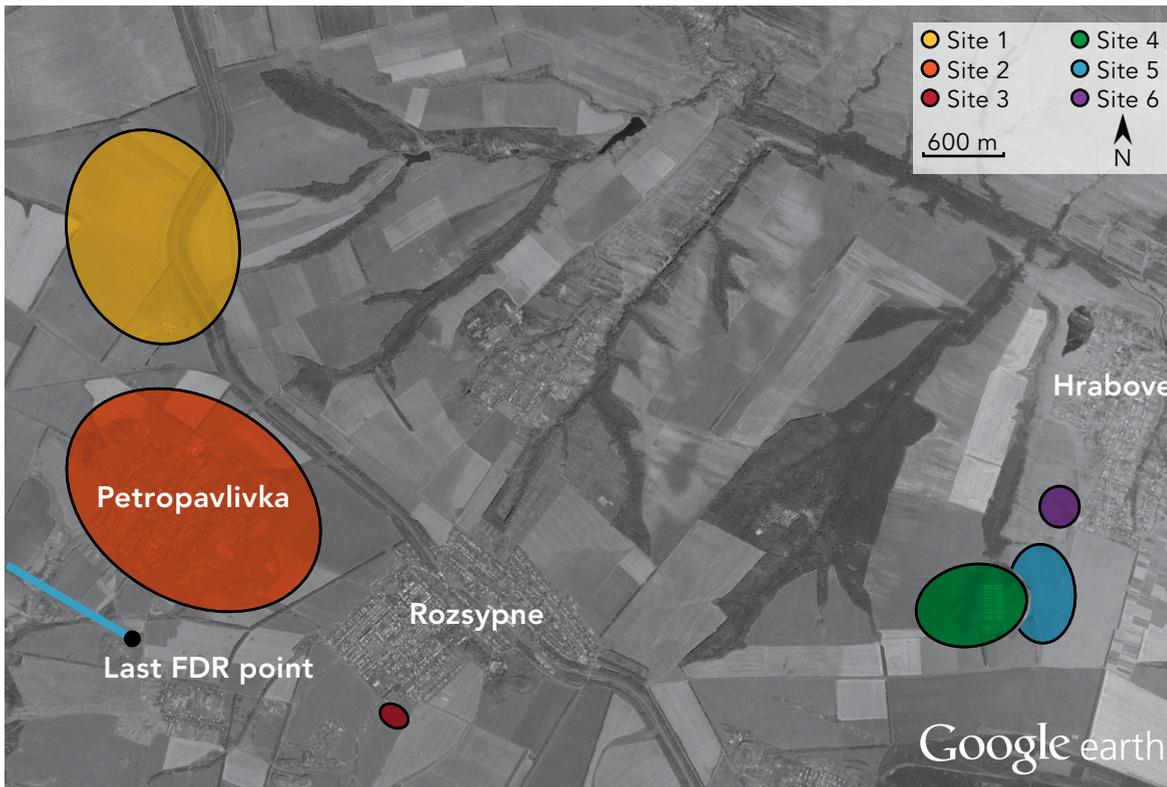
The wreckage parts of the aeroplane were identified within an area of approximately 50 km². Most of the wreckage was located on six sites within this area. The majority of the wreckage was located in three of these sites to the south-west of the village of Hrabove. Figure 12 shows the geographic location of the six wreckage sites. Each wreckage site has an associated colour. The distribution of wreckage pieces over a large area indicates an in-flight break-up.

Figure 12: Overview of wreckage area showing the six smaller sites. (Source of satellite images: Google Earth/ Digital Globe)

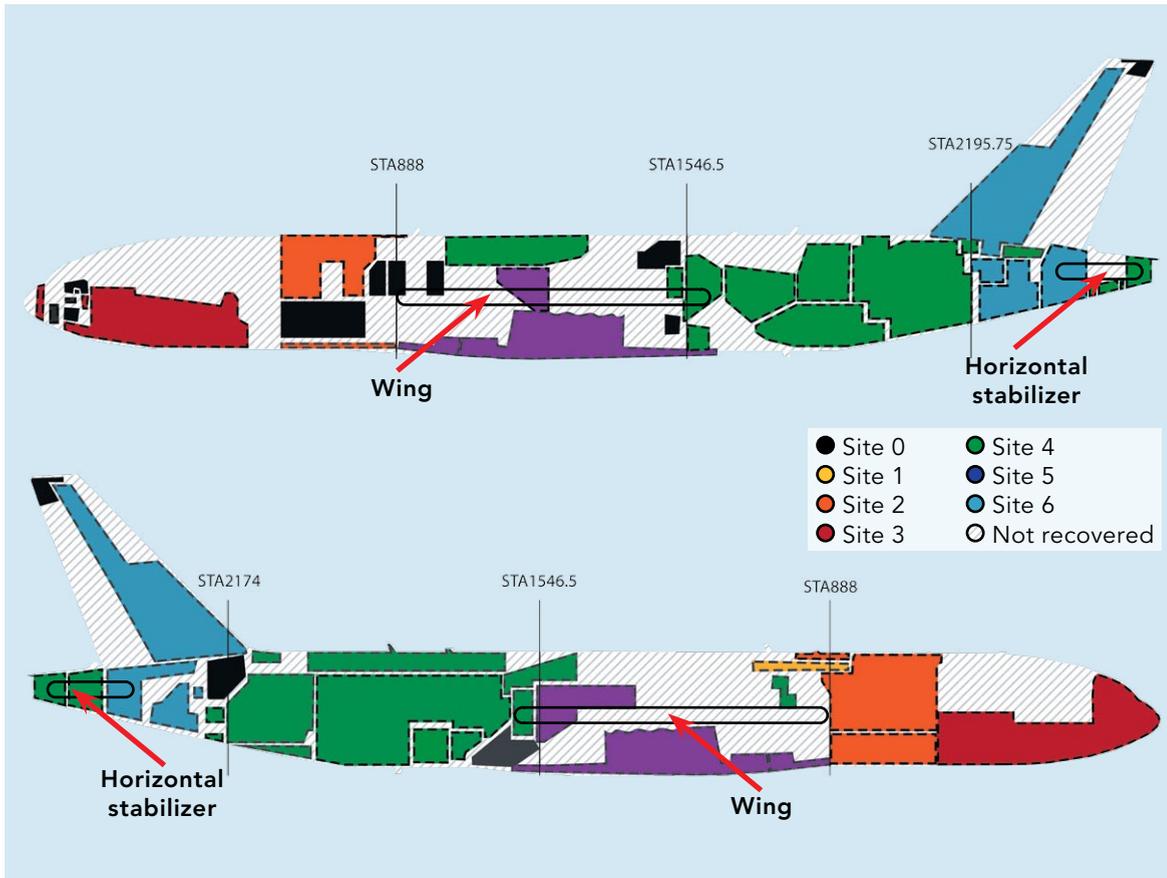
Figure 13 shows the origin of the wreckage pieces that were recovered from the various wreckage sites by the Dutch Safety Board.

Figure 13: Side view left (top) and right (bottom). Identification of wreckage retrieved from the wreckage sites. The retrieved parts of the wings, engines and horizontal stabilizers, found in sites 5 and 6, are not shown in this image, but are described in the following paragraphs. (Source: Dutch Safety Board)

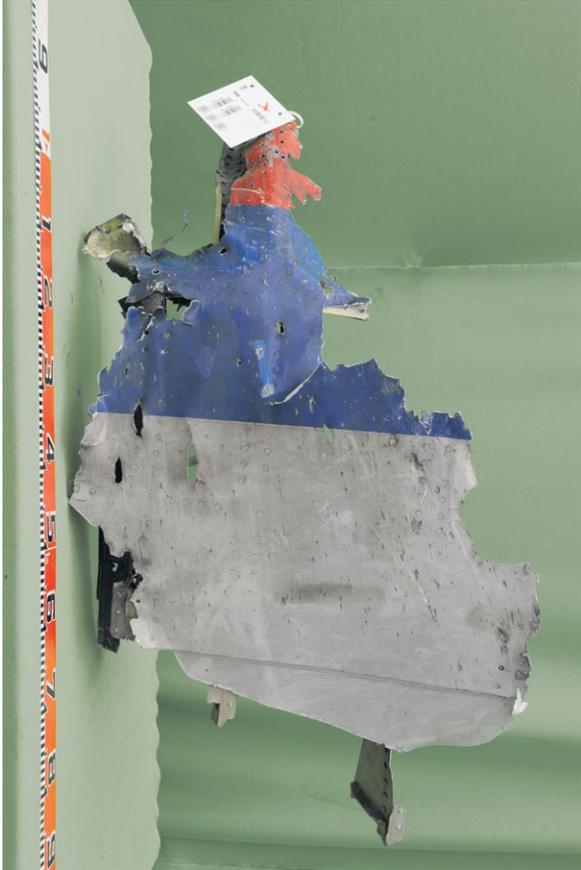
Cockpit fuselage (12)

Part of the fuselage, originating from the left hand side of the cockpit was identified in a garden in the central region of site 2. This part contained numerous puncture holes and pitting. It also showed traces of soot. The formers on the inner side of the fuselage had been sheared off. See Figure 18.

Figure 18: Part of fuselage left hand side showing holes and pitting. (Source: Dutch Safety Board)

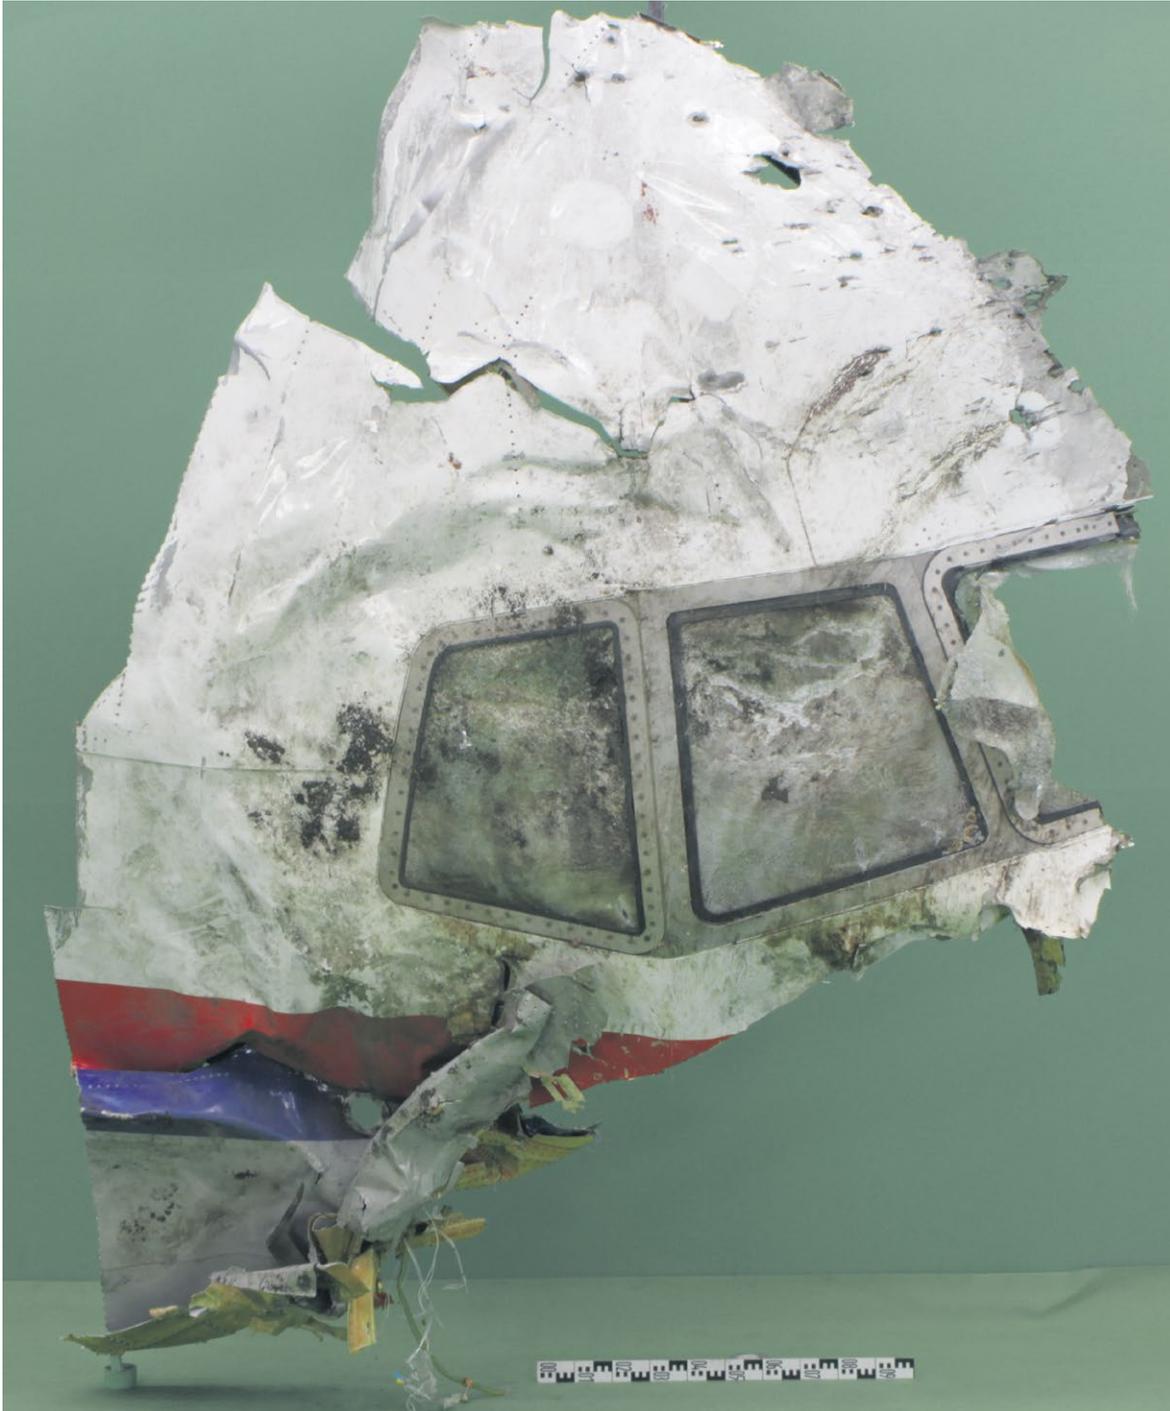
The right hand side of the cockpit remained fairly intact. The window panes of the right cockpit windows were still in place. The presence of soot is noted on the inside of the right cockpit windows 2 and 3. The upper portion of the right hand side of the fuselage showed evidence of both perforation and ricochet marks. In contrast to the left hand side of the cockpit (see paragraph 2.12.2.7), the lower right hand side did not show similar signs of perforation from the outside (see Figure 19). The size of the perforation holes is detailed in paragraph 2.6 of Appendix X.

Figure 19: Part of the right hand side of the cockpit. (Source: Dutch Safety Board)

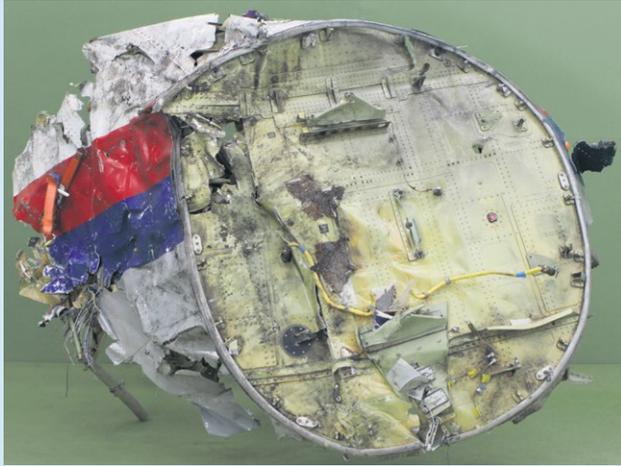
There was perforation damage on the forward pressure bulkhead. Three holes were visible. Parts of the cockpit fuselage were still attached to the left hand and right hand side of the forward bulkhead (Figure 20). The left hand side of the fuselage attached to the forward pressure bulkhead contained numerous puncture holes and pitting was observed (Figure 21). The right hand side of the fuselage attached to the forward pressure bulkhead had no perforation damage.

Figure 20: Forward pressure bulkhead and right hand fuselage. (Source: Dutch Safety Board)

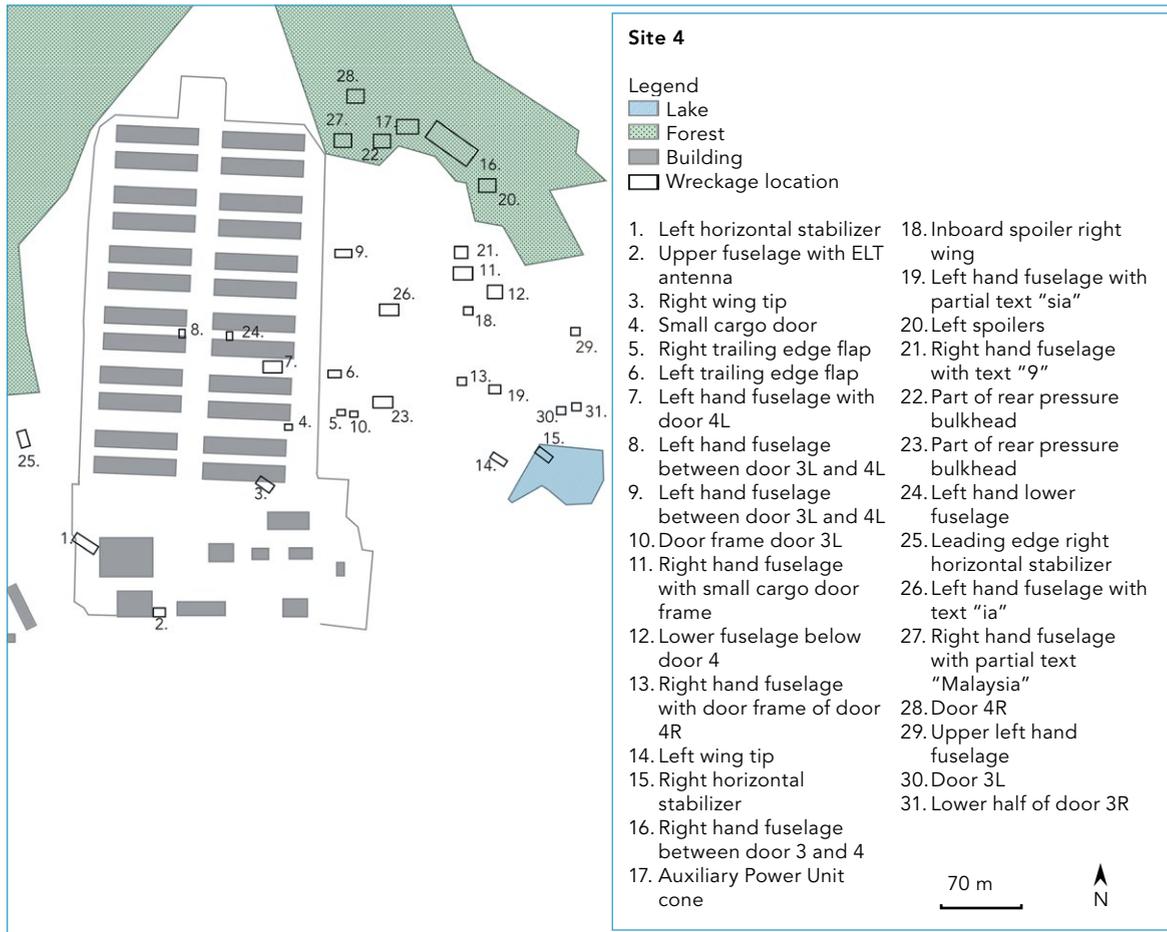
Figure 28: Overview of wreckage site 4 and the location of the wreckage pieces. (Source: Dutch Safety Board)

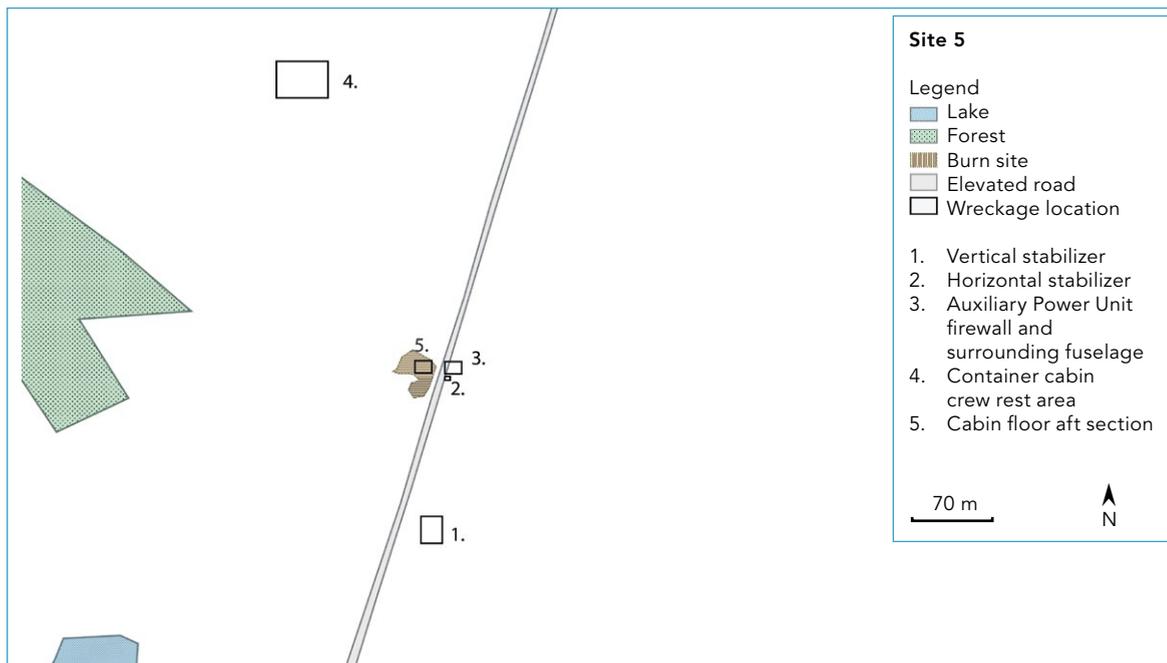
Figure 30: Overview of wreckage site 5 and the location of the wreckage pieces. (Source: Dutch Safety Board)

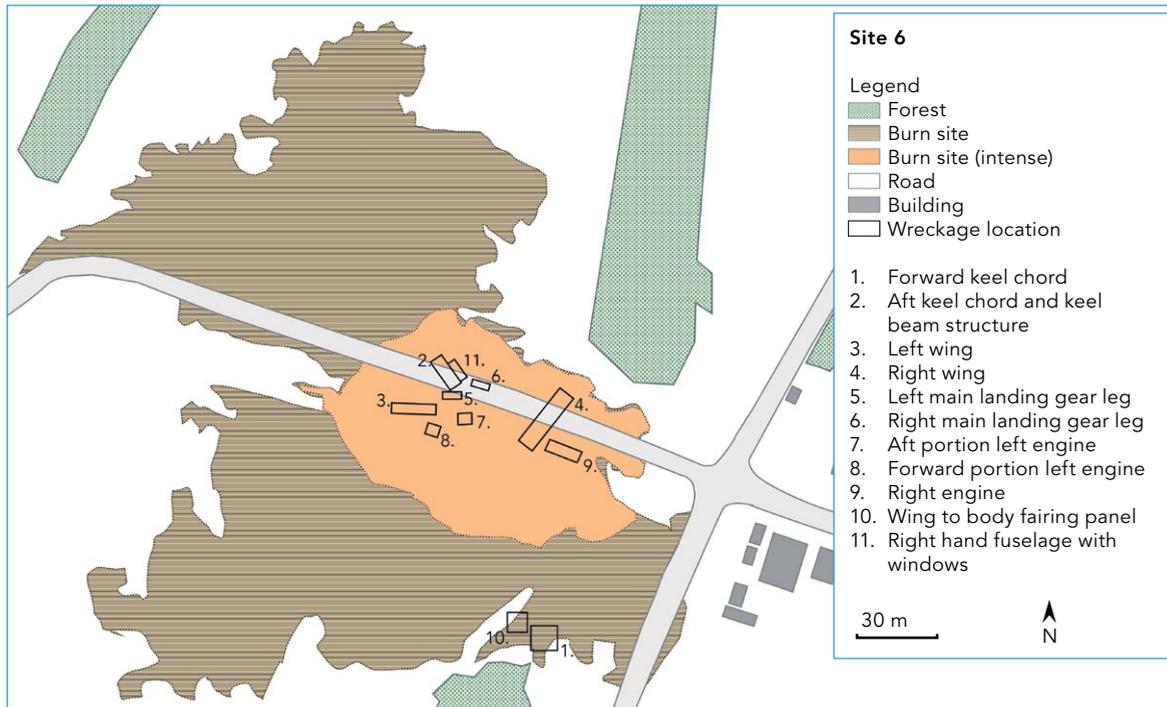
Figure 31: Overview of wreckage site 6 and the location of the wreckage pieces. (Source: Dutch Safety Board)

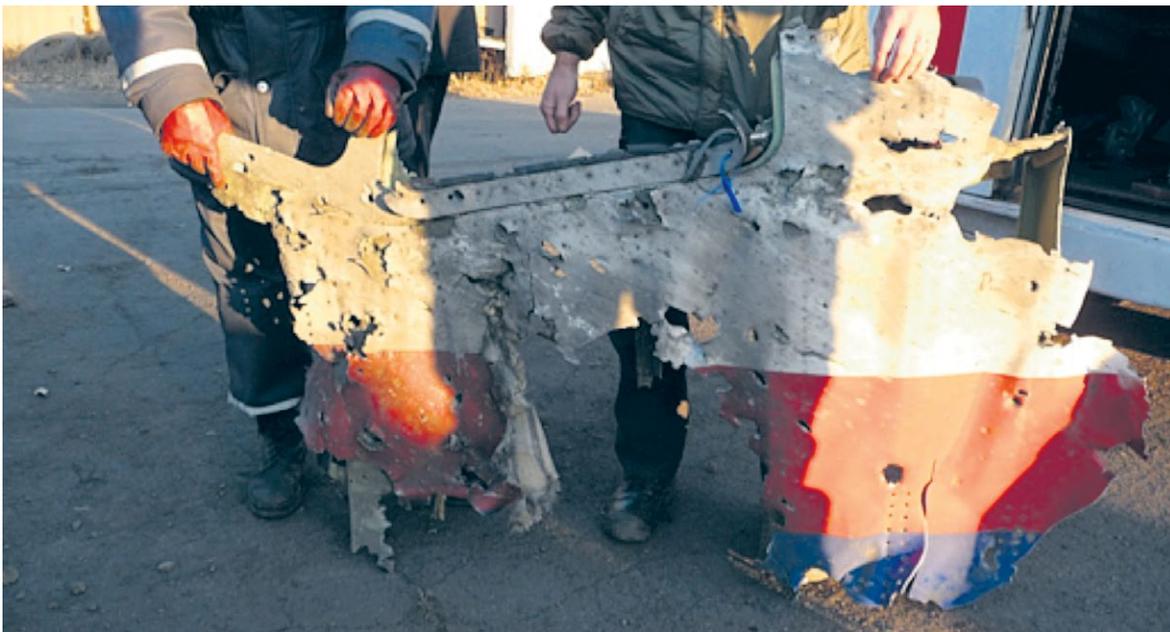
Figure 32: Handover of the left cockpit window frame to the Dutch Safety Board by members of the SES. This is the same part as is shown in Figure 33. (Source: Dutch Safety Board)

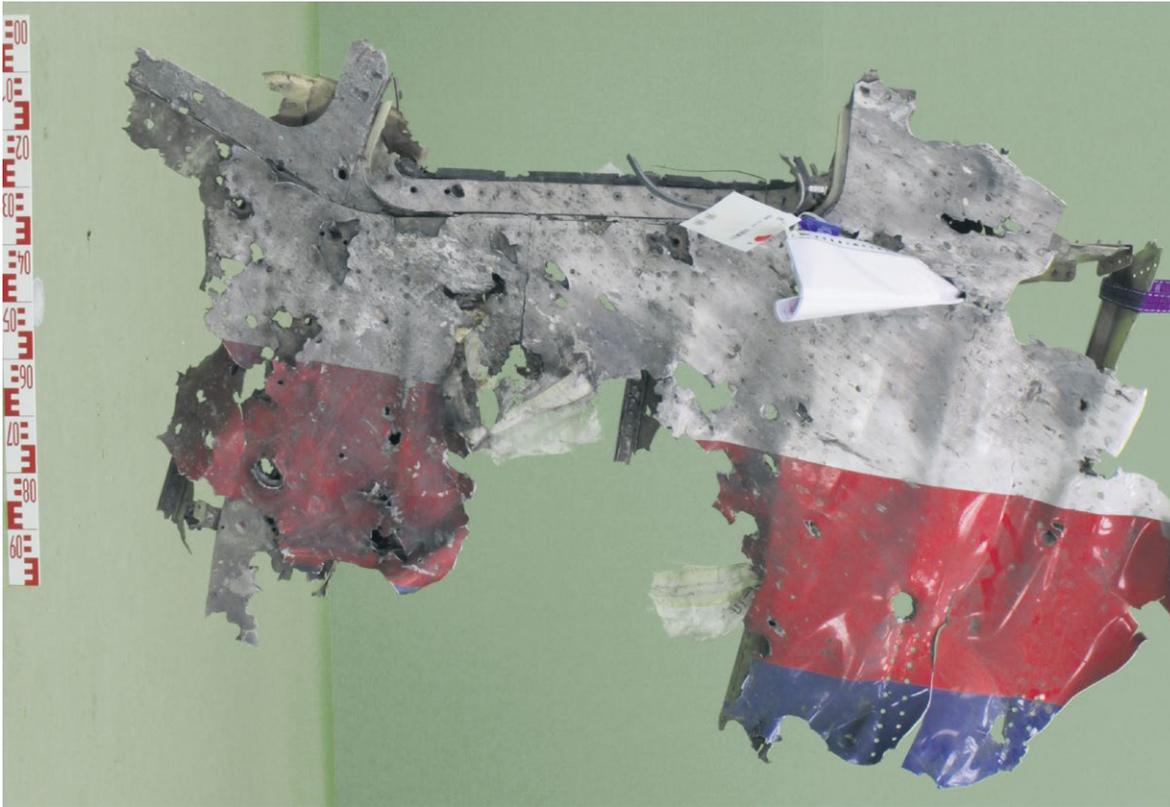
Fuselage with the lower part of a cockpit window frame

Part of the fuselage (STA180.5 to STA228.5), originating from the left hand side of the cockpit, was located at the side of the road, in the central region of site 2, near the village of Petropavlivka. Residents of the village reported that the wreckage piece had been moved to expedite the search and recovery mission. The fuselage skin was punctured from the outside in a number of places and the outside fuselage skin was pitted and showed traces of soot. Frames on the inner side of the fuselage had been sheared off.

Figure 33: Part of the left cockpit window frame. (Source: Dutch Safety Board)

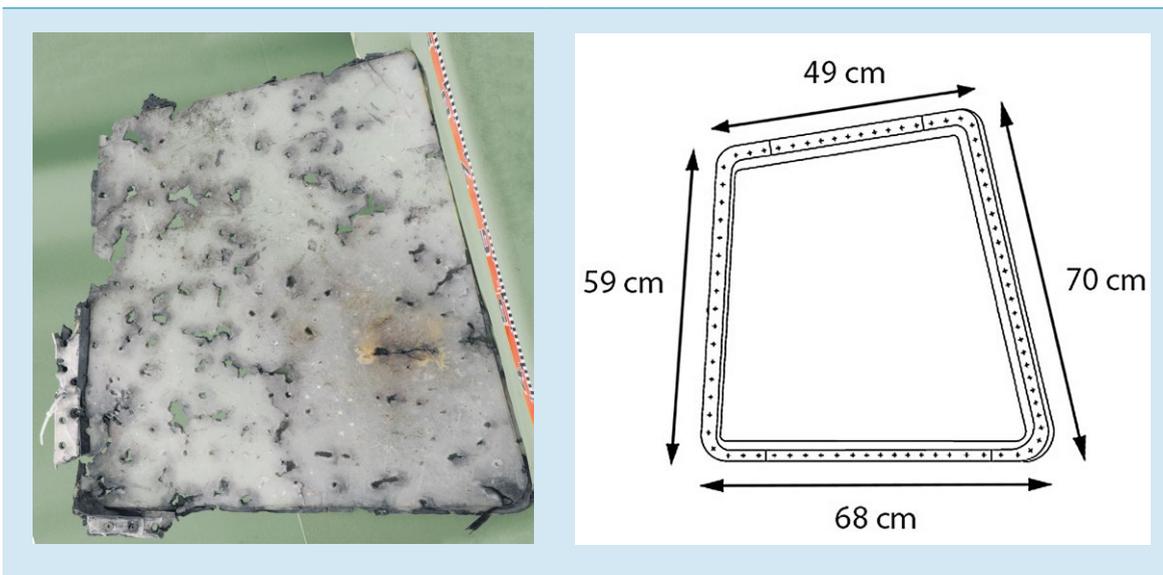
Cockpit window left hand side

One of the layers of the window (window number 2) on the left hand side of the cockpit was collected by local residents. Cockpit windows are made of multiple layers of glass and plastic. The window had a total of 102 puncture holes and marks, varying in size and shape, as seen in Figure 34. Parts of the window frame were still attached to the window.

Figure 34: Left cockpit window 2. (Source: Dutch Safety Board)

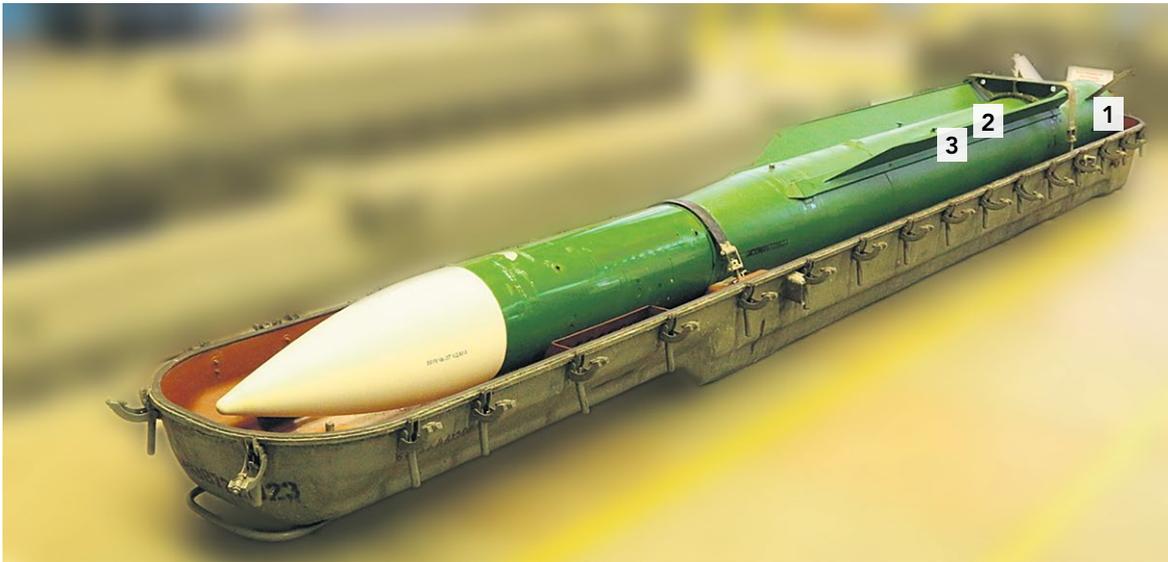
Figure 35: Image of 9M38M1 surface-to-air missile showing the approximate location of three of the parts recovered. (Source: NBAAI)

The shape and form of the parts recovered is consistent with a 9M38 series surface-to-air missile. Images of three of the recovered parts are shown in Figure 36 together with an indication of origin on a 9M38 series surface-to-air missile; namely an engine nozzle (1), part of one of the four stabilizer fins (2) and a data cable (3).

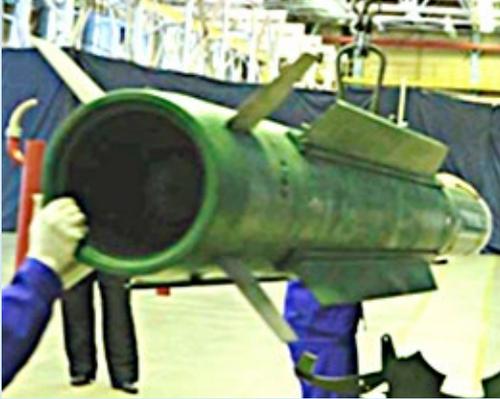
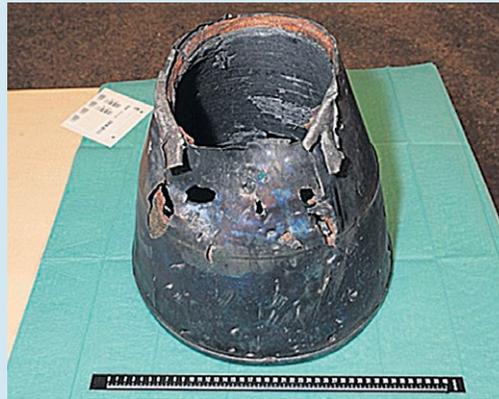
1. Rear nozzle of the missile's engine. (Source: NBAAI)

Missile engine nozzle as found in Ukraine. (Source: Dutch Safety Board/Dutch National Police)

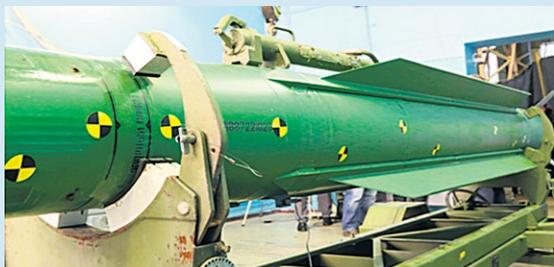
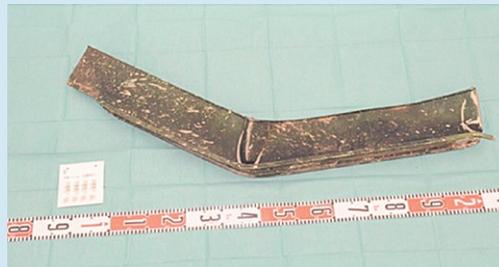
2. Stabilizing fins. (Source: NBAAI)

Part of stabilizing fin during identification at Gilze-Rijen Air Force Base. (Source: Dutch Safety Board/Dutch National Police)

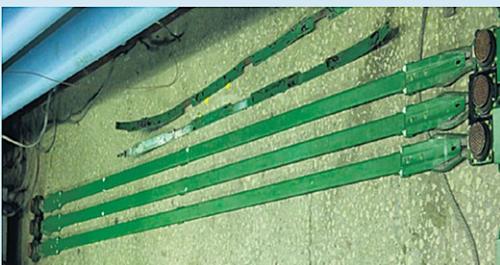
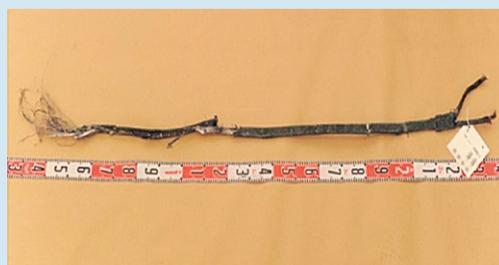
3. Data cables as mounted under the stabilizing fins. (Source: NBAAI)

Data cable during identification at Gilze-Rijen Air Force Base. (Source: Dutch Safety Board/Dutch National Police)

Figure 36: Weapon parts recovered. The parts are shown with sample photos showing their origin on a 9M38M1 surface-to-air missile. Numbers correspond with numbers in Figure 35.

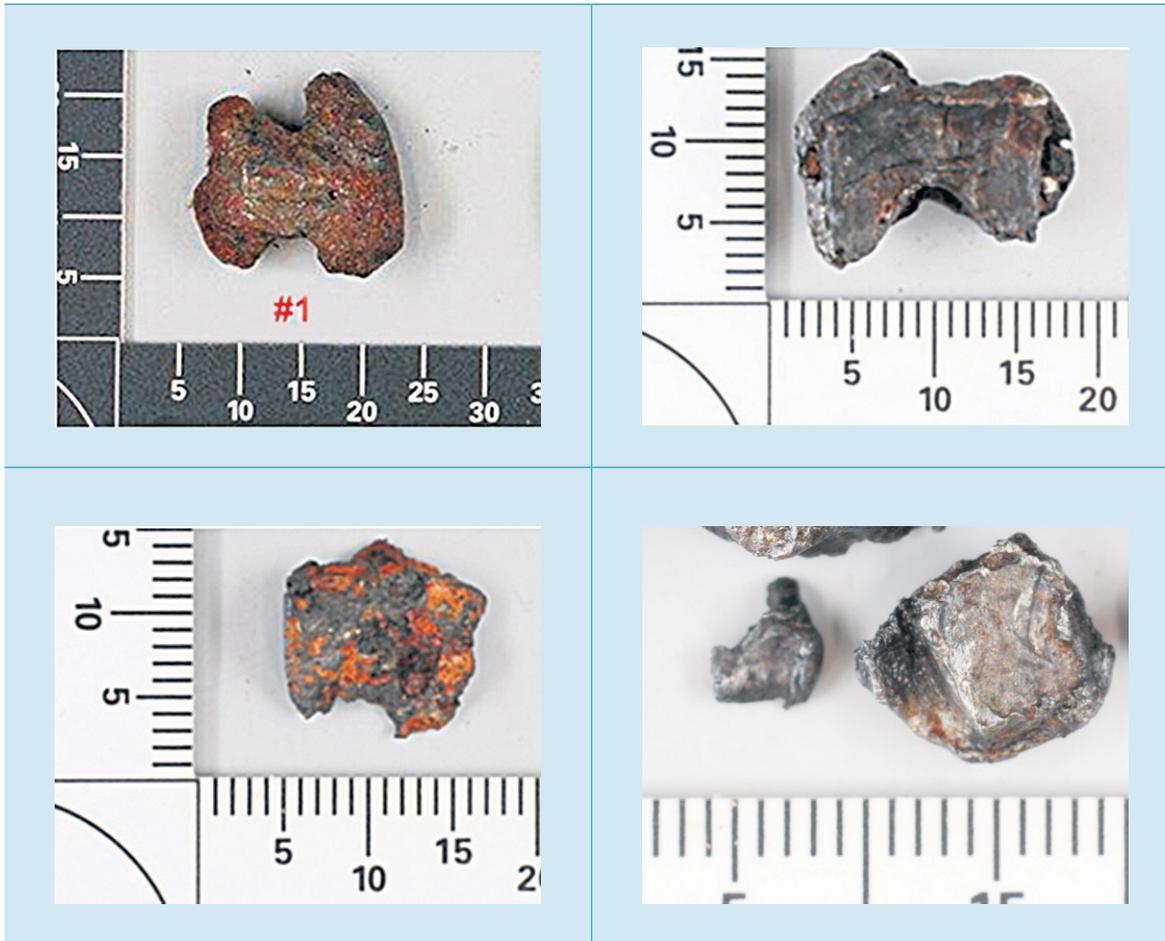
A distinct group was identified as small pieces of metal that were suspected to be high-energy objects, or parts of them. These fragments were extracted from the Captain from Team A, the First Officer from Team A, the Purser, who was present in the cockpit at the time of the crash, and from the cockpit wreckage (Figure 37). These fragments were found to be ferrous.

Figure 37: Four distinctly shaped fragments. Top left: cockpit. Top right: Captain's body. Bottom left: Purser's body. Bottom right: First Officer's body. (Source: NFI). Scale is in millimetres.

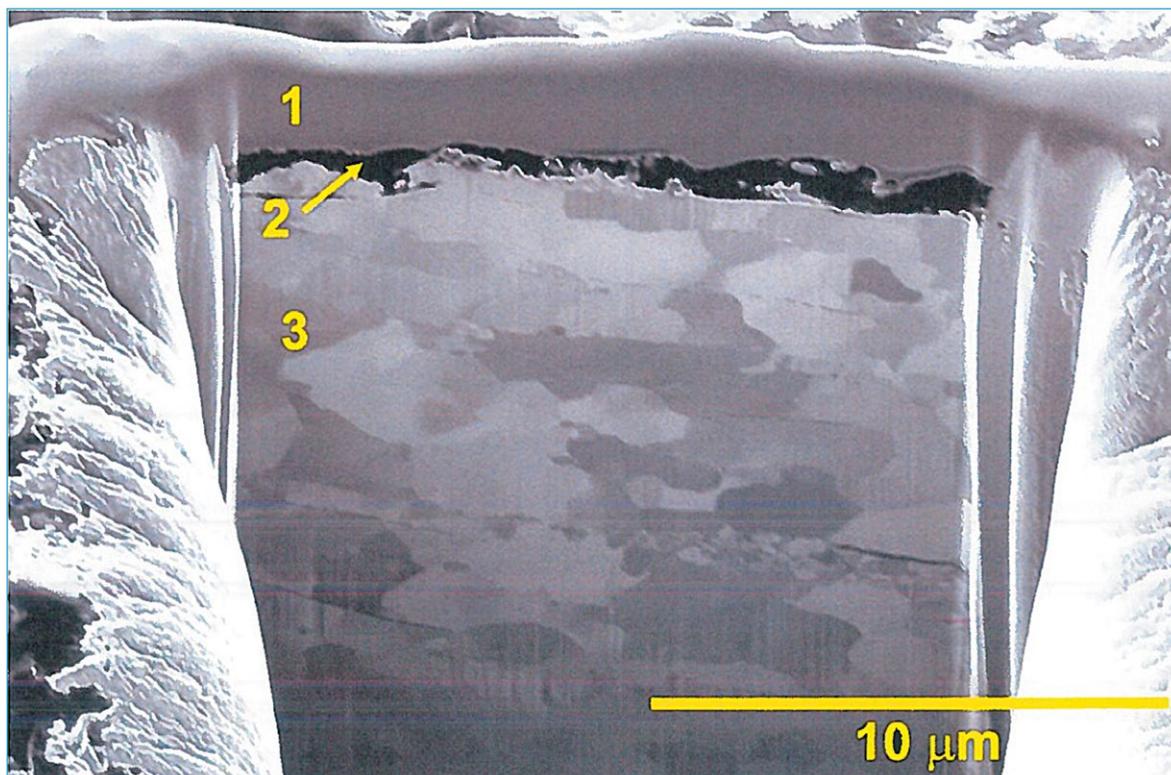
Cross-sections were made using the FIB technique on fragments recovered from the remains of the crew members, that had a glass and/or aluminium deposit. Scanning electron microscope examinations of the cross-sections created showed that both the aluminium and glass deposits were present in the form of thin layers of re-solidified material. These layers have a thickness ranging from tenths micrometres to tens of micrometres (Figure 38). On a small number of fragments thin layers containing traces of copper and plastic were found.

Figure 38: Example of SEM examination on a cross-section made using FIB. Note: 1) Layer of platina deposited by NFI, 2) layer of re-solidified molten cockpit glass, 3) unalloyed steel. (Source NFI)

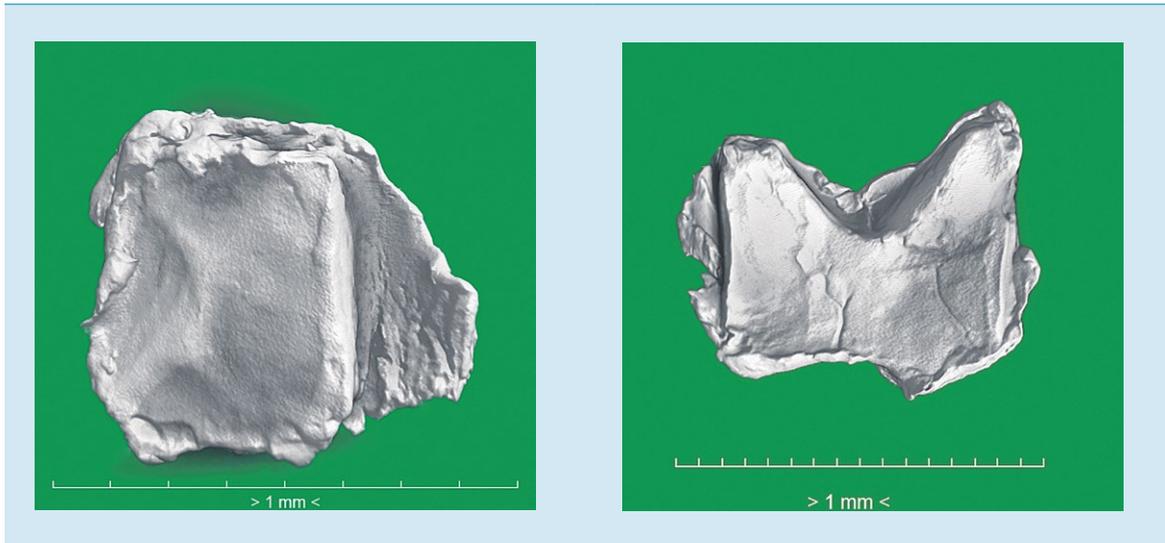
The examination further showed that several fragments recovered from the crew members (Figure 39) were heavily deformed on one side of the fragment and that the opposite side was only slightly deformed. The deposits that were detected were mainly found on the heavily deformed side of the fragments in a re-solidified state.

Figure 39: Micro CT-images of the fragments (shown at the right side of Figure 37, left from the First Officer's and right from the Captain's body) show the deformation of the fragments. (Source: NFI)

The investigation concluded that these fragments impacted the aeroplane at a very high velocity, thereby deforming the object at the side of the impact. The consequential frictional heat melted the aeroplane's materials (glass, aluminium etc.) and a thin layer of solidified aeroplane material was deposited to the heavily deformed side of the object. Although the velocity of the object was reduced due to the impact with the aeroplane, the object continued its path and then impacted the crew member where it was found. These fragments were as such assessed to be high-energy objects.

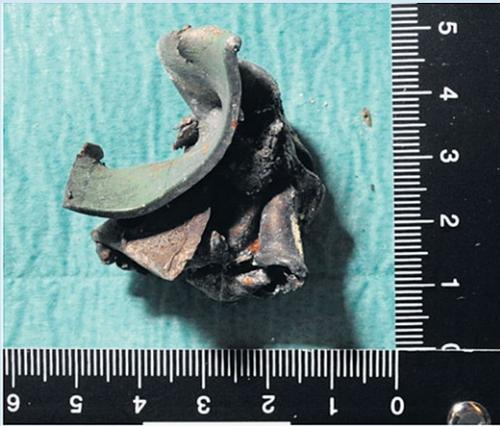
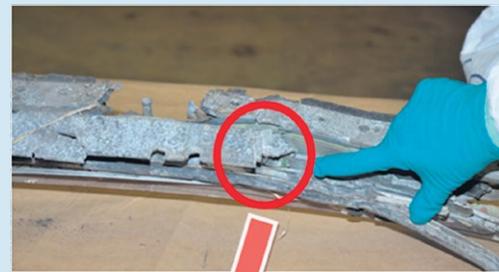
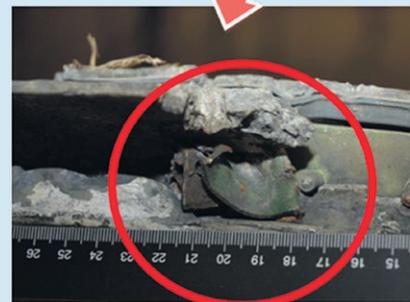
Metal fragment recovered from the left cockpit window frame. (Source: Dutch Safety Board/Dutch National Police)

Location of the fragment in the left cockpit window frame. (Source: Dutch Safety Board)

Figure 40: Two of the metal fragments recovered from the aeroplane wreckage.

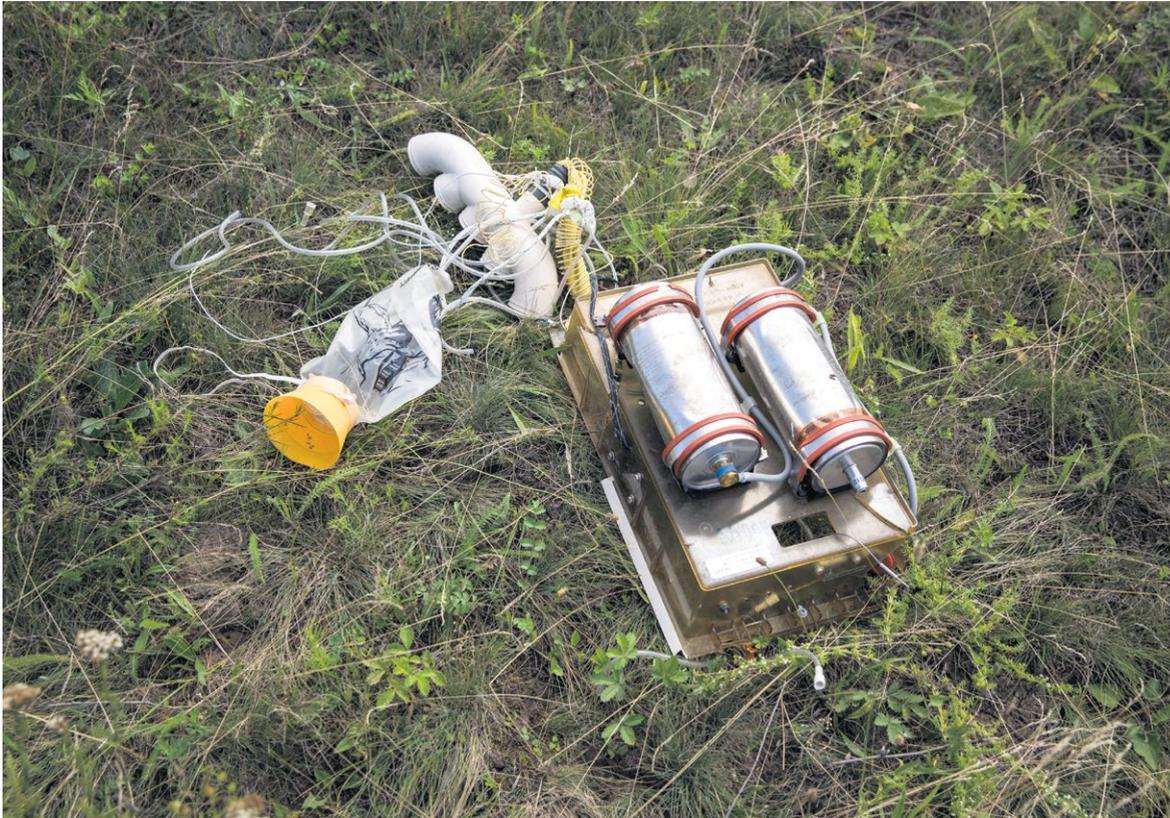
During the investigation about fifty chemical oxygen generators were recovered from the wreckage sites. With the exception of one, none of the chemical oxygen generators had its firing pin in place and all displayed a black coloured stripe; an indication that the

Figure 41: Chemical oxygen generators and part of the passenger service unit. (Source: Dutch Safety Board)

Some chemical oxygen generators were attached to their passenger service unit; others were found separated. All of the chemical oxygen generators were damaged and most of them were heavily distorted. About a dozen of the plastic PSU containers, or a part of them, which normally contain the emergency oxygen masks, were found. The containers are relatively rigid, but may nevertheless be deformed. The containers were heavily damaged, incomplete or cracked. All the latches, which cover the masks and keep them stored in the container, were missing. All of the solenoid switches were found in the 'unlatched' position. A few switches were damaged and could not be reset in the 'latched' position. For most of the chemical oxygen generators recovered, the masks and oxygen supply tubes were missing.

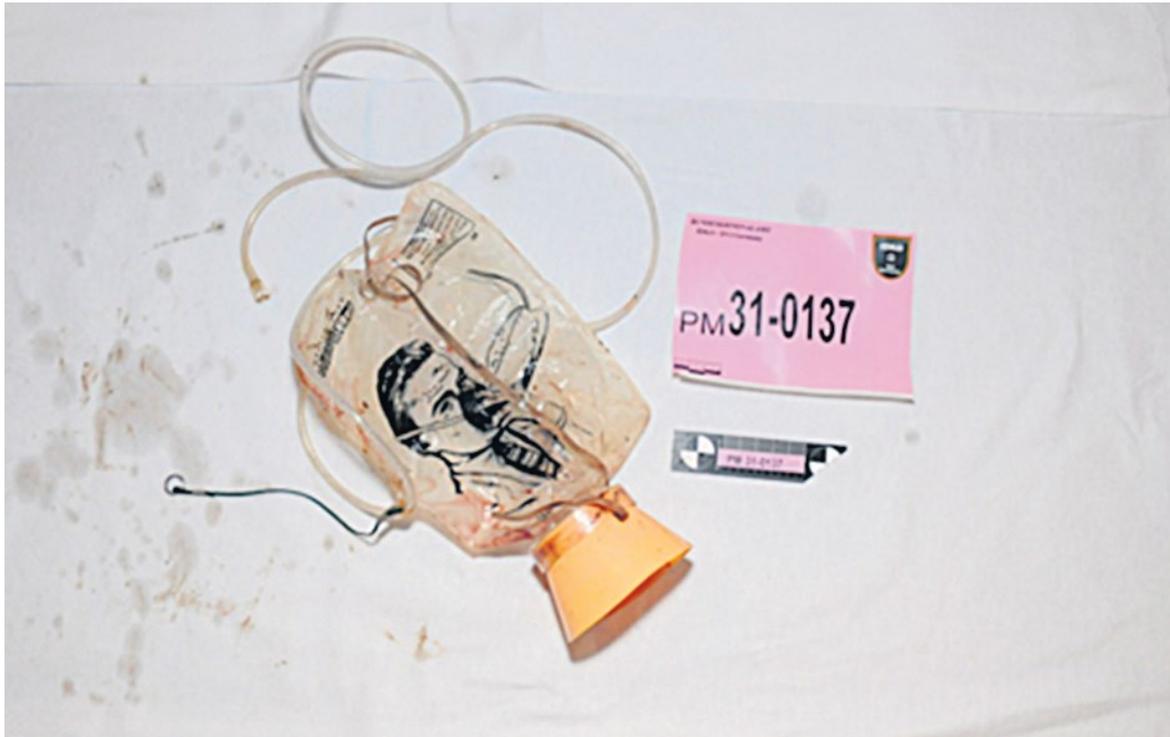
Figure 42: Emergency oxygen mask found on passenger. (Source: Dutch Safety Board)

During the victim identification process in the Netherlands, one passenger was found with an emergency oxygen mask, see Figure 42. The strap was around the passenger's neck and the mask was around the throat. No information was available about how this passenger was found at the wreckage site. The NFI examined the mask for biological traces and performed DNA tests. No DNA profiles could be obtained from the five samples taken. Therefore, DNA analysis was not possible. The lack of DNA material can be explained by the mask having been left outside for a long time at high temperatures.

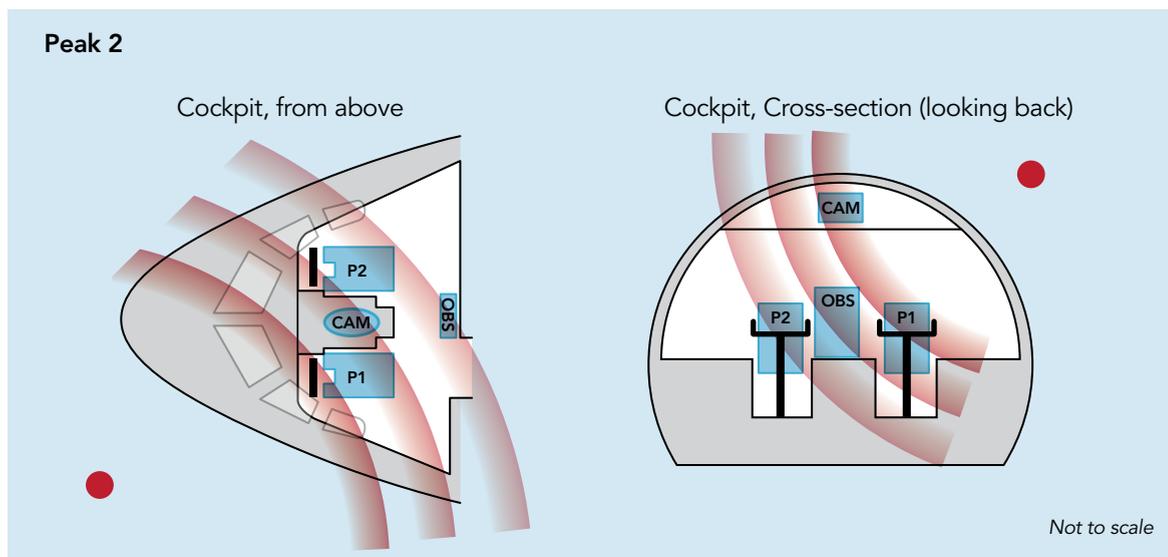
The time difference between the first and the second sound peak was determined to be 2.3 milliseconds. The second peak had a duration of 2.3 milliseconds and was recorded by all four channels. However, the recordings of the second peak were not simultaneous on all channels; some of the recordings had a different timestamp. The wave spectrum is representative for a sound wave. The time difference between the channels showed that the sound was recorded by the cockpit area microphone (CAM) and pilot 1 (P1) microphones first, followed by the pilot 2 (P2) microphone and, lastly, the observer (OBS) microphone. This difference in time showed that the sound wave originated outside the aeroplane starting from a position above the left hand side of the cockpit, propagating from front to aft (see Figure 43). It is concluded that the event was highly energetic in nature based on the short time duration of the event.

Figure 43: Second sound peak - graphic representation. (Source: Dutch Safety Board)

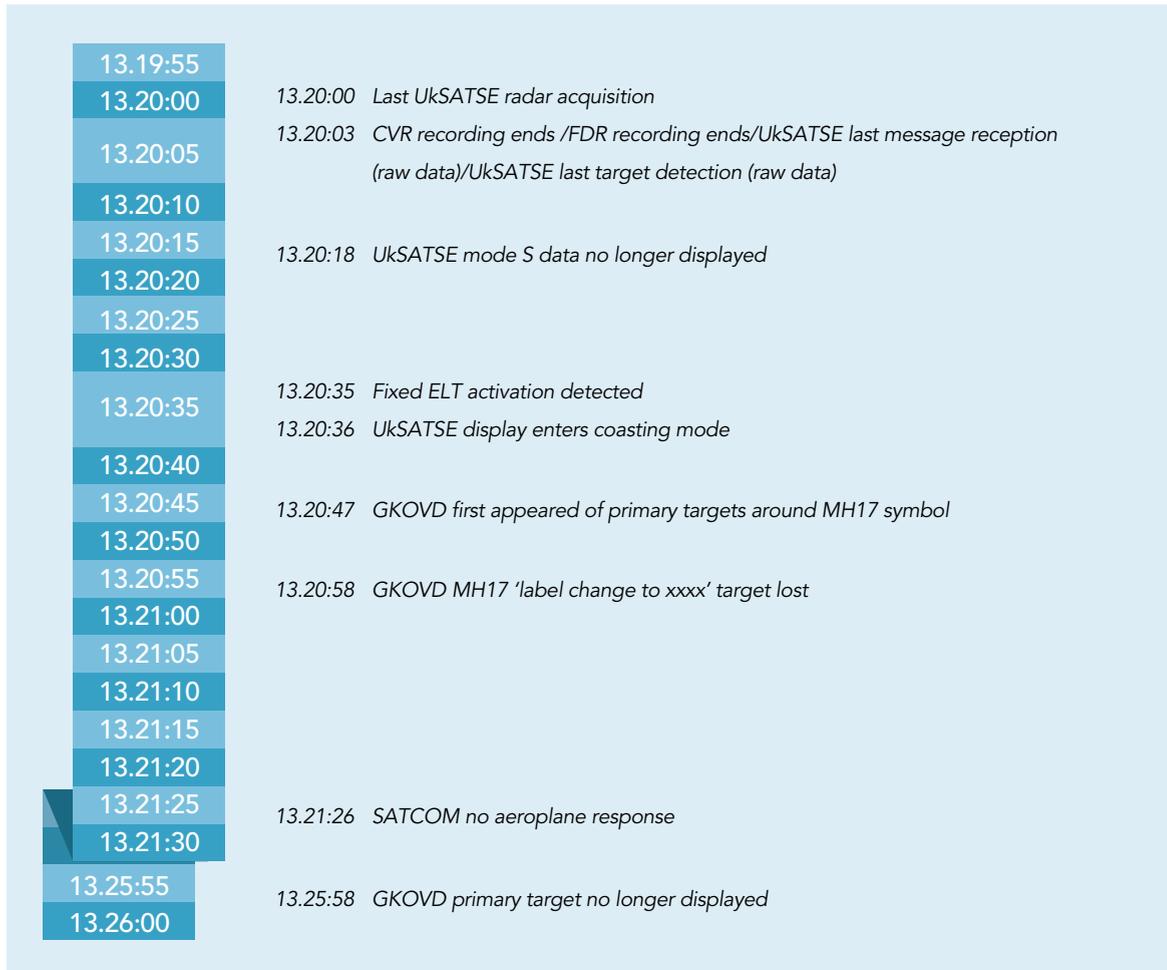
The loss of the two recorders and the radar data at 13.20:03 (15.20:03 CET) indicated that the electrical power was lost at this moment. The automatic activation of the fixed ELT between 13.20:05 - 13.20:06 (15.20:05 - 15.20:06 CET), caused by a deceleration, supported this. Finally, no other recorded data (e.g. SATCOM transmissions) contradicted the hypothesis.

Figure 44: Diagram showing a number of key moments in the recorded data. (Source: Dutch Safety Board)
