MH17 Crash

Crash of Malaysia Airlines flight MH17

Hrabove, Ukraine, 17 July 2014

The Hague, October 2015

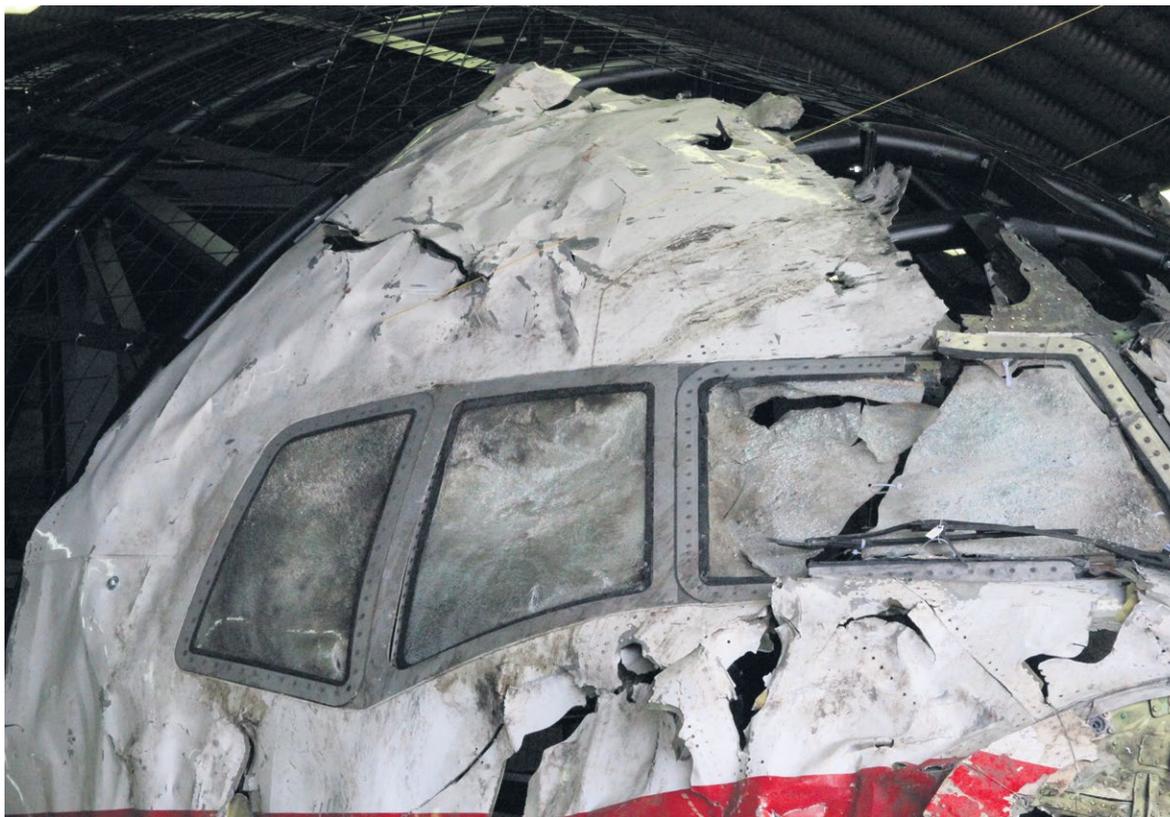
The main location of the damage of high-energy objects was on the left hand and upper side of the cockpit. The right hand side of the cockpit showed no high-energy object damage. As is shown in Figure 45 the two cockpit windows on the right hand side and the surrounding structure were unaffected by high-energy object impact.

Figure 45: Right hand side of cockpit. (Source: Dutch Safety Board)

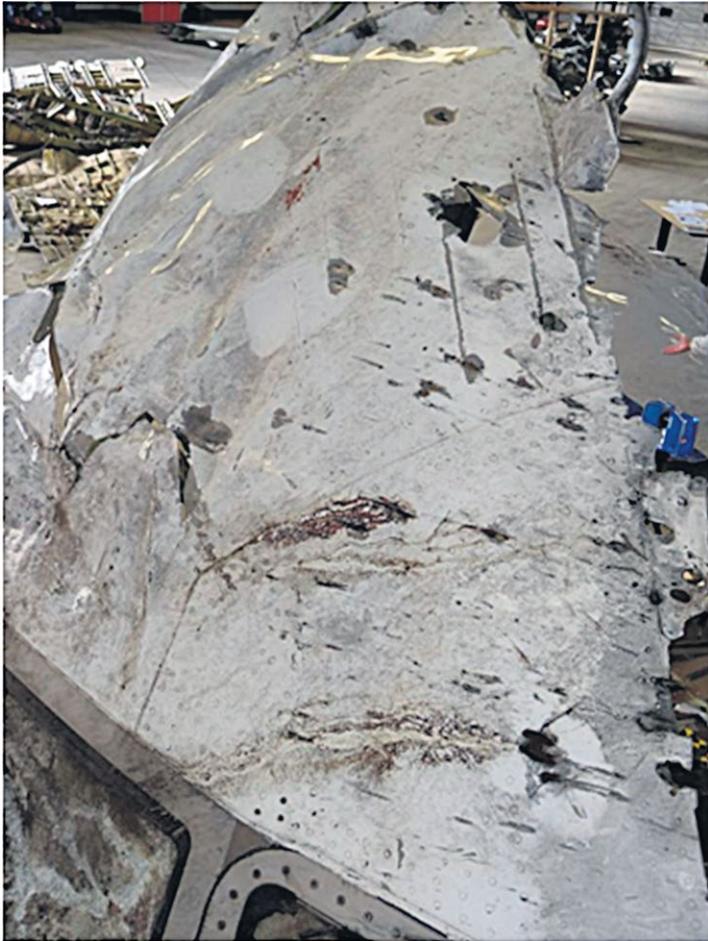
There was a relatively clear boundary between parts of the wreckage that were affected by the high-energy object impacts and parts that were unaffected. On the front side of the cockpit, the boundary was the forward corner of the left hand front window. The most forward impact damage occurred just above and aft of this corner. On the top and right hand side of the cockpit the damage boundary was indicated by the ricochet

impacts on the cockpit roof as indicated in Figure 46. To the right of this area no impact damage was present. On the left hand side, the rear impact damage boundary was found in front of the left hand forward passenger door.

Figure 46: Right hand side cockpit roof, looking front to back. (Source: Dutch Safety Board)

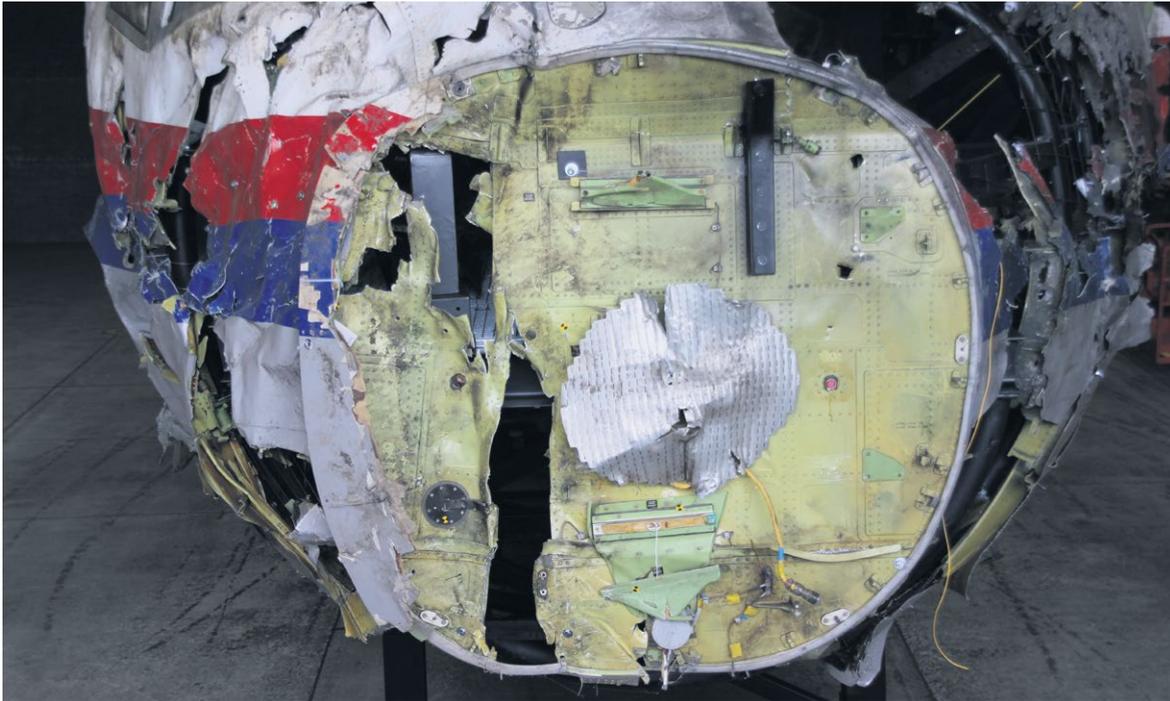
Figure 48: Cockpit bulkhead at junction with radome. (Source: Dutch Safety Board)

There was no perforation damage found in the cockpit bulkhead (Figure 48) that can be identified, with any certainty, as being from the perforation of high-energy objects. The perforation in the bulkhead was the result of other parts of the cockpit's structure having pushed through the plating.

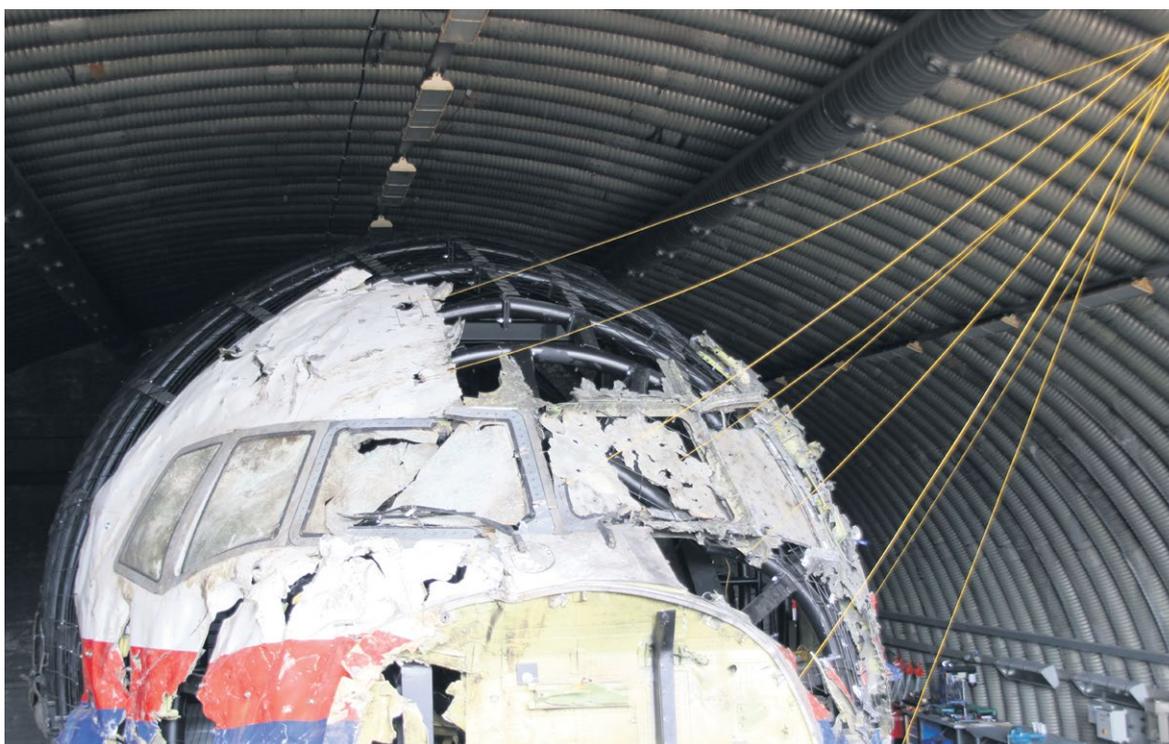
To determine the trajectory of the high-energy objects, the direction of the impact damage was analysed on several parts of the cockpit area. Using fibreglass rods and three-dimensional scans of the structure the direction of high-energy objects penetrating multiple layers of material was determined. A network of lines of string passed through straight lines of damage was set up. This is known as 'stringing' and is used to analyse the general direction of impact damage as shown in Figure 50. The results show trajectories of perforating damage converging to a general area to the left of, and above, the cockpit.

Figure 50: Impression of stringing of the cockpit. (Source: Dutch Safety Board)

It should be noted that although the 'stringing' is brought to a single point in Figure 50, it is not suggested that the point of detonation was actually a small single point. The lines are brought together to illustrate the divergent nature of the spray pattern of the high-energy objects. Stringing is only used to generate an indication of the detonation's position and is not intended to identify a specific point in space.

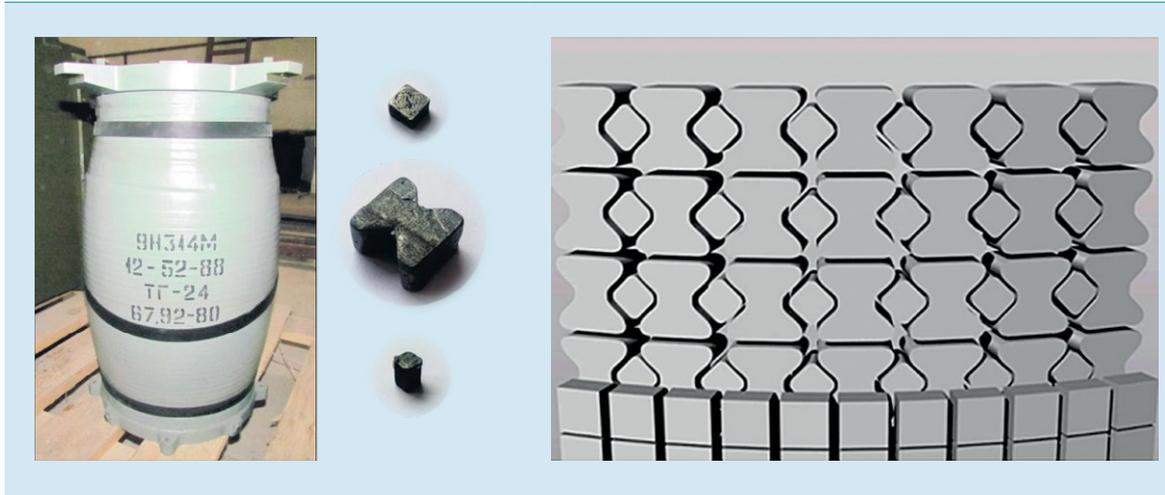
It is noted that the shapes of the pre-formed fragments found in the wreckage and the bodies of crew members in the cockpit; bow-tie and cubes, are only found in the 9N314M warhead (see Figure 56). The 9N314M warhead can be fitted to the 9M38M1 missile. These missiles are launched from a Buk surface-to-air missile system (see Figure 57).

Figure 56: Left: Sample 9N314M warhead. (Source: JSC Concern Almaz-Antey). Centre: from top to bottom, square, bow-tie and filler fragments. (Source: JSC Concern Almaz-Antey). Right: 3D print of the pre-formed fragment arrangement. (Source: AAIB). Note: the model name for the 9N314M warhead is shown on the left hand image in Cyrillic text, '9H314M'.

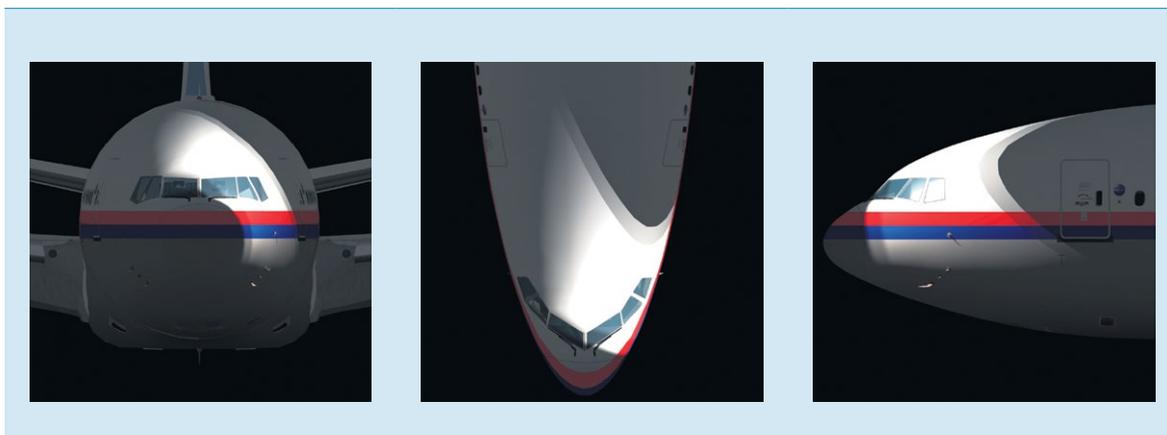
a Boeing 777. Light was used to visualise the area of the fuselage exposed to the primary fragments of the warhead (see Figure 58). This fragmentation visualisation model was used to compare the actual high-energy object damage on the cockpit with the calculated fragment spray of the warhead from the point of view of detonation location, boundary and impact angle. The full report is published in the on-line appendices on the Dutch Safety Board's website (Appendix X).

Figure 58: Expected damage pattern caused by a 9N314M-model warhead. Lit areas show where damage was expected. (Source: NLR)

Using the modelled warhead's detonation point with the aeroplane's last known location, speed and attitude (see paragraph 3.4.1), the fragmentation visualisation model matched the damage observed on the wreckage of the aeroplane. The estimated position of the detonation was 0.25 metres ahead of the aeroplane's nose, 3 metres to the left of, and 3.7 metres above the tip of the nose.

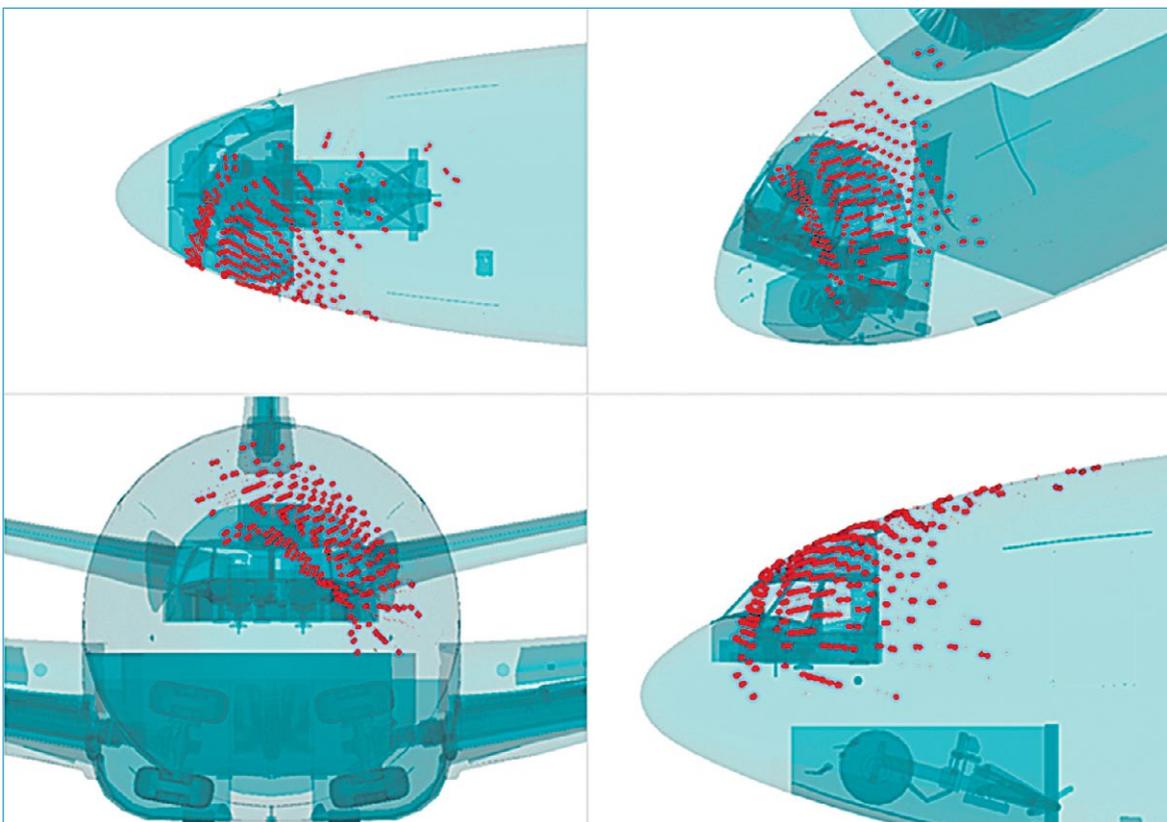
The best-match (green band in Table 19) between the simulation and the damage observed on the aeroplane was obtained with a 70 kg warhead flying at 730 metres per second and passing left of the aeroplane with an angle of 27 degrees to the aeroplane's x-axis and with a nose up attitude of 10 degrees (model IIb).

Figure 59: Image of the damage pattern produced by the model IIb in the warhead simulation model. (Source: TNO)

Based on its calculations, TNO concluded that a 70 kg warhead detonated 0.0 metres ahead and 2.0 metres to the left of, and 3.7 metres above the aeroplane's nose.

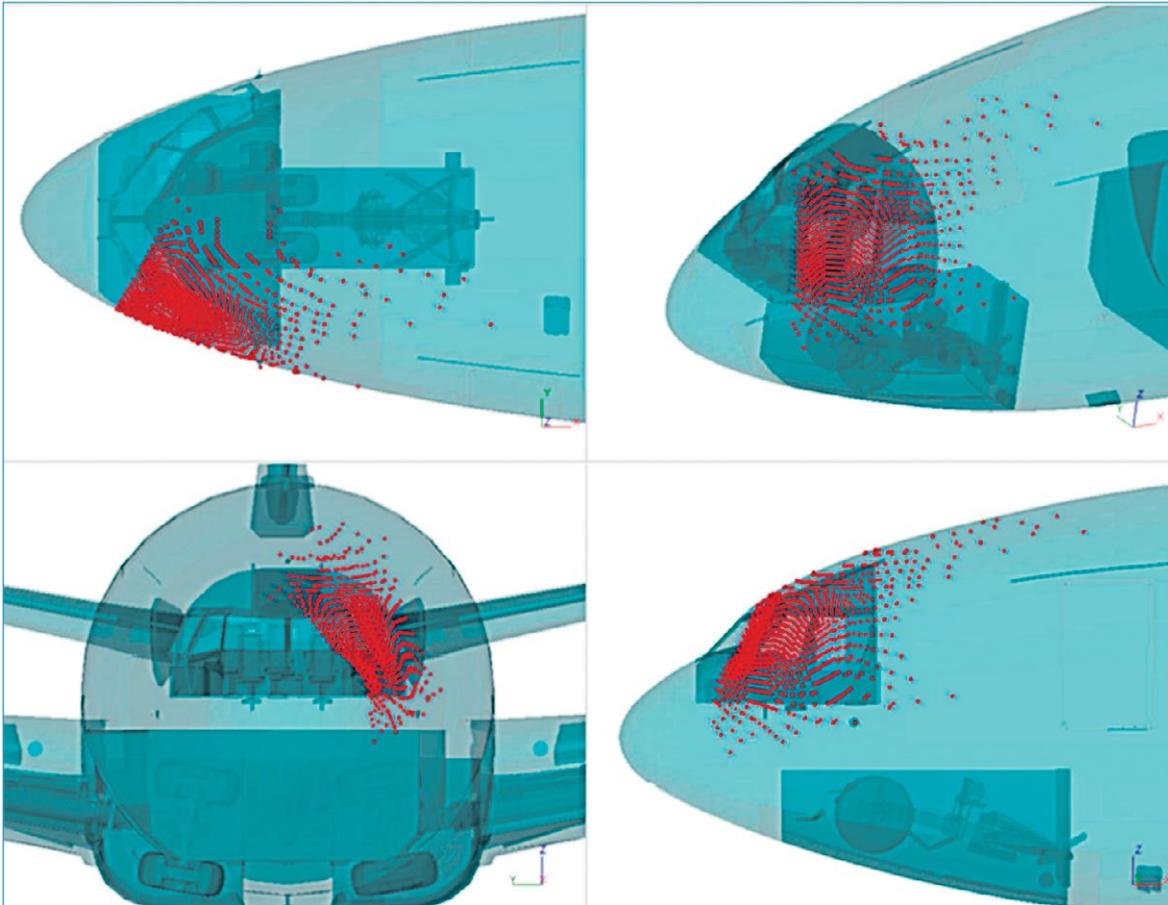
TNO's simulation also showed that there is no match obtained between the observed damage on the aeroplane and the simulated damage patterns when a smaller and lighter, 40 kg, warhead was applied. Figure 60 shows the simulated damage patterns for the set of simulations with a 40 kg warhead which were closest to the actual observed damage. This pattern gave a poorer match than was obtained with a heavier warhead (Model IIb).

Figure 60: Image of the damage pattern produced by the model of a 40 kg warhead in the warhead simulation model. (Source: TNO)

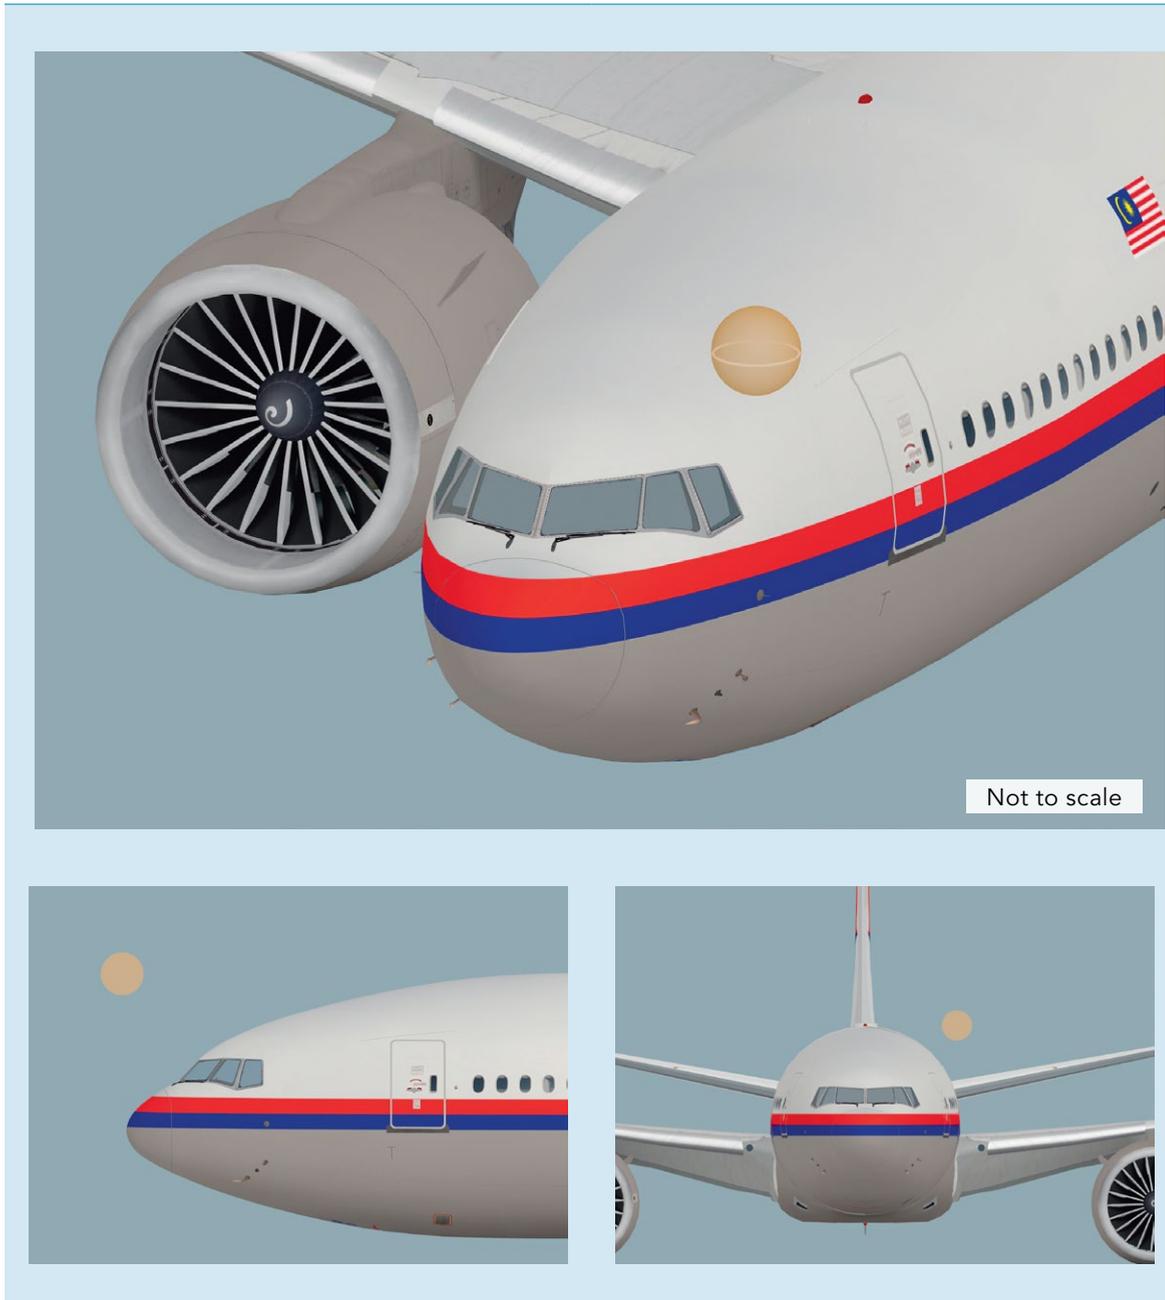
The Dutch Safety Board took account of uncertainties in the models by defining a volume of space that enclosed the results of the different simulations instead of a finite point in space. The volume of space of the warhead's detonation locations shown in Figure 61 is less than one cubic metre and is located at approximately 4 metres above the tip of the aeroplane's nose on the left side of the cockpit.

Figure 61: Simplified representation of the volume of space of the warhead detonation location according to three independent simulations. (Source: Dutch Safety Board)

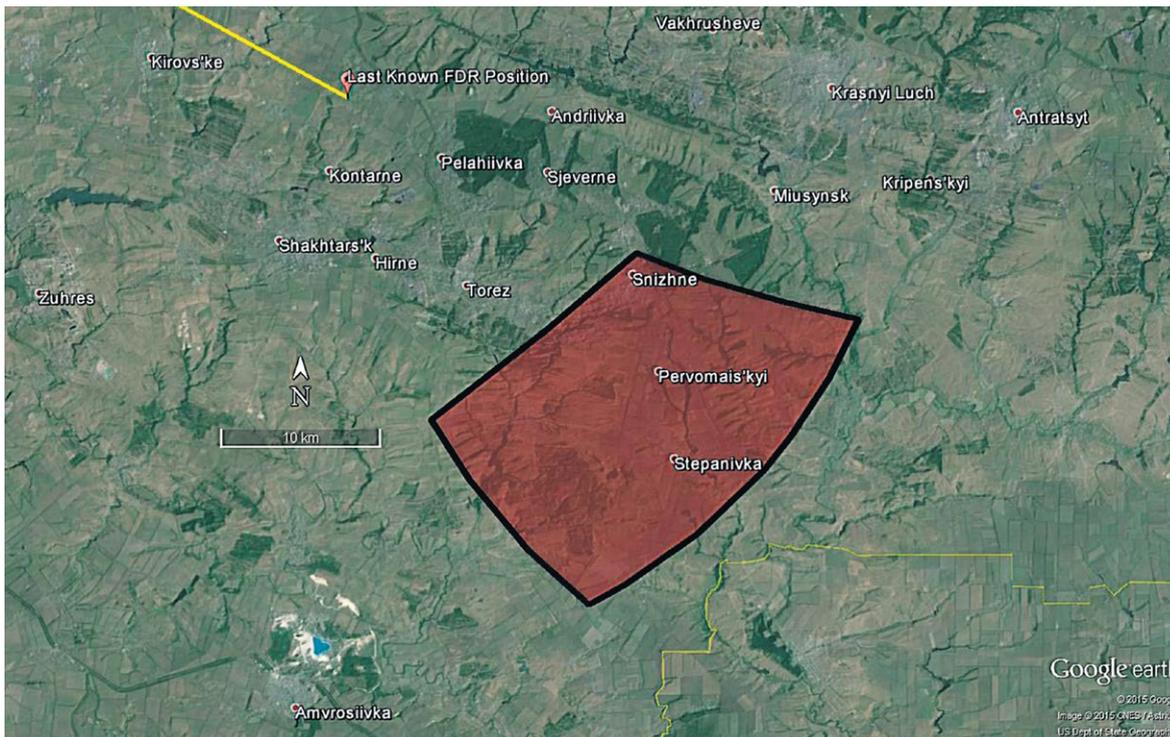
All of the possible points from where these flight paths could have commenced are visualised in Figure 62. Outside the calculated area of about 320 square kilometres, a 9N314M warhead carried on a 9M38-series missile as installed on the Buk surface-to-air missile system cannot create the damage pattern observed on the aeroplane.

Figure 62: Visualisation of NLR fly out simulation results. (Source: NLR)

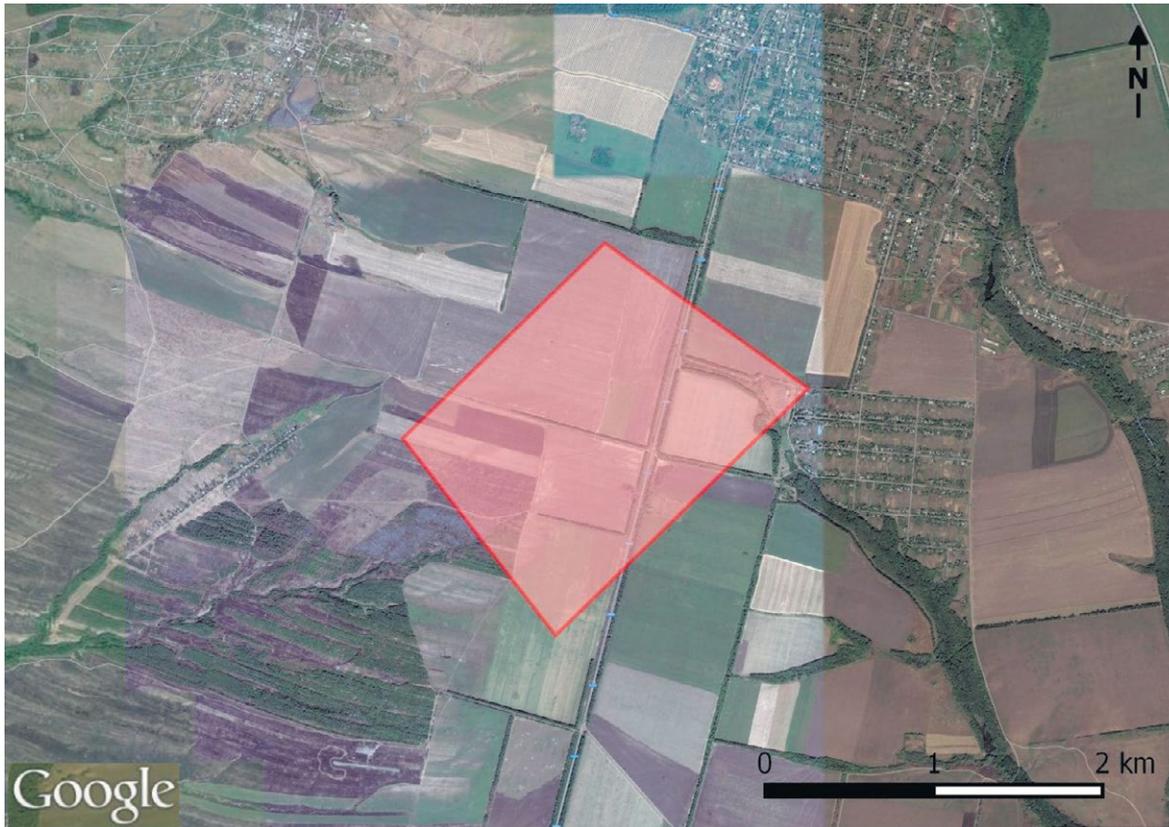
In a simulation performed by the Kyiv Research Institute for Forensic Expertise, an area of 4 square kilometres was calculated using the 9M38M1 missile and 9N314M warhead. This is shown in Figure 63.

Figure 63: Visualisation of Kyiv Research Institute for Forensic Expertise fly out simulation results. (Source: Kyiv Research Institute for Forensic Expertise)

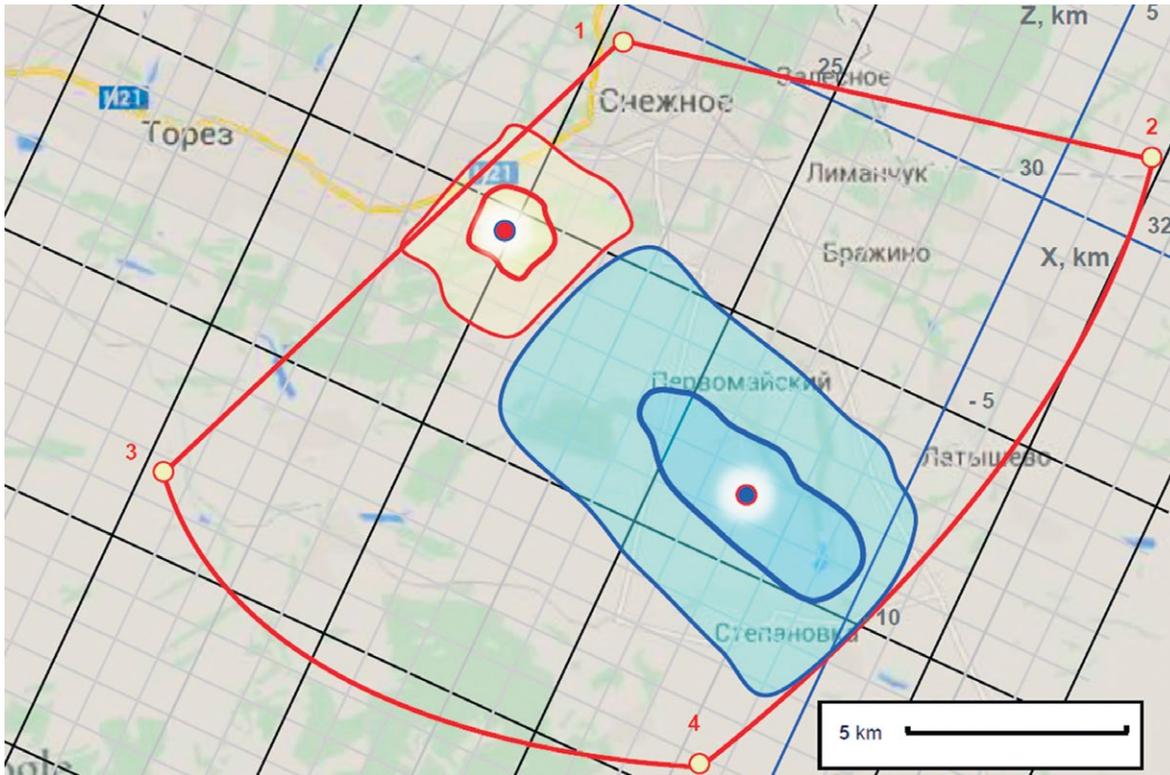
Results for sets of similar calculations were supplied; one for a warhead launched by a 9M38 missile and one for the same warhead launched by a 9M38M1 missile. These calculations produced two areas, respectively, approximately 20 and 63 square kilometres. The areas calculated by JSC Concern Almaz-Antey (see Figure 64) are consistent with the results of the NLR and Kyiv Research Institute for Forensic Expertise calculations.

Figure 64: Visualisation of JSC Concern Almaz-Antey fly out simulation results. Note: The red line, numbered 1 to 4, marks the initial area identified by the NLR fly out simulation; an area since updated. (Source: JSC Concern Almaz-Antey)

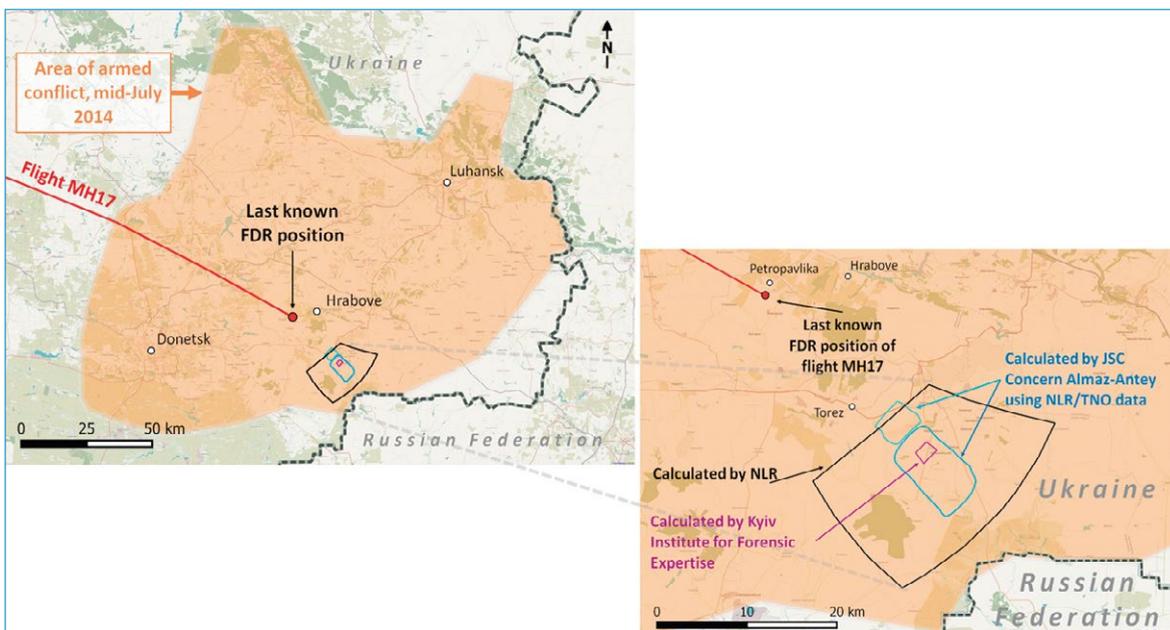
The results of the three sets of simulations are shown in a combination sketch (see Figure 65) of the calculated areas from which a 9N314M warhead carried on a 9M38-series missile as installed on the Buk surface-to-air missile system could have reached the warhead's detonation location in the volume of space near to flight MH17 and could have created the damage observed.

Figure 65: Combination sketch of the calculated areas. (Source: Dutch Safety Board)

Whilst the results of the three studies all point to a similar geographic area, further forensic research is required. Such work falls outside the mandate of the Dutch Safety Board, both in terms of Annex 13 and the Kingdom Act '*Dutch Safety Board*'.

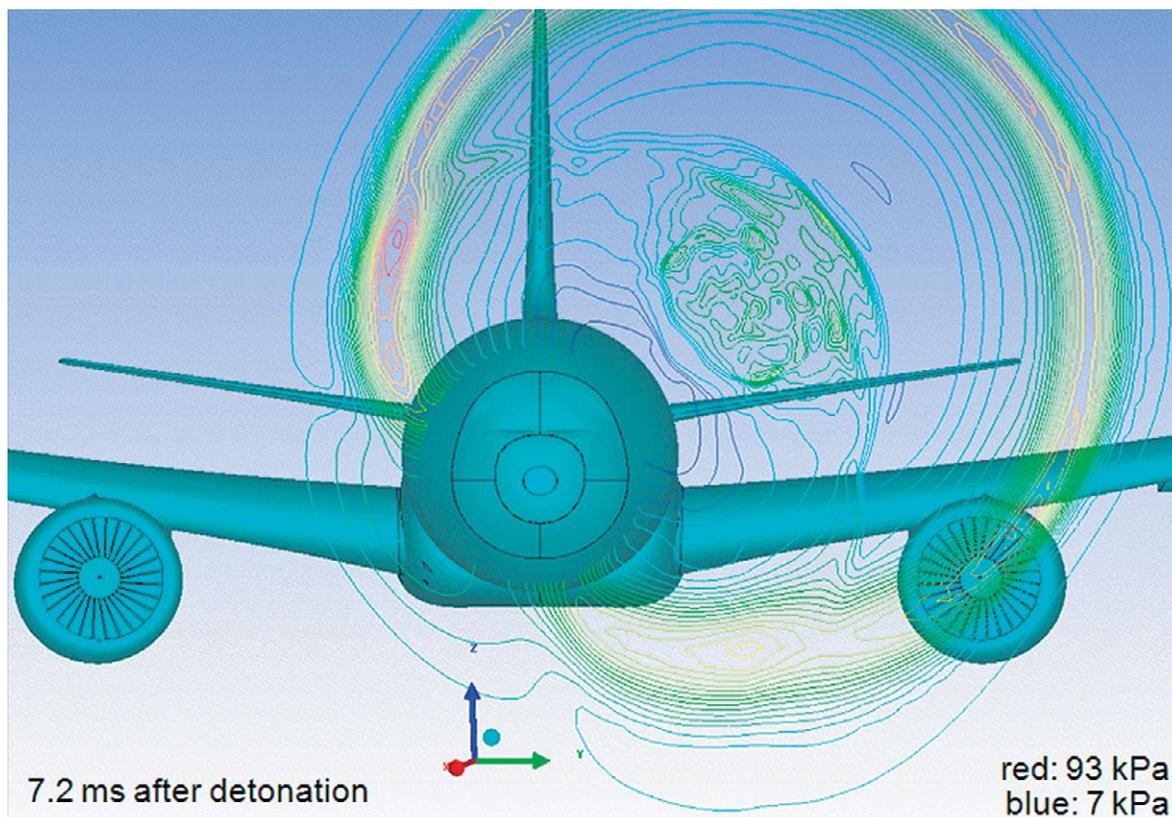
Figure 66: Sample image of blast simulation showing blast wave around fuselage, 7.2 milliseconds after detonation. (Source: TNO)

Calculations show how peak pressure decreases with increasing distance. The blast following the detonation of the warhead created an area of very high pressure near the cockpit with a maximum value of about 5,000 kilopascals. 75 kilopascals was taken to be

the threshold for the mildest form of blast damage on the aeroplane structure. At a distance from the aeroplane's nose of 12.5 metres the pressure drops below 75 kilopascals. Pressure kept decreasing until the effect of the blast became negligible at approximately 35 metres from the aeroplane's nose.

The damage to the wreckage recovered was consistent with the predictions made by the blast simulation.

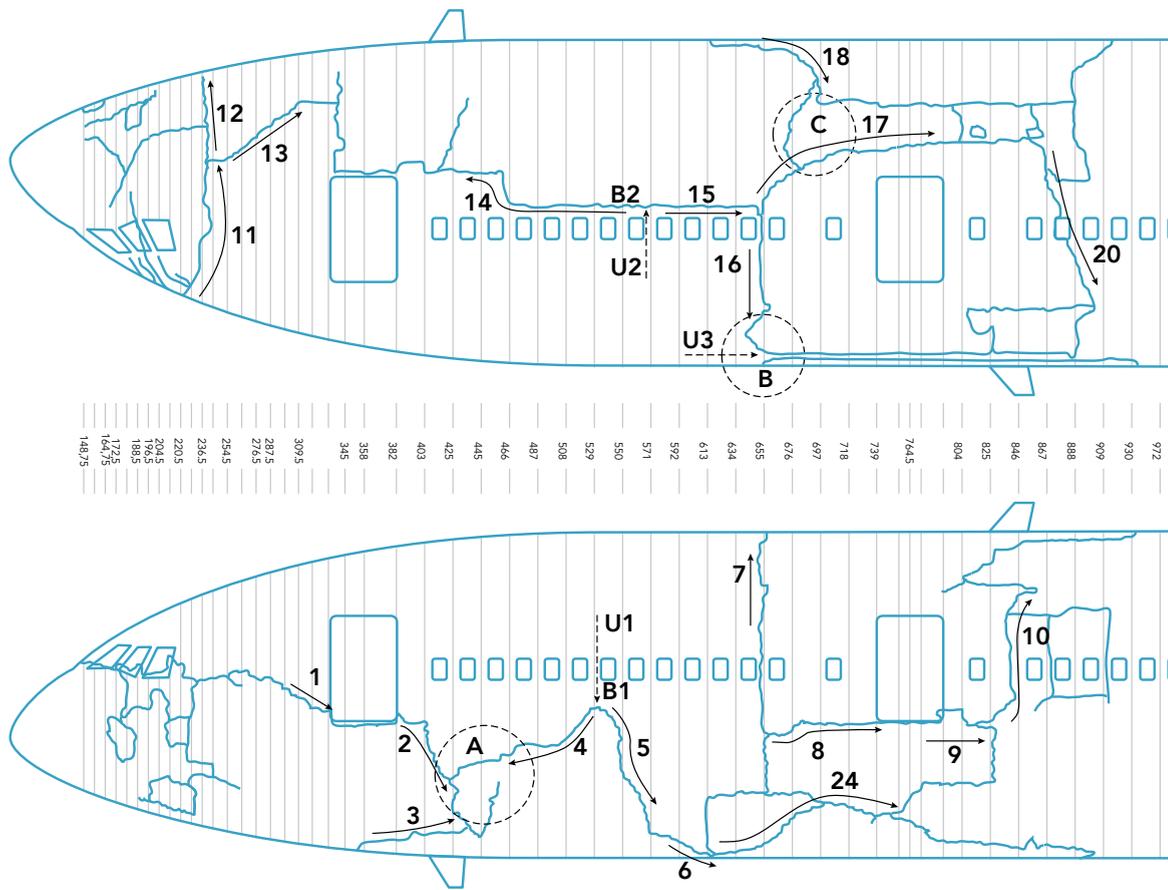
The other main fractures in the front fuselage are shown in Figure 67. These fractures are numbered (1 up to and including 20).

Figure 67: Front fuselage left hand side (bottom) and right hand side (top) view with main fracture lines and fracture growth directions. The arrows represent the growth direction. The lack of an arrow besides (part of) a fracture indicates that the growth direction could not be established. Frame locations are indicated by STA numbers. (Source: Dutch Safety Board)

Fractures 11 and 12 along STA236.5 can be associated with the initial direct blast wave due to their proximity to the cockpit and initial blast location. The horizontal fractures at the level of the passenger floor running aft (fractures 1, 2 and 13), caused a separation of the top part from the lower part of the front fuselage with the cockpit. The circumferential fractures at STA655 (fractures 7, 16 and 18) indicate a complete separation of the fuselage part in front of it.

The fractures in the upper part at STA655 (fractures 7 and 16) propagating upward indicate an upward bending moment acting on upper front parts and a separation of upper parts in upward direction. The fractures in the lower part at STA655 (fracture 18) and on the left hand side between STA529 and STA613 (fractures 5 and 6), propagating down indicate a downward bending moment acting on the part below the passenger floor plus cockpit and a separation of these parts in downward direction.

Following this separation, several longitudinal fractures developed in the fuselage part from STA655 until STA888/909, (fractures 8, 9, 17, 19 and 24) propagating to the rear, caused radial opening of it and locally peeling of the skin from stringers and frames. The other fractures between STA655 and STA888/STA909 were consistent with the radial opening of the fuselage due to aerodynamic loads. Finally this fuselage part separated from the centre fuselage behind it between STA888 and STA930, see Figure 68.

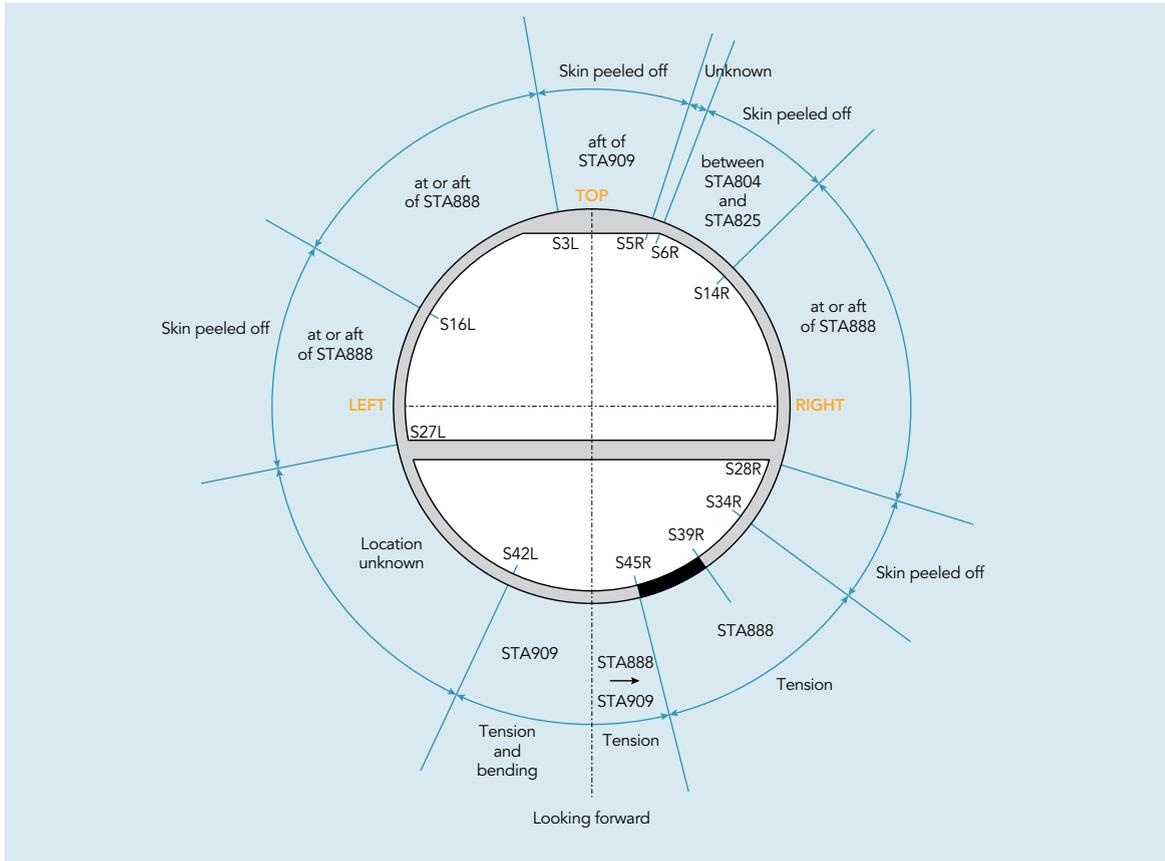
Figure 68: Observed position of fracture at STA 888/909 and type of loading of the fracture at STA888/909. Only between stringers 45R and 39R parts from the front and the centre fuselage fitted together. In the figure the thick line indicates this location. (Source: Dutch Safety Board)

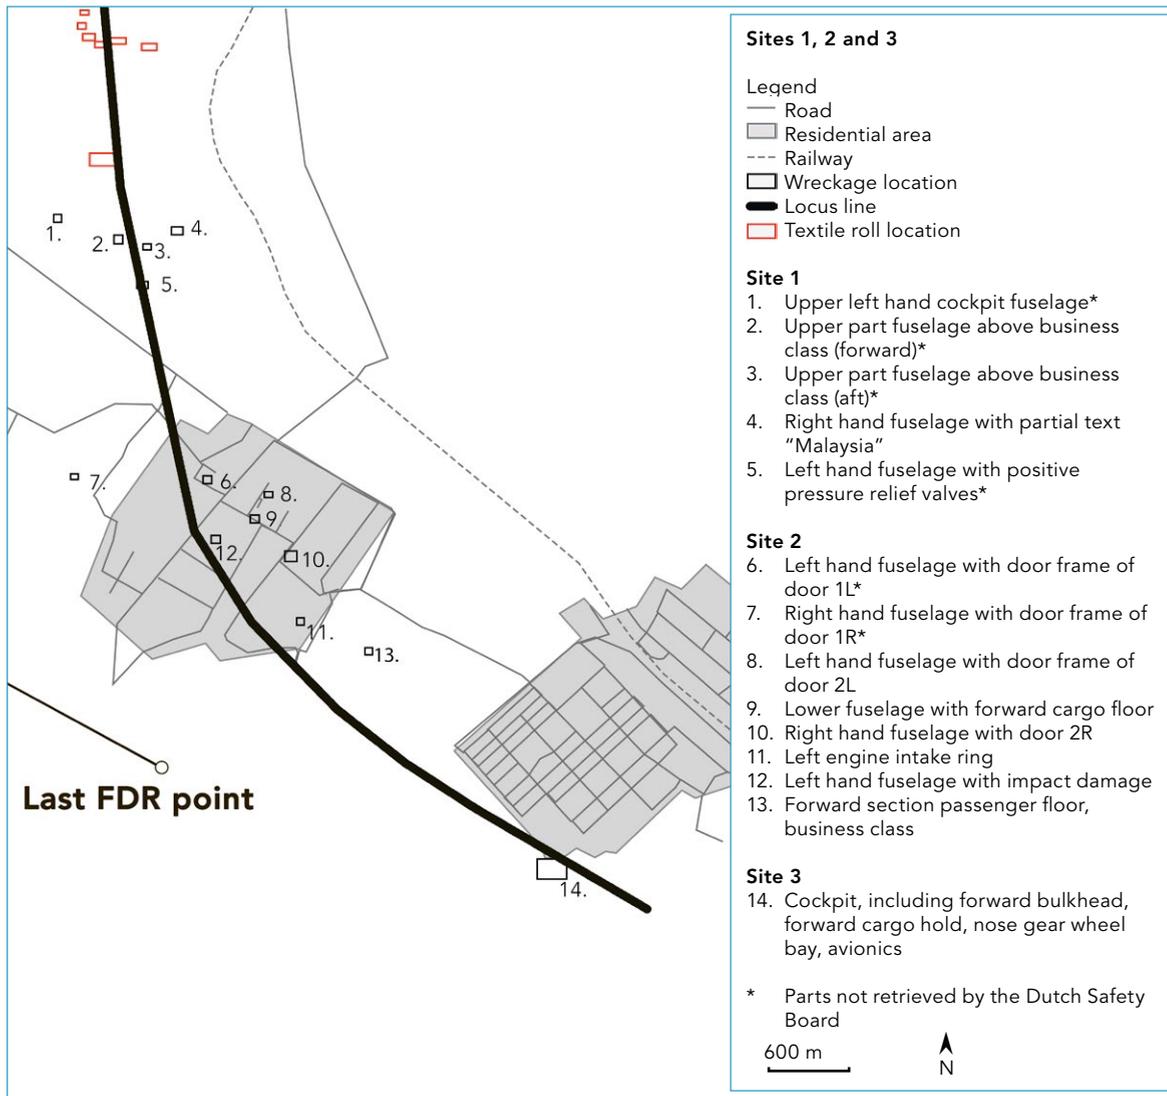
By running the ballistic trajectory analysis for multiple ballistic coefficients, a so-called locus line was obtained. The locus line represents the possible ground positions of wreckage parts after break-up, assuming that they all separated at the same initial position, altitude and speed and assuming a ballistic trajectory taking into account the wind, see Figure 74.

Figure 74: Calculated locus line (black) from ballistic trajectory analysis with identified wreckage and cargo parts in sites 1, 2 and 3. (Source: Dutch Safety Board)

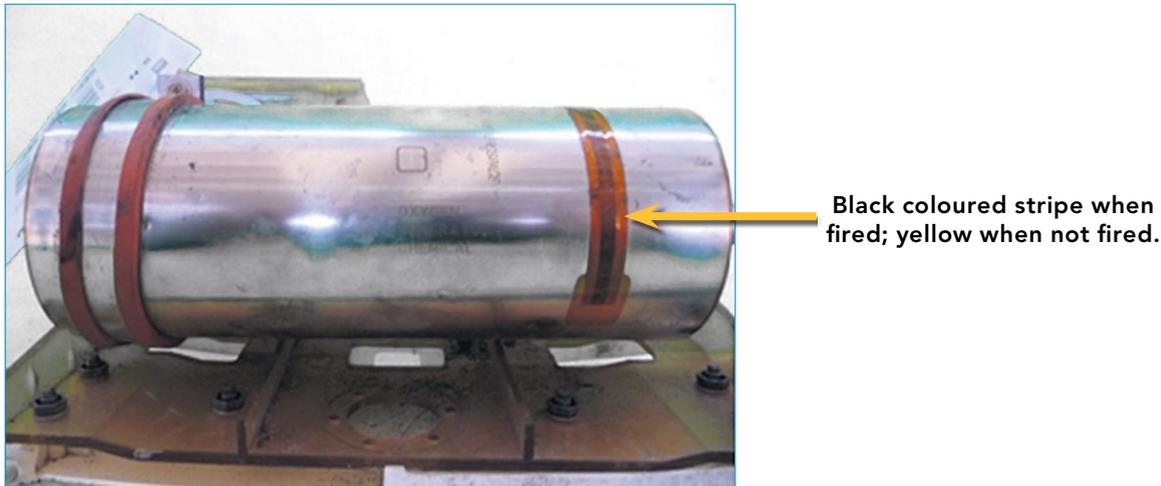
On the oxygen generators recovered from sites 4 and 5, some solenoid switches were deformed and the latches had separated from all of the recovered containers. It is therefore considered likely that oxygen masks dropped out of the passenger service unit containers due to torsion or other forces upon these containers. This would then result in the unlocking or separation of the latches. This could have been the result of either the blast of the warhead explosion, the effects of the in-flight break-up or the impact with the ground.

It requires a force of only a few Newton²⁰ to remove the firing pin from the oxygen generator. Therefore, it is conceivable that the oxygen generators were fired as a result of the blast, the dynamic forces during the in-flight break-up or the impact with the ground. The oxygen generator which had not been fired, originated from the crew rest area. It is considered possible that the rest area, a closed container, may have been better protected against the dynamic forces during the in-flight break-up or from the impact with the ground.

Figure 75: One of the recovered passenger oxygen generators. (Source: Dutch Safety Board)
